# Scene 0 · MS4 Assessment

Black Branch 2

City of Lebanon TN

36.17005, -86.26820 · Generated October 23, 2026

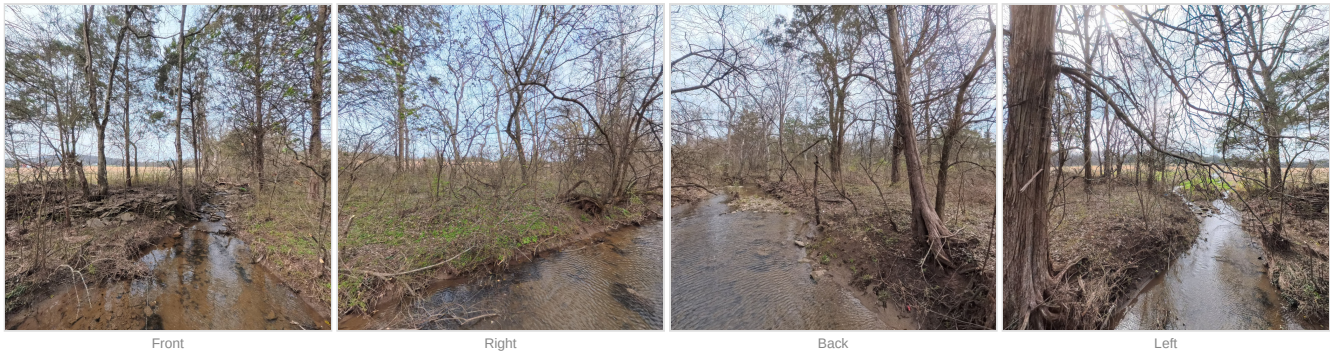
**Front:** Looking downstream, the channel narrows and flows through a wooded corridor with predominantly bare deciduous trees. Exposed flat rock slabs are visible on the left bank forming a shelf-like ledge above the water. The channel appears to have a slight curve to the right. Agricultural fields are visible through the trees in the background on the left side.

**Right:** The right bank (left bank when facing downstream) shows a low to moderate bank with deciduous trees and shrubs in dormant condition. Green herbaceous ground cover is emerging on the bank. The bank shows exposed soil and some root exposure where trees meet the water's edge. Agricultural fields or open land with structures are visible in the background through the bare canopy.

**Back:** Looking upstream, the channel curves away to the left with flowing water visible. The right bank shows exposed soil with tree roots and cedar trees. A wooded riparian corridor is present on both sides but the buffer appears narrow, especially on the left side where open land is nearby. Some woody debris is in the channel near the banks.

**Left:** The left bank view (right bank when facing downstream) shows a narrow wooded riparian corridor with large cedar and deciduous trees. Beyond the riparian strip, open agricultural fields are clearly visible. The stream curves downstream with shallow water flowing over what appears to be flat rock substrate. The riparian buffer is thin, perhaps only 25-50 feet before transitioning to open agricultural land. Some flat rock visible at the far right edge of the view in the channel.

Black Branch 20 at this starting reach is a small headwater perennial stream flowing through a narrow riparian corridor bordered by agricultural fields. The stream shows moderate impairment primarily from agricultural sedimentation, with fine silt and mud covering the native limestone bedrock substrate. Bank erosion is moderate on both sides, and the riparian buffer, while meeting minimum 30-foot TDEC standards, is thin and provides limited protection. Instream habitat is marginal due to sparse woody debris, shallow pools, and embedded substrate. No stormwater infrastructure or outfalls are present at this rural location, and no illicit discharge indicators were observed.

| Metric | Score | Notes |
|---|---|---|
| Sediment Deposition | 5 | Fine sediment (silt and mud) covers much of the channel bed, partially burying what appears to be natural bedrock and gravel substrate. Silt deposits are visible in the down face view. While not forming large bars, fine sediment deposition is pervasive, suggesting ongoing sedimentation from agricultural runoff. Estimated 20-35% of bed affected. |

| Side | Stability | Veg. Protection | Erosion | Notes |
|---|---|---|---|---|
| Left | 6 | 6 | 26_50_percent | Left bank shows moderate erosion with exposed roots at waterline. Agricultural field is visible beyond a thin riparian strip. Early spring herbaceous growth is beginning. |
| Right | 6 | 5 | 26_50_percent | Right bank shows more pronounced erosion than left, with steeper slopes, exposed roots, and undercutting. Cedar tree roots provide significant anchoring in places. Agricultural land visible beyond thin riparian buffer. |

| Metric | Score/Value | Notes |
|---|---|---|
| TDEC 30ft Buffer Met? | L: Yes / R: Yes | The 30ft minimum buffer appears to be met on both sides but barely. Agricultural fields are clearly visible through the riparian corridor indicating the buffer is narrow. Buffer widening through conservation easements or agricultural buffer programs would significantly improve stream health and sediment filtration capacity. |

| Action | Priority | Timeline |
|---|---|---|
| Complete outfall mapping for upstream drainage area to verify no unreported discharge points | medium | annual |
