# Scene 1 · MS4 Assessment

Black Branch 2

City of Lebanon TN

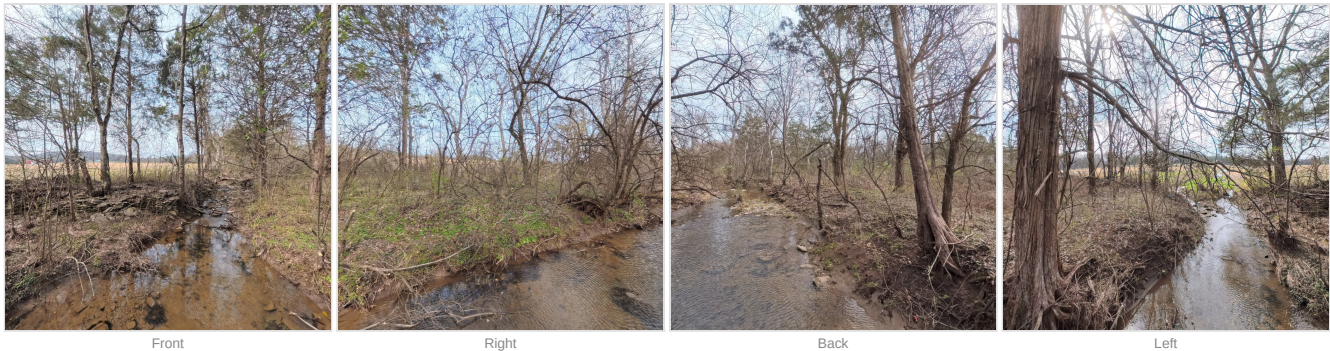
**Front:** Looking downstream, a small headwater stream flows through a narrow wooded corridor with exposed bedrock/limestone substrate visible in the channel. Beyond the thin riparian buffer, open agricultural fields are visible in the background with what appears to be a red barn or structure on the far left. The stream channel is shallow with scattered flat rock in and along the bed.

**Right:** The right bank (left bank when facing downstream) shows a low bank with herbaceous ground cover and bare deciduous trees. The bank rises gently with a mix of grass, scattered shrubs, and dormant deciduous trees. Beyond the thin riparian strip, what appears to be agricultural land or open fields is faintly visible through the trees. Some bank erosion is evident with exposed soil near the waterline.

**Back:** Looking upstream, the stream channel extends with shallow water flowing over a mixed substrate. The left bank (right when facing upstream) has exposed soil and roots with some erosion evident. Eastern red cedar and other deciduous trees line both banks with exposed root systems visible at the waterline. The channel appears slightly incised with moderate bank heights.

**Left:** The left bank (right bank when facing downstream) shows a narrow stream channel with a large eastern red cedar tree at the bank edge and various dormant deciduous trees. Agricultural fields are visible beyond the thin riparian buffer on this side. The bank shows some root exposure and minor erosion. The stream is narrow, maybe 4-6 feet wide at this point, with low banks and a thin riparian corridor separating the channel from open fields.

Black Branch 21 at this headwater location is a small (5-8 ft wide), low-gradient perennial stream flowing through a narrow riparian corridor bordered by agricultural fields. The stream shows moderate impairment primarily from agricultural sediment loading, with fine silt/mud dominating the substrate and burying what would naturally be a limestone bedrock/gravel bed. The riparian buffer is inadequate, particularly on the right bank where it may not meet TDEC's 30-foot minimum standard. Instream habitat is limited with sparse woody debris, few pools, and low habitat diversity. No stormwater infrastructure or outfalls were observed at this rural location; the primary water quality concern is non-point source agricultural runoff.

| Metric | Score | Notes |
|---|---|---|
| Sediment Deposition | 5 | Significant fine sediment (silt/mud) dominates the substrate, suggesting excess sediment loading likely from agricultural runoff. Approximately 30-50% of the bed appears affected by fine sediment deposition. The natural bedrock visible in the front view is partially buried by sediment in other areas. |

| Side | Stability | Veg. Protection | Erosion | Notes |
|---|---|---|---|---|
| Right | 5 | 5 | 26_50_percent | Right bank shows more active erosion than left bank. Root exposure on eastern red cedar trees indicates ongoing bank retreat. Thin riparian buffer with agricultural fields visible beyond the tree line. |

| Metric | Score/Value | Notes |
|---|---|---|
| TDEC 30ft Buffer Met? | L: Yes / R: No | Right bank riparian buffer appears insufficient per TDEC 30ft standard in some areas. Agricultural land directly adjacent to narrow riparian corridor contributes to sediment loading and reduces buffering capacity. Buffer restoration on both banks, particularly the right bank, would improve water quality and habitat. |

| Action | Priority | Timeline |
|---|---|---|
| Coordinate with agricultural extension services regarding riparian buffer restoration and agricultural BMP implementation in the contributing watershed. | medium | 90_days |
