# Scene 10 · MS4 Assessment

Black Branch 2

City of Lebanon TN

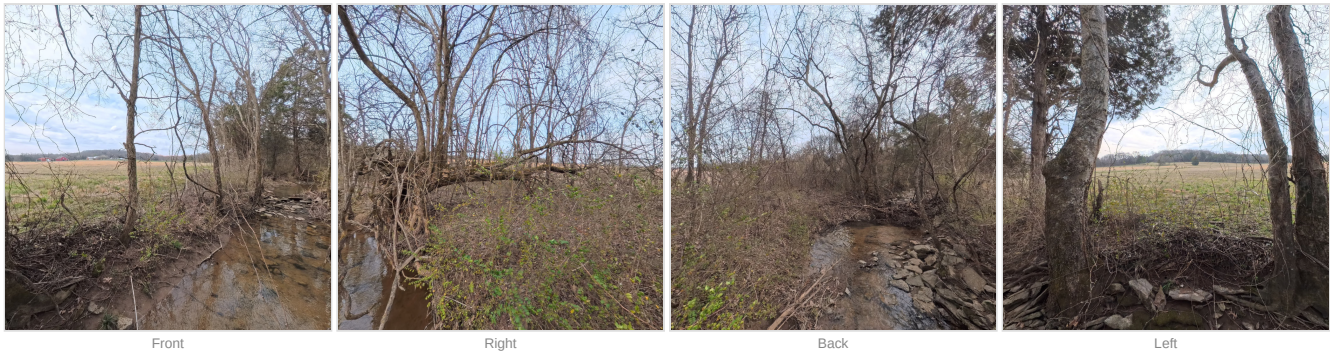
**Front:** Looking downstream, the view shows a narrow stream channel flowing through a riparian corridor of bare deciduous trees. To the left, open agricultural pasture/hay fields extend to the horizon with a red barn visible in the far distance. The right bank has a narrow wooded riparian buffer with exposed rock and some green understory vegetation beginning to emerge. Flat limestone/shale rock slabs are visible along the right bank edge.

**Right:** The right bank (looking downstream) shows a narrow riparian buffer of deciduous trees and dense understory shrubs/vines, all mostly bare or just beginning to leaf out. Behind the riparian buffer, open agricultural pastureland is visible through the vegetation. A large fallen tree spans across the area. The bank appears moderately steep with exposed roots and soil. Green ground cover (possibly invasive) is emerging at ground level.

**Back:** Looking upstream, the stream channel is visible as a narrow, shallow flow over exposed bedrock and flat limestone/shale substrate. The channel curves slightly through a wooded riparian corridor. Both banks show bare deciduous trees with some shrub understory. The right bank (from this perspective, which is the left bank looking downstream) has prominent flat rock slabs along the channel edge. The left side shows dense low vegetation and scattered trees.

**Left:** The left bank (looking downstream) shows a very narrow riparian tree line of mature sycamore and other deciduous trees, then immediately transitions to open agricultural pasture/hay field extending to the distant treeline on rolling hills. The bank edge has exposed flat limestone/shale rock with leaf litter and debris. A fence post or old structure may be visible. The buffer between the stream and the open field is extremely narrow, perhaps only 10-30 feet wide.

Black Branch at this location is a small headwater limestone bedrock stream flowing through an agricultural landscape in rural Middle Tennessee. The stream is moderately to severely impaired, primarily due to inadequate riparian buffers (especially the left bank at 10-25ft, below TDEC's 30ft minimum), channel entrenchment disconnecting the floodplain, and limited instream habitat diversity. Water quality indicators are relatively good with no evidence of illicit discharge, but the shallow bedrock channel offers poor pool development and limited fish/macrobenthic habitat. Invasive bush honeysuckle and Japanese honeysuckle are colonizing the narrow riparian zone. Priority management actions include riparian buffer restoration on both banks, particularly the left bank, and invasive species management.

| Side | Stability | Veg. Protection | Erosion | Notes |
|---|---|---|---|---|
| Left | 5 | 4 | 1_25_percent | Left bank has extremely narrow riparian buffer transitioning to open agricultural pasture/hay fields. Sycamore trees provide some canopy but the buffer is inadequate for effective filtering. Possible fence line along the bank edge may indicate livestock management. |
| Right | 5 | 5 | 1_25_percent | Right bank has a somewhat wider riparian buffer than the left but still transitions to agricultural land. Dense understory of shrubs and vines likely includes invasive species. A large fallen tree indicates some bank instability. Moderate root exposure and undercutting present. |

| Metric | Score/Value | Notes |
|---|---|---|
| TDEC 30ft Buffer Met? | L: No / R: Yes | Left bank riparian buffer is non-compliant with TDEC MS4 permit section 4.2.5.4 minimum 30ft buffer requirement. Agricultural pasture/hay field extends to within approximately 10-25 feet of the channel. Right bank meets minimum standard but not enhanced protection requirements. Buffer restoration along both banks, particularly the left, would significantly improve stream health and is a high priority recommendation. |

| Action | Priority | Timeline |
|---|---|---|
| Document inadequate riparian buffer on left bank (below 30ft TDEC minimum) and coordinate with agricultural landowner on buffer restoration opportunities | high | 90_days |
