# Scene 11 · MS4 Assessment

Black Branch 2

City of Lebanon TN

36.17007, -86.26896 · Generated October 23, 2026

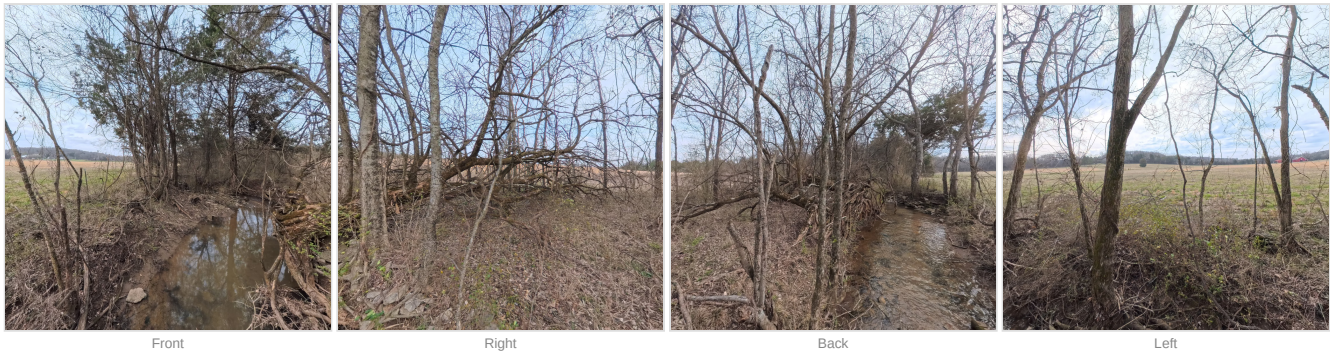
**Front:** Looking downstream, the channel curves slightly to the right through a narrow, wooded riparian corridor. A pool of standing/slow-moving water is visible with brown-tinted, slightly turbid water reflecting bare tree canopy. Large woody debris including a fallen log spans across the channel. Open agricultural field is visible to the left beyond the thin riparian strip.

**Right:** Looking toward the right bank (left bank when facing downstream), a steep wooded slope rises from the channel. Several deciduous trees in bare winter condition are present, along with a large fallen tree spanning horizontally. The ground is covered with leaf litter and some small rocks/rubble visible at the base near the channel. Beyond the riparian trees, an open agricultural or pasture field is faintly visible through the tree trunks.

**Back:** Looking upstream, the channel is visible as a shallow, flowing reach with brown-tinted water over a substrate that appears to be a mix of exposed rock and gravel. Significant root exposure is visible on the left bank (right bank facing downstream) where trees are perched above eroded banks. The channel appears slightly wider upstream. Open fields are visible on both sides beyond the narrow riparian corridor. Some flat rock fragments in the channel could be natural limestone bedrock or potentially concrete rubble—warrants closer inspection.

**Left:** Looking toward the left bank (right bank when facing downstream), an open agricultural pasture/field extends to the horizon. A red barn or agricultural building is visible in the distance. The riparian corridor is extremely narrow at this point, consisting of only a single row of bare deciduous trees and sparse shrubs. The transition from pasture to stream bank is abrupt with minimal buffer. Some green herbaceous growth is visible at ground level suggesting early spring emergence.

Black Branch at this location is a small perennial warmwater stream in marginal condition, primarily impacted by inadequate riparian buffers and agricultural land use encroachment. The channel has incised to form an unstable Rosgen F-type, disconnecting from its floodplain and producing moderate bank erosion on both sides. Fine sediment from agricultural runoff is degrading substrate quality and water clarity. No stormwater infrastructure or outfalls are present at this rural location, but the absence of agricultural BMPs such as riparian buffers and livestock exclusion fencing represents a significant nonpoint source pollution concern for MS4 watershed management.

| Metric | Score | Notes |
|---|---|---|
| Channel Condition | 6 | Channel appears natural with no engineered modifications visible, but shows evidence of active incision and lateral erosion. The channel is somewhat entrenched relative to the adjacent floodplain, with moderate to steep banks. Root exposure on banks suggests ongoing downcutting. No artificial structures but the channel is responding to altered hydrology from surrounding agricultural land use. |
| Hydrologic Alteration | 4 | Channel shows moderate incision with banks 3-6 feet high relative to the bed. The stream appears disconnected from its floodplain, meaning only larger flood events access the floodplain. Agricultural drainage from surrounding fields likely increases flashiness and contributes to incision. Low flow conditions at the time of assessment further suggest altered hydrology. |
| Sediment Deposition | 5 | Moderate sediment deposition is evident. The downstream pool has brown/turbid water suggesting fine sediment inputs. Some aggradation is apparent from the exposed channel bed at the camera position, though the limestone substrate provides some resistance. Agricultural runoff is a likely sediment source. Approximately 20-30% of visible channel bottom appears affected by fine sediment deposition. |

| Side | Stability | Veg. Protection | Erosion | Notes |
|---|---|---|---|---|
| Left | 4 | 4 | 26_50_percent | Left bank shows moderate erosion with active undercutting. Riparian buffer is narrow with agriculture immediately adjacent. Root exposure indicates ongoing lateral migration. Bank would benefit from buffer expansion and stabilization. |
| Right | 5 | 5 | 1_25_percent | Right bank is slightly more stable than left with denser woody vegetation. Some fallen trees contribute natural bank armoring. Agricultural field visible beyond the riparian strip but buffer appears marginally wider on this side. Moderate erosion on outside of bends. |

| Metric | Score/Value | Notes |
|---|---|---|
| TDEC 30ft Buffer Met? | L: No / R: No | Significant buffer deficiency on both banks. Agricultural use extends to near the bank edge, particularly on the left bank. High potential for buffer restoration through agricultural set-aside or riparian planting programs. This is a priority area for buffer establishment to reduce sediment and nutrient loading from agricultural fields. |

| Action | Priority | Timeline |
|---|---|---|
| Document inadequate riparian buffer conditions for watershed management plan | medium | 90_days |
| Coordinate with agricultural extension services regarding voluntary riparian buffer establishment programs | medium | annual |
