# Scene 12 · MS4 Assessment

Black Branch 2

City of Lebanon TN

36.17008, -86.26905 · Generated October 23, 2026

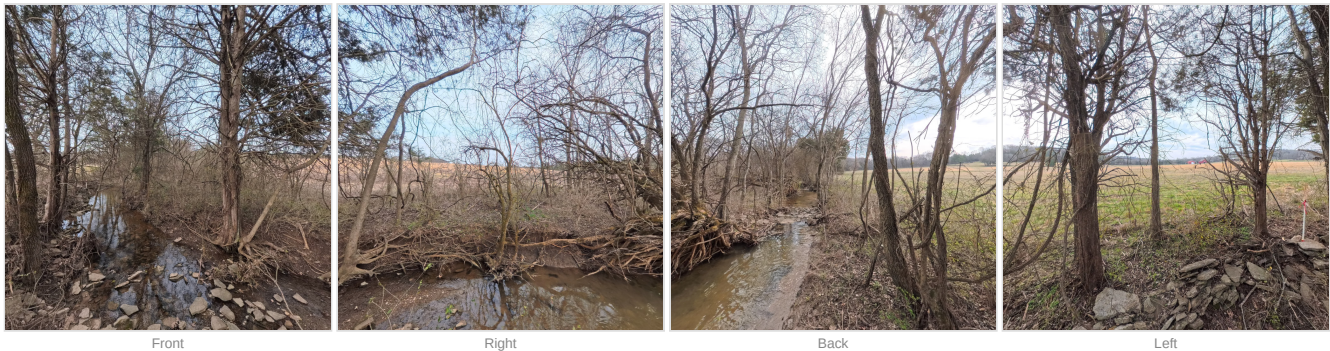
**Front:** Looking downstream, a narrow stream channel winds through a deciduous riparian corridor with bare winter trees. The channel is shallow with exposed flat rock/stone substrate and very low water. In the distance, what appears to be a structure or building is partially visible through the trees.

**Right:** Looking toward the right bank (left bank when facing downstream), dense bare deciduous shrubs and small trees are visible with exposed root systems at the bank edge. Beyond the riparian zone, an open agricultural field/pasture is visible in the background with what appears to be bare or dormant brown grass. Significant bank undercutting is evident with exposed roots.

**Back:** Looking upstream, the stream channel extends with shallow turbid water over a rocky/gravel bed. The left bank shows exposed root wads from a large tree with significant undercutting. Open agricultural/pastoral land is visible on the left (right bank facing downstream) through sparse riparian trees. A fencing post or marker stake may be visible on the right side.

**Left:** Looking toward the left bank (right bank facing downstream), an open agricultural pasture field extends beyond a very thin riparian buffer. A red barn/agricultural structure is visible in the distance. A marker stake with red and white markings is visible at the bank edge. Flat rocks/stones are piled along the bank top, which could be placed stone or natural limestone outcrop — requires closer inspection. The riparian buffer is extremely narrow, perhaps only 10-20 feet of scattered trees.

Black Branch at this location is a small headwater stream in marginal condition, primarily impacted by adjacent agricultural land use that has reduced the riparian buffer to inadequate widths, particularly on the right bank. The channel is moderately entrenched (Rosgen Type F) with active bank erosion and undercutting, especially on the left bank where severe root exposure is evident. Water quality appears fair with some turbidity but no evidence of acute contamination. No stormwater infrastructure or outfalls were observed. The primary management need is riparian buffer restoration on the right bank and bank stabilization to reduce sediment inputs.

| Metric | Score | Notes |
|---|---|---|
| Channel Condition | 6 | Channel appears natural with no direct modifications visible. However, moderate incision is evident from the bank heights (3-6 ft) relative to the narrow channel width, and the exposed root systems suggest ongoing downcutting. The channel is not artificially altered but shows geomorphic instability likely related to altered hydrology from surrounding agricultural land use. |
| Hydrologic Alteration | 5 | The channel shows moderate incision with 3-6 ft banks for a stream that is less than 10 ft wide. This degree of incision limits floodplain connectivity. The surrounding agricultural land use likely has increased runoff and reduced infiltration, altering the hydrologic regime. Flooding of the adjacent fields appears infrequent based on the incision depth. |
| Sediment Deposition | 5 | Some sediment deposition is visible in the channel, with fine sediments and gravel accumulating in the shallow runs. The turbid water color suggests active sediment transport. Point bars appear to have some sediment accumulation. Approximately 20-30% of the visible bed appears affected by recent deposition. |

| Side | Stability | Veg. Protection | Erosion | Notes |
|---|---|---|---|---|
| Left | 4 | 5 | 26_50_percent | Left bank shows significant undercutting with exposed root systems. The narrow riparian buffer transitions quickly to agricultural pasture. Severe root exposure on mature trees suggests ongoing lateral migration and bank retreat. |
| Right | 5 | 4 | 1_25_percent | Right bank has a very narrow riparian buffer with agricultural pasture extending to within 10-25 ft of the channel. Flat limestone rock at the bank surface provides some natural armoring. A survey/property marker stake is visible. Red barn visible in the distance across the pasture. |

| Metric | Score/Value | Notes |
|---|---|---|
| TDEC 30ft Buffer Met? | L: Yes / R: No | The right bank buffer is inadequate and does not appear to meet TDEC's minimum 30 ft riparian buffer requirement. Agricultural pasture extends to within approximately 10-20 ft of the channel in some areas. Buffer restoration through planting and livestock exclusion fencing would significantly improve stream health. The left bank buffer is marginal but may meet minimum requirements. |

| Metric | Score | Notes |
|---|---|---|
| Water Appearance | 5 | Water appears slightly turbid with a brownish color. Visibility appears to be approximately 1-2 ft based on the ability to see the substrate in shallow areas. No oil sheen, foam, or algal mats are visible. The brown color could be from natural tannins or sediment. |

| Action | Priority | Timeline |
|---|---|---|
| Document inadequate riparian buffer on right bank for MS4 compliance records | medium | 90_days |
| Verify agricultural land use practices adjacent to stream do not contribute to water quality impairment | medium | 90_days |
