# Scene 13 · MS4 Assessment

Black Branch 2

City of Lebanon TN

36.17006, -86.26915 · Generated October 23, 2026

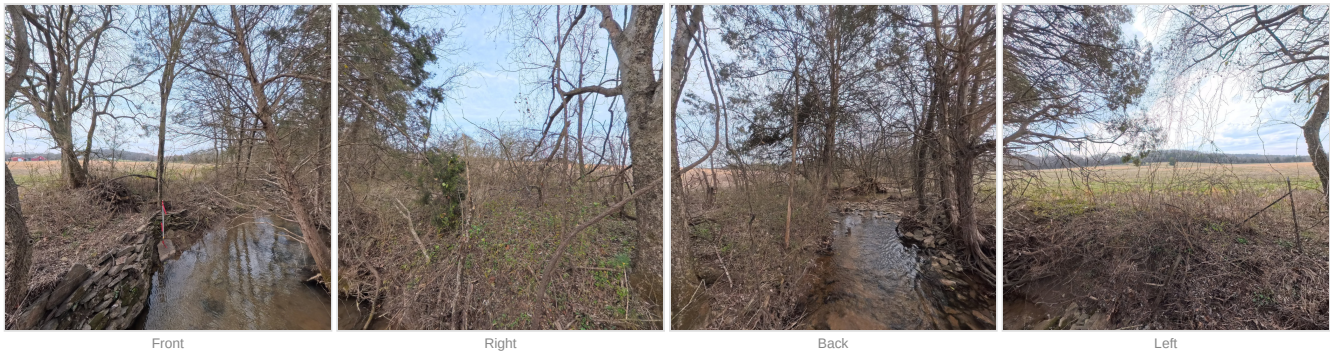
**Front:** Looking downstream, a narrow stream channel flows between wooded banks with bare deciduous trees. The left bank features a prominent exposed rock/stone ledge face approximately 3-4 feet high. A red and white survey rod or marker stake is visible at the bank edge. Agricultural fields and a red barn are visible in the background through the bare trees on the left side.

**Right:** The right bank (facing downstream) shows a densely vegetated area with bare deciduous trees and thick understory of dormant shrubs, vines, and herbaceous vegetation. The area appears to be a wooded riparian buffer zone with several Eastern Red Cedar trees (evergreen) mixed among deciduous hardwoods. Ground cover is dense with leaf litter, dormant vines (possibly Japanese honeysuckle), and low vegetation. Some green ground cover is visible even in winter.

**Back:** Looking upstream, the narrow stream channel winds through a wooded corridor. Both banks are lined with trees including Eastern Red Cedar and bare deciduous hardwoods. The stream bed shows exposed rock substrate and shallow flowing water with visible ripples. Rocky material is visible on both banks, with the right bank (looking upstream, which is left bank facing downstream) showing exposed flat rock ledges. Agricultural fields are visible in the background through gaps in the tree line.

**Left:** The left bank (facing downstream) shows an open agricultural field extending to the horizon with brown dormant grass or harvested crop stubble. The riparian buffer between the stream and the field is very narrow, consisting of a thin line of trees with a fence line visible at the edge. The field appears to be actively farmed pasture or row crop land. Hills with forested ridgeline are visible in the far background. Some stone is visible at the base of the bank edge near the camera position.

Black Branch at this location (scene 13 of 53) is a narrow, low-order perennial stream flowing through an agricultural landscape in Wilson County, Tennessee. The stream rates as marginally impaired (6.2/10) with its primary limitations being an inadequate riparian buffer on the left bank where agricultural fields extend within 10-25 feet of the stream, moderate channel incision disconnecting the stream from its floodplain, and limited instream habitat diversity. The limestone bedrock substrate provides some natural stability and habitat value, and the right bank maintains a reasonable wooded buffer. No stormwater infrastructure, outfalls, or illicit discharges were observed. Priority management actions include establishing a wider riparian buffer on the left bank and enhancing instream habitat through woody debris additions.

| Metric | Score | Notes |
|---|---|---|
| Hydrologic Alteration | 5 | The channel shows moderate incision with 3-6 foot bank heights and exposed rock ledges, suggesting the stream does not frequently access its floodplain. The surrounding agricultural land use has likely increased runoff and contributed to incision. The left bank agricultural field sits well above the current stream level. The stream appears moderately disconnected from its floodplain. |

| Side | Stability | Veg. Protection | Erosion | Notes |
|---|---|---|---|---|
| Left | 5 | 4 | 26_50_percent | Left bank is the more vulnerable bank due to narrow riparian buffer and proximity to agricultural field. The natural limestone provides some erosion resistance but does not fully protect against undercutting. The fence line visible near the stream suggests the agricultural field extends close to the riparian zone. |
| Right | 7 | 7 | 1_25_percent | Right bank is in better condition than the left bank with a wider riparian buffer and denser vegetation. The wooded area on the right side extends further from the stream providing better bank protection and habitat. |

| Metric | Score/Value | Notes |
|---|---|---|
| TDEC 30ft Buffer Met? | L: No / R: Yes | The left bank riparian buffer does not appear to meet TDEC's 30-foot minimum standard. Agricultural field extends to within approximately 10-25 feet of the stream bank based on visible fence line. This represents a significant buffer deficiency that should be addressed. The right bank buffer appears adequate. Buffer restoration on the left bank would significantly improve stream protection and is a high priority recommendation. |

| Action | Priority | Timeline |
|---|---|---|
| Document this reach in visual stream survey database with photo panoramas. Flag the inadequate left bank buffer for further evaluation. | medium | 90_days |
| Coordinate with agricultural landowner on left bank regarding voluntary riparian buffer establishment programs (USDA CRP, EQIP, or similar). | medium | annual |
