# Scene 14 · MS4 Assessment

Black Branch 2

City of Lebanon TN

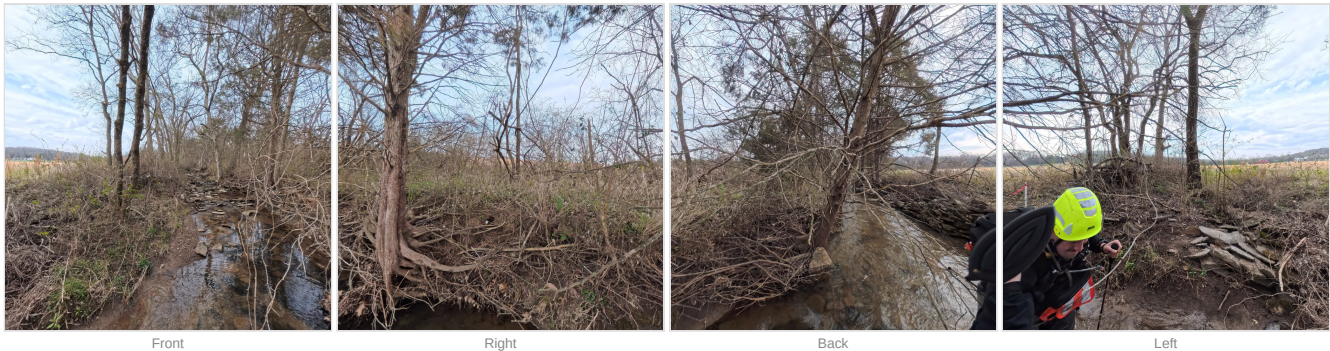
**Front:** Looking downstream, a narrow shallow stream flows over exposed flat limestone/bedrock substrate with scattered thin rock slabs. The channel is very narrow (approximately 3-5 feet wide) with minimal water depth. Deciduous trees (bare) and cedar trees line both banks, with open agricultural fields visible to the left beyond a thin riparian strip. Dense dormant brush and debris are present along both banks.

**Right:** Looking toward the right bank (facing downstream), a cedar tree with exposed roots stands at the bank edge. The bank rises moderately with dense dormant brush, vines, and dead herbaceous vegetation. Beyond the narrow riparian strip, what appears to be agricultural land or open fields with structures (possibly farm buildings) are faintly visible through the bare vegetation. The bank shows some root exposure and bare soil patches.

**Back:** Looking upstream, the narrow channel continues with shallow water flowing over exposed bedrock/limestone substrate. A large cedar tree with significant root exposure grows on the left bank, leaning over the channel. Flat limestone bedrock forms the channel bed with thin sheets of rock visible. The right bank shows exposed rock ledges. Dense dormant vegetation and open agricultural fields are visible beyond the narrow riparian corridor on the right side. A person in safety gear (the surveyor's equipment) is partially visible at the right edge.

**Left:** Looking toward the left bank (facing downstream), a field surveyor wearing a Petzl safety helmet and high-visibility gear is visible wading in the stream. The left bank is low with bare soil and scattered flat limestone rock fragments. Beyond the narrow band of dormant trees and shrubs, open agricultural fields with a red barn or farm building are clearly visible, indicating a very thin riparian buffer on this side. The bank has moderate bare soil exposure with some dormant herbaceous cover.

| Side | Stability | Veg. Protection | Erosion | Notes |
|---|---|---|---|---|
| Left | 6 | 5 | 1_25_percent | Left bank transitions quickly from narrow riparian strip to open agricultural fields. Thin buffer is the primary concern. Red barn/farm building visible beyond buffer. Bank is naturally low and relatively stable due to bedrock control. |
| Right | 6 | 6 | 1_25_percent | Right bank has somewhat better vegetative protection than left bank, with cedar trees providing year-round root stabilization. Some undercutting evident at the base of the cedar tree. Agricultural land and possible structures visible beyond the riparian strip but buffer appears slightly wider on this side. |

| Metric | Score/Value | Notes |
|---|---|---|
| TDEC 30ft Buffer Met? | L: No / R: Yes | The narrow riparian buffer on the left bank is a compliance concern. Agricultural fields extend close to the stream channel. Buffer restoration through replanting and establishment of a wider vegetated corridor would significantly improve filtering function and TDEC compliance. The flat topography and agricultural setting suggest high potential for buffer restoration. |

| Action | Priority | Timeline |
|---|---|---|
| Document narrow left bank riparian buffer for TDEC buffer compliance tracking | medium | 90_days |
| Verify agricultural operations are not contributing direct runoff to stream during growing season | low | annual |
