# Scene 15 · MS4 Assessment

Black Branch 2

City of Lebanon TN

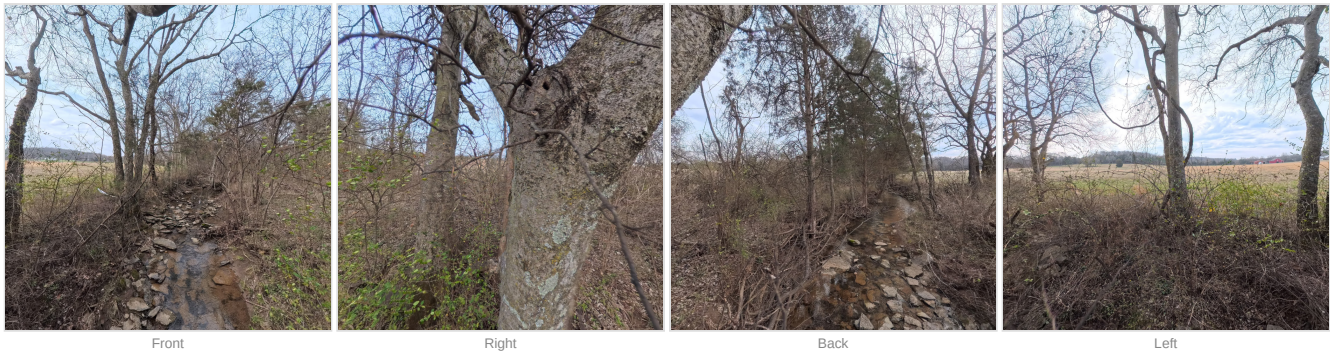
**Front:** Looking downstream, a very narrow channel (approximately 3-5 feet wide) winds through a riparian corridor of bare deciduous trees. The streambed is dominated by flat limestone/bedrock substrate with a thin sheet of water flowing over it. Open agricultural fields are visible through the trees on the left side. Some green vegetation (possible evergreen or early-emerging invasives) is visible on the right bank.

**Right:** The right bank (left bank when facing downstream) shows a large mature sycamore tree trunk dominating the foreground, with lichen-covered bark. Behind it, the right bank rises moderately with dormant deciduous shrubs and small trees forming a dense understory. Some green vegetation is emerging at lower levels, possibly including invasive honeysuckle or privet. The riparian zone extends into what appears to be woodland or scrubby vegetation.

**Back:** Looking upstream, the narrow channel continues with the same bedrock/limestone substrate and very shallow flow. The channel is bordered by bare deciduous trees and shrubs. A few evergreen trees (likely eastern red cedar) are visible in the riparian zone. Open agricultural fields can be seen through the trees on the right side. The stream appears to have a slight sinuosity as it bends through this corridor.

**Left:** The left bank (right bank when facing downstream) shows open agricultural fields beyond a narrow riparian strip. A red barn/outbuilding is visible in the distance across the field. The riparian buffer on this side consists of bare deciduous trees (including sycamore) and dense dormant shrubs, with some green leafy vegetation at ground level that may include invasive species such as bush honeysuckle or multiflora rose retaining some green foliage. The buffer appears relatively narrow, transitioning quickly to open pasture/cropland.

Black Branch at this location is a small headwater stream flowing over natural Ordovician limestone bedrock in a rural agricultural setting near Lebanon, Tennessee. The channel is natural and unmodified with good bank stability but limited instream habitat diversity due to the bedrock-dominated substrate and low flow conditions. The riparian buffer is narrow on the left bank adjacent to agricultural fields, with a wider buffer on the right bank. Water quality appears good with no evidence of nutrient enrichment or contamination. No stormwater infrastructure or outfalls were observed. The primary management concerns are the narrow agricultural buffer, limited large woody debris, and potential for invasive species encroachment. Overall condition is marginal, primarily limited by instream habitat deficiencies inherent to the bedrock substrate and agricultural land use impacts on the riparian zone.

| Side | Stability | Veg. Protection | Erosion | Notes |
|---|---|---|---|---|
| Left | 7 | 6 | 1_25_percent | Left bank has narrow riparian buffer transitioning to open agricultural field. The buffer width appears to be approximately 25-50 feet of woody vegetation before reaching cropland/pasture. A red barn/outbuilding is visible in the distance. |
| Right | 7 | 7 | 0_percent | Right bank has wider riparian buffer extending into woodland. Large mature sycamore tree provides significant root protection and bank stabilization. Some open agricultural fields visible through vegetation on this side as well but at greater distance. |

| Metric | Score/Value | Notes |
|---|---|---|
| Canopy Cover | 5 | Currently in winter with bare deciduous canopy, shade is minimal (<25%). During growing season, the canopy of sycamores and other deciduous trees would provide approximately 50-75% shade. Score reflects the annual average considering seasonal variation. The canopy is present but not dense enough for full coverage even in summer due to gaps where agricultural fields are close. |

| Metric | Score/Value | Notes |
|---|---|---|
| TDEC 30ft Buffer Met? | L: Yes / R: Yes | The left bank buffer could benefit from widening through agricultural setback or planting additional native trees and shrubs. The right bank buffer is more adequate. Both buffers would benefit from invasive species management to improve native vegetation dominance and ecological function. |

| Action | Priority | Timeline |
|---|---|---|
| Continue visual stream survey documentation of this reach during annual assessment cycle | medium | annual |
| Confirm no outfalls present in adjacent scenes; verify agricultural drainage does not constitute an illicit discharge | low | annual |
