# Scene 16 · MS4 Assessment

Black Branch 2

City of Lebanon TN

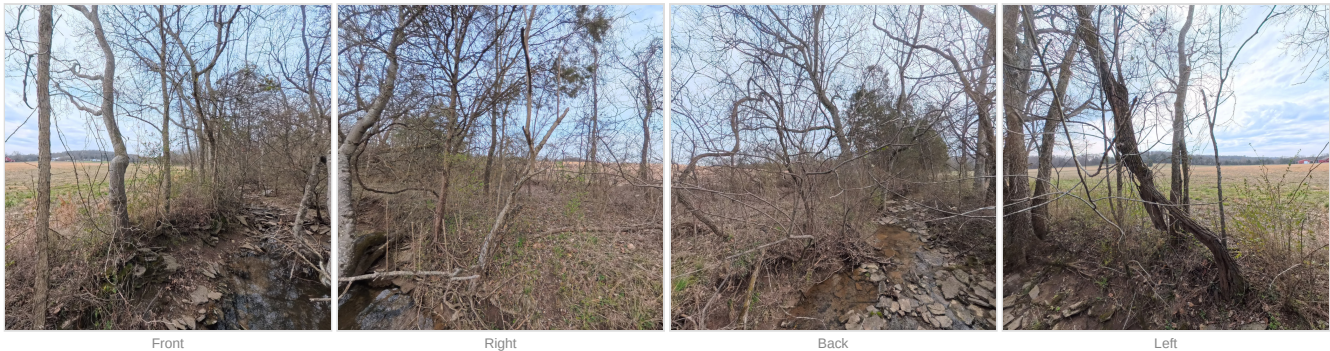
**Front:** Looking downstream, a narrow stream channel is visible winding through a wooded riparian corridor. The left bank opens to a broad agricultural field (pasture/hay) with a red barn visible in the far distance. The channel bed is dominated by flat, layered limestone bedrock and cobble-sized rock fragments. Bare deciduous trees line both banks.

**Right:** The right bank rises moderately into a wooded hillside with bare deciduous trees and some eastern red cedar. The understory is sparse with dormant herbaceous vegetation and leaf litter. Through the trees, what appears to be exposed reddish-brown earth or a cleared area is visible on higher ground, possibly a field edge or disturbed area. A small amount of water is visible at the lower left edge of the frame.

**Back:** Looking upstream, the narrow stream channel continues through a corridor of dense bare deciduous trees and shrubs. The channel bed is exposed limestone bedrock with flat layered surfaces and rubble. A shallow flow of slightly turbid water moves across the bedrock surface. Vine tangles and dormant shrub thickets are visible on both sides of the channel, and the stream appears to bend slightly.

**Left:** The left bank transitions from a narrow riparian tree line into a broad, flat agricultural field (pasture or hay field) that extends to the horizon. Dormant grass covers the field, and a red barn/agricultural building is visible in the middle distance. The riparian buffer on this side is very narrow - only a single row of mature trees separates the stream from the open field. Some exposed soil and rock is visible at the bank toe.

Black Branch at this location (scene #16 of 53) is a small, low-gradient headwater stream with a natural limestone bedrock channel in a rural agricultural setting near Lebanon, Tennessee. The stream's primary limitation is the severely inadequate riparian buffer on the left bank, where agricultural land (pasture/hay field) extends nearly to the stream's edge with only a single row of trees providing any buffer function. The right bank has a more adequate wooded buffer. Water quality appears fair with slightly turbid but generally acceptable conditions during dry weather low flow. Instream habitat is limited by the bedrock-dominated substrate and absence of large woody debris, resulting in poor velocity-depth diversity and limited fish and macroinvertebrate habitat. No stormwater infrastructure, outfalls, or illicit discharges were observed.

| Side | Stability | Veg. Protection | Erosion | Notes |
|---|---|---|---|---|
| Left | 6 | 5 | 1_25_percent | Left bank transitions quickly from stream to agricultural field. Very narrow riparian buffer is the primary concern. The bedrock at the bank toe provides natural protection, but the lack of deep-rooted vegetation in the upper bank could lead to erosion during high flow events. |
| Right | 7 | 6 | 1_25_percent | Right bank has a wider riparian buffer zone than the left, with the wooded area extending upslope. The bank appears more stable than the left bank due to greater root density and wider vegetated area. |

| Metric | Score/Value | Notes |
|---|---|---|
| TDEC 30ft Buffer Met? | L: No / R: Yes | The left bank represents a significant buffer deficiency. The flat agricultural field adjacent to the stream offers excellent restoration potential - establishing native trees and shrubs in a 30-60 foot buffer strip would be straightforward and highly beneficial. This should be flagged as a priority for TDEC MS4 permit section 4.2.5.4 compliance. |

| Action | Priority | Timeline |
|---|---|---|
| Document the inadequate left-bank riparian buffer as a priority for buffer restoration under MS4 watershed management | high | 90_days |
| Coordinate with agricultural landowner regarding voluntary buffer establishment program (NRCS Conservation Reserve Program or similar) | medium | annual |
