# Scene 17 · MS4 Assessment

Black Branch 2

City of Lebanon TN

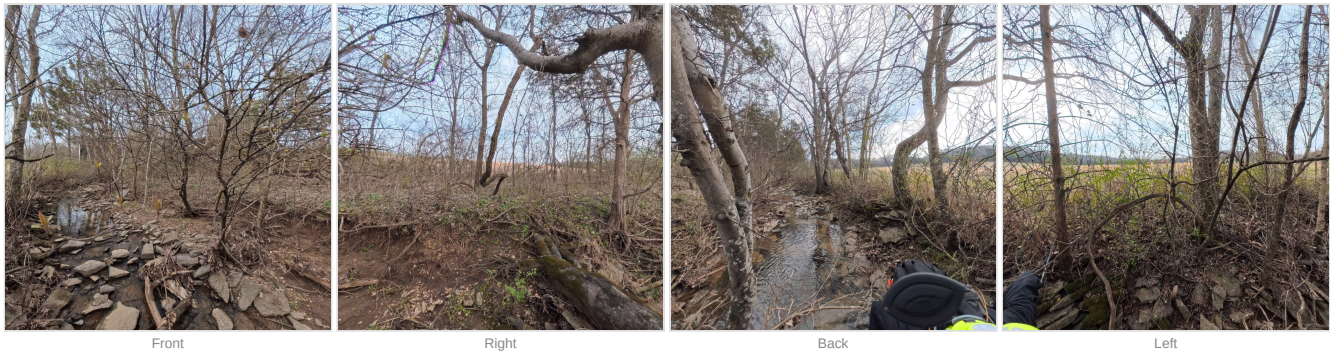
**Front:** Looking downstream, a narrow channel with very low flow is visible winding through a heavily wooded corridor. The bed is dominated by flat, angular limestone/shale slabs with shallow pools of still to barely flowing water. Deciduous trees are mostly bare with early spring bud break visible on a few small saplings.

**Right:** The right bank (left bank facing downstream) shows a steep, eroded bank approximately 3-5 feet high with exposed soil and root systems. Dense vine and shrub tangles cover the bank top. Through the bare trees, an open agricultural field or pasture is visible in the background, indicating the riparian buffer is relatively narrow on this side.

**Back:** Looking upstream, the narrow channel continues with shallow water flowing over exposed limestone bedrock slabs. The channel is flanked by bare deciduous trees with an open field/pasture visible through the vegetation on the right side. A person wearing high-visibility safety gear is visible, confirming wading/backpack pole capture method. The channel substrate is entirely natural bedrock/limestone.

**Left:** The left bank (right bank facing downstream) shows a moderately steep bank with dense shrub and vine tangles. Through the bare vegetation, open agricultural/pasture land is clearly visible. The riparian buffer appears narrow, approximately 25-50 feet wide, with a mix of small trees and dense understory. Rock fragments visible at base of bank are consistent with natural limestone bedrock.

Black Branch at this location is a small bedrock-controlled headwater stream in a rural agricultural setting near Wilson County, Tennessee. The channel exhibits moderate incision with 3-5ft banks, reducing floodplain connectivity. Water quality appears good with clear baseflow, but the narrow riparian buffer on both sides (25-50ft) adjacent to agricultural land limits filtering capacity and stream shading. Key limitations include low instream habitat diversity on the bedrock-dominated substrate, sparse large woody debris, limited pool development, and bank erosion on the outer meander. No stormwater infrastructure or outfalls were observed, and no MS4 compliance concerns were identified at this specific location.

| Metric | Score | Notes |
|---|---|---|
| Channel Condition | 7 | Channel appears natural with no direct structural modifications. However, the moderate incision (3-5ft banks) and exposed bedrock substrate suggest some downcutting, possibly related to altered hydrology from adjacent agricultural land use changes. The channel is moderately entrenched but appears to have achieved a degree of stability on bedrock. |
| Hydrologic Alteration | 5 | Moderate channel incision (3-5ft bank heights) reduces floodplain access. The bedrock-controlled channel limits further downcutting but the stream is clearly disconnected from its floodplain for most flow events. Agricultural land use in the watershed likely contributes to flashier hydrology. |

| Side | Stability | Veg. Protection | Erosion | Notes |
|---|---|---|---|---|
| Left | 5 | 6 | 1_25_percent | Left bank has narrow riparian buffer with agricultural field visible beyond. Bank height moderate at 3-5 feet. Natural bedrock at base provides some resistance to erosion. Vine and shrub growth moderate but appears to include invasive species. |
| Right | 4 | 5 | 26_50_percent | Right bank shows more active erosion than left bank. Steep face with undercutting, exposed roots, and bare soil. Narrow riparian buffer with agricultural land beyond. This bank appears to be on the outside of a slight meander, contributing to higher erosion rates. |

| Action | Priority | Timeline |
|---|---|---|
| Document this reach as part of the visual stream assessment inventory for Black Branch watershed | medium | annual |
| Coordinate with agricultural landowners regarding riparian buffer enhancement opportunities | low | annual |
