# Scene 18 · MS4 Assessment

Black Branch 2

City of Lebanon TN

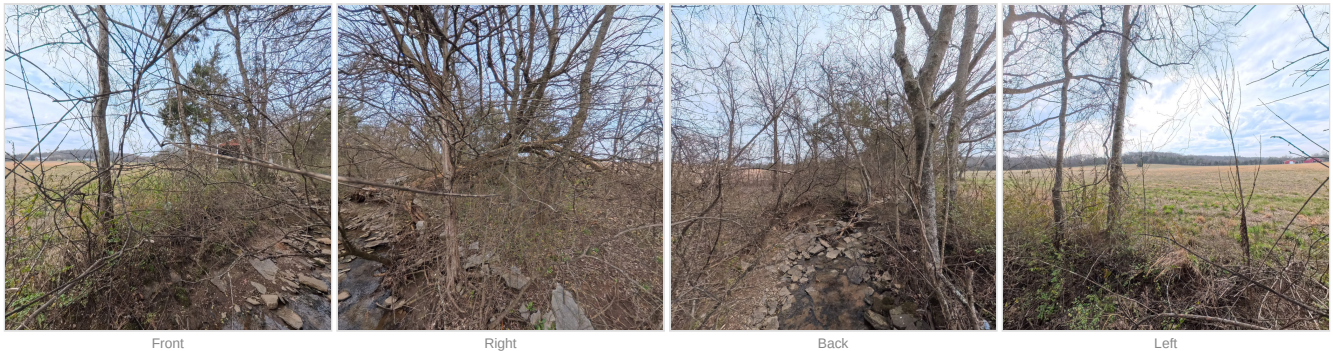
**Front:** Looking downstream (direction of travel), the view shows a narrow stream channel flanked by bare deciduous trees and dense shrubby understory. Beyond the immediate riparian corridor on the left, a large open agricultural field (dormant pasture/hay field) is visible extending to distant treeline and structures. The right side has a thicker riparian strip with exposed rocky bank material visible at the lower edge.

**Right:** Looking toward the right bank (when facing downstream), a dense thicket of bare deciduous shrubs and small trees occupies the bank zone. Rocky/stony material is visible along the lower bank at left edge where it meets the channel. The riparian zone extends with moderate depth of woody vegetation before giving way to what appears to be more open land beyond. Some flat stone slabs are visible at the bank-channel interface.

**Back:** Looking upstream, the narrow channel is visible with a rocky/cobble bed showing shallow flowing water. The stream appears to be a small first or second order channel with exposed flat stone substrate. Both banks are vegetated with bare deciduous trees and shrubs. The channel is quite narrow, perhaps 3-5 feet wide, with the rocky bed dominating the view. A sycamore tree is visible on the right side with its characteristic white bark.

**Left:** Looking toward the left bank (when facing downstream), the view opens to a wide, flat agricultural field — dormant pasture or hayfield — extending to distant hills. A red barn/agricultural building is visible in the distance to the right. The riparian buffer on this side is extremely narrow, consisting of only a few scattered trees and sparse shrub cover along the bank edge before transitioning immediately to open pasture. The bank drops steeply from the grassy field to the channel.

Black Branch Scene 18 depicts a small (3-5 ft wide), bedrock-dominated headwater stream flowing at low baseflow through a narrow riparian corridor bordered by agricultural pasture on the left and moderate woody vegetation on the right. The most critical issue is the severely deficient riparian buffer on the left bank where open pasture extends to within feet of the channel, failing to meet TDEC 30ft minimum buffer standards. Instream habitat quality is marginal, limited by uniform bedrock substrate, absence of pools, and near-total lack of large woody debris. Water quality appears acceptable during current dry weather conditions but the agricultural adjacency presents chronic nutrient and sediment loading risk. Priority actions include riparian buffer establishment on the left bank and LWD additions to improve instream habitat diversity.

| Metric | Score | Notes |
|---|---|---|
| Channel Condition | 7 | Channel appears relatively natural with no direct structural alteration. However, the channel shows evidence of incision with moderate bank heights relative to the small channel width, suggesting some downcutting likely related to changes in watershed hydrology from agricultural land use. The bedrock substrate is controlling further incision. |
| Hydrologic Alteration | 5 | The channel shows moderate incision with banks 3-6 feet high relative to the narrow channel width. The adjacent agricultural fields appear to be above the current channel elevation with limited floodplain connection. Agricultural land use in the watershed likely increases flashiness while the incised channel limits floodplain access. |

| Side | Stability | Veg. Protection | Erosion | Notes |
|---|---|---|---|---|
| Left | 4 | 3 | 26_50_percent | Left bank is the most vulnerable bank at this location. The extremely narrow riparian buffer between the channel and agricultural field provides inadequate protection. TDEC minimum buffer requirements are likely not met on this side. |
| Right | 6 | 6 | 1_25_percent | Right bank in better condition than left, with denser riparian vegetation and natural rock providing toe protection. |

| Metric | Score/Value | Notes |
|---|---|---|
| TDEC 30ft Buffer Met? | L: No / R: No | The left bank agricultural encroachment within the required buffer zone is a significant compliance concern. The open pasture extends nearly to the channel edge. Buffer restoration on the left bank by establishing native woody vegetation would significantly improve stream function and comply with TDEC MS4 permit section 4.2.5.4 requirements. The right bank buffer, while better, should also be assessed for adequacy. |

| Metric | Score | Notes |
|---|---|---|
| Water Appearance | 7 | Water appears clear in the DOWN face view, with the bedrock substrate easily visible beneath the shallow flow. No sheen, film, or discoloration is evident. Water depth is so shallow that clarity is easily assessed. Under current dry weather conditions, water quality appears good. Score reduced slightly from 10 because the agricultural adjacency suggests periodic turbidity during storm events. |

| Action | Priority | Timeline |
|---|---|---|
| Document deficient riparian buffer on left bank for buffer compliance tracking under TDEC MS4 permit | high | 30_days |
| Conduct dry weather screening of baseflow to characterize water quality and check for agricultural runoff indicators | medium | 90_days |
| Verify potential overhead utility crossing visible in UP face and add to crossing inventory if confirmed | low | annual |
