# Scene 19 · MS4 Assessment

Black Branch 2

City of Lebanon TN

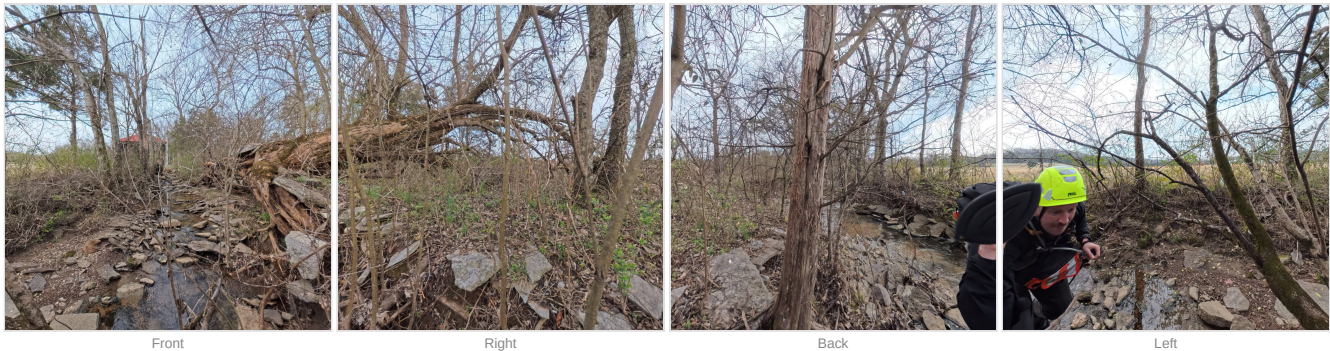
**Front:** Looking downstream, a very narrow channel with minimal water flows over exposed flat limestone/shale substrate. A red-roofed structure (likely a barn or outbuilding) is visible through bare deciduous trees on the left bank. The channel is bordered by dense dormant shrubs and small trees, with abundant flat rock pieces scattered along both banks and in the channel bed.

**Right:** The right bank (when facing downstream) shows a steep, heavily vegetated bank rising above the channel. Dense dormant shrubs, vines, and small deciduous trees cover the bank. A large fallen tree is visible spanning across the upper bank area. Flat limestone/shale rock fragments are visible at the base of the bank near the channel edge. Some early green herbaceous growth is emerging on the ground surface.

**Back:** Looking upstream, the narrow channel continues through a wooded corridor. A large eastern red cedar tree is prominent in the center view. Water is visible flowing over flat rock substrate with exposed bedrock ledges. The right bank has flat rock ledges at water level, and a field surveyor in dark clothing is partially visible on the right side. Beyond the riparian corridor, open agricultural/pastoral land and possibly structures are visible in the distance through bare trees.

**Left:** Looking at the left bank (when facing downstream), a field surveyor wearing a Petzl helmet and dark clothing is visible in the foreground. The left bank rises moderately with exposed soil, rock fragments, and dense dormant shrubs and small trees. Beyond the narrow riparian strip, open agricultural/pastoral fields with brown grass are visible in the distance. The bank shows some exposed soil and rock. A small pool or standing water is visible at the channel edge near the surveyor's feet.

Black Branch 219 at this location is a small headwater bedrock-controlled stream in marginal condition. The channel itself is natural and unmodified, flowing over exposed limestone bedrock with very low flow at the time of assessment. Key issues include a narrow riparian buffer on the left bank adjacent to agricultural fields that likely does not meet TDEC 30-foot minimum standards, limited instream habitat diversity due to flat bedrock substrate and shallow water depth, and minimal pool development. Water quality indicators are favorable with clear water and no evidence of contamination or nutrient enrichment. No stormwater infrastructure or outfalls were observed at this location. The rural/agricultural setting presents non-point source concerns but no immediate MS4 compliance issues were identified.

| Side | Stability | Veg. Protection | Erosion | Notes |
|---|---|---|---|---|
| Left | 6 | 5 | 1_25_percent | Left bank transitions from the channel edge through a narrow riparian strip of dormant shrubs and small trees to open agricultural fields. The narrow buffer width is a concern for filtering and bank protection. Bedrock at the channel bed provides natural grade control. |
| Right | 6 | 6 | 1_25_percent | Right bank is taller and steeper than the left, with dense shrub coverage. A large fallen tree may indicate past bank instability. The red-roofed structure visible downstream appears to be on or near the right bank floodplain, suggesting some residential development in the corridor. |

| Metric | Score/Value | Notes |
|---|---|---|
| TDEC 30ft Buffer Met? | L: No / R: Yes | The left bank riparian buffer is likely below the TDEC MS4 permit minimum of 30 feet. Agricultural fields extend close to the channel. Buffer restoration through planting native trees and shrubs along the left bank and expanding the existing buffer would significantly improve filtering capacity and bank stability. The right bank is marginally compliant with a structure visible in the downstream direction. |

| Action | Priority | Timeline |
|---|---|---|
| Verify left bank riparian buffer width against TDEC 30-foot minimum standard and document compliance status | medium | 90_days |
