# Scene 2 · MS4 Assessment

Black Branch 2

City of Lebanon TN

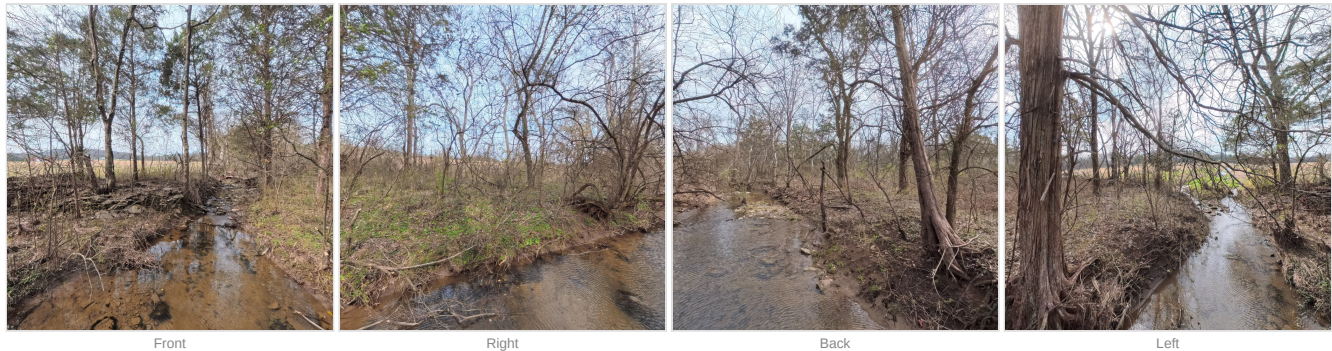
**Front:** Looking downstream, the channel narrows and bends slightly to the left through a thin riparian corridor of bare deciduous trees and eastern red cedars. A flat rock/limestone ledge outcrop is visible on the left bank forming a natural step or riffle feature. Beyond the thin tree line, open agricultural fields are visible in the background with a distant red structure (barn). The channel bed shows shallow water flowing over flat rock substrate.

**Right:** The right bank (left bank when facing downstream) shows a moderately vegetated riparian area with bare deciduous trees, scattered shrubs, and some green herbaceous ground cover. The bank is low to moderate height with exposed root systems and minor bank erosion. The water surface is gently flowing and slightly rippled. Beyond the immediate riparian zone, hints of open land or cleared areas are visible through the bare canopy.

**Back:** Looking upstream, the channel extends with gentle flowing water through a wooded riparian corridor. The left bank shows bare deciduous trees and shrubs with exposed root wads at the bank edge. Some fallen and leaning woody debris is visible in and near the channel. The riparian corridor appears narrow with hints of open agricultural land visible beyond. The channel bed appears to be a mix of silt, mud, and some flat rock. Eastern red cedars are visible on the right bank.

**Left:** The left bank view (right bank when facing downstream) shows eastern red cedars (*Juniperus virginiana*) as prominent bank trees with exposed root systems. The channel flows downstream with shallow, gently moving water. Open agricultural fields are clearly visible beyond the thin riparian buffer, indicating the buffer is very narrow on this side—likely only 10-25 feet wide. Some fencing may be present at the field edge. The bank has bare soil exposure and minor erosion.

Black Branch at this location (#2 of 53) is a small headwater stream rated as marginally impaired, primarily due to fine sediment accumulation from adjacent agricultural land use and an inadequate riparian buffer on the left bank. The channel itself retains natural morphology with bedrock riffle features and floodplain connectivity, but instream habitat quality is limited by silt-dominated substrate, lack of woody debris, and poor pool development. No stormwater infrastructure, outfalls, or illicit discharges were observed. The primary management need is riparian buffer restoration on the left bank to reduce sediment loading and improve stream corridor functions.

| Side | Stability | Veg. Protection | Erosion | Notes |
|---|---|---|---|---|
| Left | 6 | 5 | 1_25_percent | Left bank has thin riparian buffer with agricultural fields visible immediately beyond. Cedar trees provide some bank stabilization through root systems. The narrow buffer width is the primary concern on this bank. |
| Right | 7 | 6 | 1_25_percent | Right bank has a wider riparian buffer than the left bank. Deciduous trees and some shrubs provide moderate bank stabilization. Minor undercutting visible in places. Root exposure is moderate. |

| Metric | Score/Value | Notes |
|---|---|---|
| TDEC 30ft Buffer Met? | L: No / R: Yes | Left bank riparian buffer is critically thin with agricultural fields encroaching within the 30ft TDEC minimum. Right bank buffer is marginally adequate at approximately 25-50ft. Buffer restoration on the left bank should be a priority. Agricultural best management practices including buffer establishment would significantly improve stream corridor function. |

| Action | Priority | Timeline |
|---|---|---|
| Document this reach in outfall mapping inventory as having no stormwater outfalls. Note agricultural non-point source as primary pollutant pathway. | low | annual |
| Continue visual stream survey documentation through remaining 51 scenes in this reach to identify any outfalls or illicit discharges further downstream. | medium | 90_days |
