# Scene 20 · MS4 Assessment

Black Branch 2

City of Lebanon TN

36.17008, -86.26969 · Generated October 22, 2026

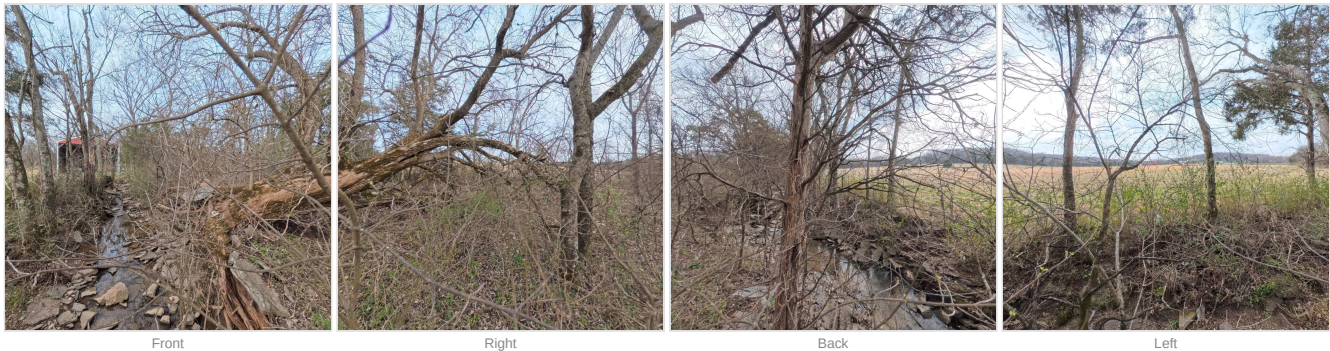
**Front:** Looking downstream, a very narrow channel with minimal water flow is visible winding through exposed rocky substrate. A structure with a red/orange roof is visible in the background on the left bank, partially obscured by bare deciduous trees. Large fallen tree trunk and woody debris are prominent on the right side of the channel.

**Right:** The right bank (left bank when facing downstream) shows a moderately steep wooded hillside with bare deciduous trees and dense understory of dormant vines and shrubs. A large fallen/leaning tree trunk crosses diagonally through the view. The ground is covered with leaf litter and some early green herbaceous growth. No water or channel is visible from this angle.

**Back:** Looking upstream, the narrow channel continues with exposed rocky substrate and very shallow water. A prominent tree trunk stands in the center of view. Through the bare trees, an open agricultural field is visible in the distance on the left side (right bank when facing downstream). The channel bed shows flat rock pieces and cobble with water visible between rocks.

**Left:** The left bank (right bank when facing downstream) shows a narrow riparian buffer of bare deciduous trees and one prominent eastern red cedar/pine giving way to a large open agricultural field in the background. The field appears to be fallow or recently harvested with brown/tan exposed soil visible. Farm equipment (red-colored) is visible in the distant field. The riparian buffer is very narrow here, perhaps 25-50 feet wide.

Black Branch at this location (#20 of 53) is a small, intermittent headwater stream flowing through a narrow riparian corridor with agricultural land immediately adjacent on the right bank. The channel is moderately incised and disconnected from its floodplain, with a limestone cobble/slab substrate carrying low flow. The left bank has a reasonable wooded buffer of 50+ feet, but the right bank buffer is marginal at only 25-50 feet before transitioning to row crop agriculture. Key concerns include the narrow agricultural buffer compromising water quality filtering, channel incision limiting floodplain function, and limited habitat diversity. No stormwater infrastructure or outfalls were observed. A residential structure with red roof is visible nearby on the left bank. The stream rates as marginal overall with the greatest improvement potential through right bank riparian buffer enhancement.

| Metric | Score | Notes |
|---|---|---|
| Channel Condition | 6 | Channel appears generally natural but shows evidence of incision. No artificial structures visible but the channel is somewhat entrenched relative to floodplain. Some downcutting evident from bank heights and exposed rock bed. Adjacent agricultural use has likely contributed to altered hydrology. |
| Hydrologic Alteration | 5 | Channel appears moderately incised with banks 3-6 feet high relative to channel bottom. The stream is disconnected from its floodplain based on visible bank heights. Agricultural land conversion likely increased runoff volumes and flashiness, contributing to channel incision. Flooding of the floodplain appears infrequent. |
| Sediment Deposition | 5 | Some fine sediment deposition visible between cobbles. The channel bed shows a mix of exposed rock and areas of sediment fill. Not severe but noticeable, likely from agricultural runoff. Approximately 20-30% of bottom affected by fine sediment deposition. |

| Side | Stability | Veg. Protection | Erosion | Notes |
|---|---|---|---|---|
| Left | 6 | 6 | 1_25_percent | Left bank is the wooded hillside. Moderate stability with dormant tree and shrub cover. Some natural scour at base. The wooded buffer extends at least 50+ feet on this side. |
| Right | 5 | 5 | 1_25_percent | Right bank has a much narrower riparian buffer compared to left bank. Agricultural field begins within approximately 25-50 feet of the channel. This narrow buffer is a significant concern for stream health and water quality. |

| Metric | Score/Value | Notes |
|---|---|---|
| TDEC 30ft Buffer Met? | L: Yes / R: No | The right bank riparian buffer is the primary compliance concern. Agricultural cultivation appears to extend within or close to the 30ft minimum buffer zone. Buffer restoration on the right bank through agricultural set-asides or riparian planting would significantly improve stream condition and compliance. The structure visible on the left bank may also represent encroachment but appears to be set back further. |

| Metric | Score | Notes |
|---|---|---|
| Water Appearance | 6 | Water appears slightly turbid with a brownish color. Given the very shallow depth, the bottom is visible throughout suggesting reasonable clarity. No oil sheen, foam, or scum observed. The brownish tint could be from tannins or fine sediment. Water quality appears fair for visual assessment during low-flow conditions. |

| Action | Priority | Timeline |
|---|---|---|
| Map this reach segment and document the narrow right bank buffer condition for watershed planning purposes | medium | 90_days |
| Verify substrate material composition at this location — some flat rock slabs may be old concrete fragments requiring documentation | low | annual |
