# Scene 21 · MS4 Assessment

Black Branch 2

City of Lebanon TN

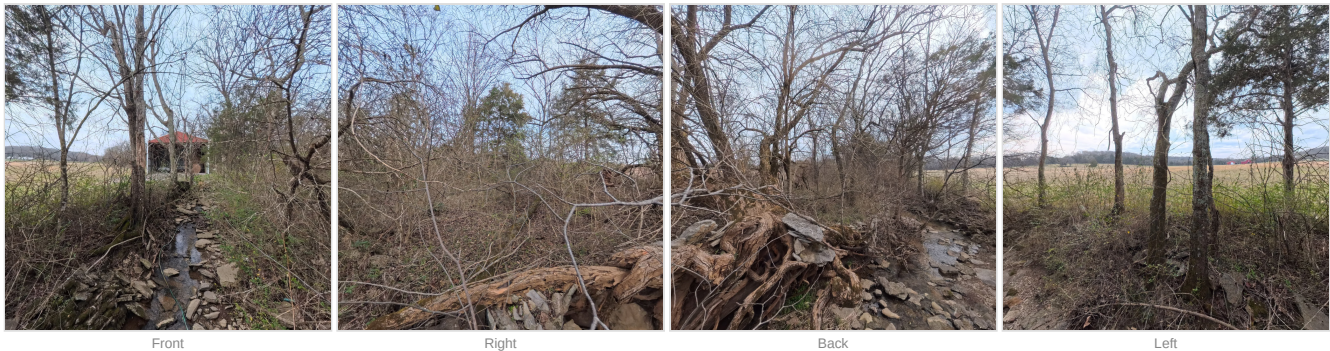
**Front:** Looking downstream, a very narrow channel (2-4 ft wide) winds through a thin riparian corridor toward a small red-roofed structure/building. The stream bed is dominated by flat, angular limestone/rock slabs with very shallow water flowing over them. Agricultural fields are visible to the left beyond the thin tree line. A green garden hose or similar tubing is visible crossing the stream bed.

**Right:** Looking toward the right bank (left bank when facing downstream), dense dormant vegetation including shrubs and tangled vines rises on a moderate slope. A large decaying log is visible at the base of the bank. Several scattered rocks and a few evergreen trees (cedar/pine) are visible through the bare deciduous canopy. The bank rises moderately with thick understory vegetation.

**Back:** Looking upstream, the channel is visible with very shallow water flowing over flat limestone slabs. A large root mass from a mature tree is prominently exposed on the left side of the channel, with angular rock fragments embedded among the roots. Agricultural fields and a thin riparian corridor are visible beyond. The substrate is dominated by flat, thin limestone fragments consistent with natural bedrock weathering.

**Left:** Looking toward the left bank (right bank when facing downstream), open agricultural fields (pasture/hay) extend to the horizon with a red barn/agricultural building visible in the distance. A thin row of scattered trees (deciduous and a few cedar/pine) forms a very narrow riparian buffer between the stream and the fields. The bank transitions quickly from the channel to open agricultural land with minimal buffer width.

Black Branch at this location is a small headwater stream with bedrock-controlled substrate flowing through a rural agricultural landscape in the Central Basin of Tennessee. The stream is at low flow with very shallow depth over limestone bedrock. The primary concern is the inadequate riparian buffer on the right bank where agricultural fields encroach to within approximately 10-25 feet of the channel, failing to meet TDEC's minimum 30-foot buffer standard. Instream habitat is limited by the shallow depth, narrow channel, and bedrock dominance, with few pool or deep-water habitats available. No stormwater infrastructure or illicit discharges were observed, consistent with the rural setting, but overland agricultural runoff enters the stream without treatment.

| Side | Stability | Veg. Protection | Erosion | Notes |
|---|---|---|---|---|
| Right | 4 | 4 | 1_25_percent | Right bank has a very narrow riparian buffer before agricultural fields begin. Severe root exposure on at least one large tree. The agricultural fields appear to be pasture/hay. A red barn is visible in the distance. The narrow buffer is a significant concern for water quality protection. |

| Metric | Score/Value | Notes |
|---|---|---|
| TDEC 30ft Buffer Met? | L: Yes / R: No | The right bank buffer is inadequate and does not meet TDEC minimum 30ft buffer requirements. Agricultural use extends close to the stream channel. Buffer restoration on the right bank is highly recommended and has high potential for success given the adjacent agricultural land. USDA CRP or EQIP programs could support buffer establishment. |

| Action | Priority | Timeline |
|---|---|---|
| Document inadequate riparian buffer on right bank for TDEC buffer compliance review | medium | 90_days |
| Investigate the red-roofed structure downstream for potential outfall or discharge points | medium | 90_days |
