# Scene 22 · MS4 Assessment

Black Branch 2

City of Lebanon TN

## Detailed Observations · Scene 22

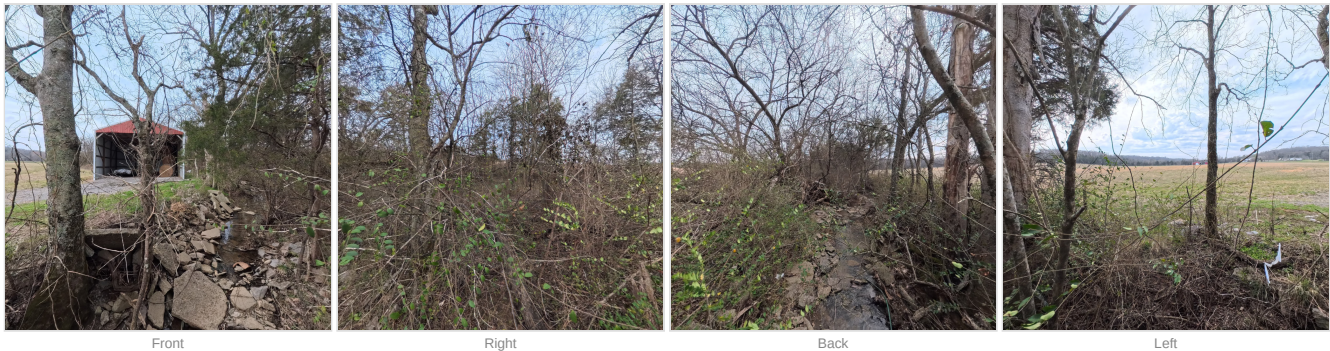
**Front:** Looking downstream, a narrow channel (approximately 2-3 feet wide) flows through a heavily disturbed area. A red-roofed open-front agricultural storage shed/barn is visible on the left bank, set back approximately 30-40 feet from the channel. The channel bed is dominated by flat, angular rock fragments that appear to be broken concrete rubble rather than natural bedrock, with some weathered pieces showing aggregate patterns. A gravel driveway/pad is visible adjacent to the shed.

**Right:** Looking toward the right bank (facing downstream), dense thicket of shrubs and vines dominates. Many of the green-leaved shrubs appear to be bush honeysuckle or privet based on their semi-evergreen leaf retention in winter. Bare deciduous trees are visible above the shrub layer. The bank slopes upward from the channel through this dense vegetation.

**Back:** Looking upstream, the very narrow channel is visible with thin water flow over flat rock/concrete substrate. The channel is bordered by dense shrubby invasive vegetation and bare deciduous trees. The substrate consists of flat, angular pieces that appear to be broken concrete or limestone rubble. Open agricultural fields are visible beyond the right bank tree line. Orange-colored objects (possibly osage orange fruits) are scattered on the ground.

**Left:** Looking toward the left bank (facing downstream), an expansive open agricultural field (pasture or hay field) extends into the distance. The riparian buffer on the left bank is extremely narrow - only a few scattered trees separate the stream from the open field. A few farm structures (red barn/buildings) are visible in the distance. A piece of white litter (possibly fabric or plastic) is visible on the ground near the stream. The buffer is clearly insufficient, perhaps only 10-20 feet of sparse tree cover.

Black Branch at Scene 22 is a severely degraded headwater stream flowing through an agricultural landscape in Wilson County, TN. The channel bed has been filled with concrete rubble/construction debris, eliminating natural substrate and destroying aquatic habitat. The left bank riparian buffer is critically deficient (under 10 feet) due to encroachment by an agricultural storage shed and gravel driveway, while the right bank is dominated by invasive shrubs (likely bush honeysuckle or privet). Water quality indicators are fair, with no obvious contamination, but the absence of functional habitat renders the reach nearly devoid of ecological value. Key MS4 compliance concerns include potential unpermitted fill material in the stream channel, a green hose/tubing of unknown purpose, and failure to meet minimum 30-foot riparian buffer requirements.

| Metric | Score | Notes |
|---|---|---|
| Channel Condition | 3 | The channel bed is heavily altered with dumped concrete rubble. While there is no formal channelization, the substrate has been completely replaced with artificial material. The concrete debris fills much of the channel cross-section and has altered natural channel morphology. Adjacent agricultural shed and gravel pad indicate historic site modification. Score of 3 reflects substantial alteration but floodplain connection still partially intact. |

| Side | Stability | Veg. Protection | Erosion | Notes |
|---|---|---|---|---|
| Left | 4 | 3 | 1_25_percent | Left bank is the more impacted side due to proximity of agricultural infrastructure (shed, gravel drive). The riparian buffer is critically narrow. Concrete rubble dump along bank toe. Open agricultural field begins within approximately 20 feet of channel. |

| Metric | Score/Value | Notes |
|---|---|---|
| TDEC 30ft Buffer Met? | L: No / R: No | Left bank buffer is critically deficient with agricultural structures and gravel driveway within 20 feet of channel. Right bank buffer exists but is dominated by invasive species. Buffer restoration should focus on widening the left bank buffer and replacing invasive species on the right bank with native plantings. TDEC MS4 permit section 4.2.5.4 buffer requirements are not met at this location. |

| Action | Priority | Timeline |
|---|---|---|
| Investigate concrete rubble dumping in channel for potential Section 404/ARAP violation | high | 30_days |
| Investigate green hose/tubing in channel for potential unpermitted discharge or withdrawal | high | 30_days |
| Document riparian buffer encroachment on left bank for buffer compliance records | medium | 90_days |
