# Scene 23 · MS4 Assessment

Black Branch 2

City of Lebanon TN

36.17012, -86.26988 · Generated October 22, 2026

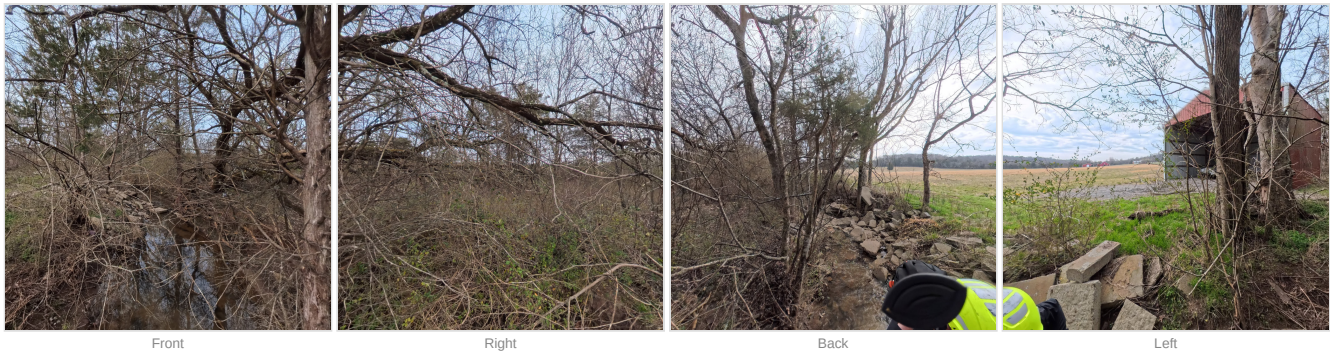
**Front:** Looking downstream, a narrow stream channel is visible with standing/slow-moving water reflecting bare winter trees overhead. The channel is heavily choked with fallen branches, vines, and woody debris. On the left bank, there appears to be angular rock/rubble material that could be placed concrete or rubble rather than natural stone, forming a crude bank stabilization. Dense dormant vegetation lines both sides.

**Right:** Looking toward the right bank (left bank when facing downstream), dense dormant shrubs and vines dominate the view. The vegetation is extremely thick with tangled branches typical of invasive bush honeysuckle and Japanese honeysuckle. Some green herbaceous growth visible at ground level. Mature trees visible in background with a few evergreen cedars. No water or channel directly visible in this direction.

**Back:** Looking upstream, the narrow stream channel flows through a confined corridor with angular rubble/rock material along banks. The stream bed shows shallow flowing water over rocky substrate. A person in high-visibility safety gear is visible on the bank — this is the survey crew member. Beyond the channel, an open agricultural field is visible to the right, and deciduous/cedar trees line the bank to the left. The angular, flat-surfaced rubble along the stream bank has characteristics strongly suggestive of broken concrete rather than natural rock — uniform gray color, flat surfaces, angular breaks, and proximity to agricultural infrastructure.

**Left:** Looking toward the left bank (right bank when facing downstream), a red agricultural barn/pole building is prominently visible with open agricultural fields beyond. Large angular concrete blocks/rubble are clearly visible at the base of the bank near the water. These are unmistakably broken concrete — rectangular blocks with flat surfaces, sharp angular edges, and uniform gray color. Green grass and some herbaceous growth visible near the barn. The buffer between the agricultural structures and the stream is very narrow, likely under 25 feet.

Black Branch at position #23 is a severely impaired small headwater stream flowing through an agricultural landscape. The channel is moderately incised with 3-6 foot banks, disconnected from its floodplain, and dominated by silt/mud substrate from agricultural runoff. The right bank (left when facing downstream) has a critically deficient riparian buffer with an agricultural barn within 20-25 feet of the channel. Broken concrete debris has been dumped along banks as informal stabilization — this represents unpermitted fill material. The left bank has a wider buffer but is dominated by invasive bush honeysuckle and Japanese honeysuckle. MS4 compliance concerns include buffer violations and unpermitted bank filling.

| Metric | Score | Notes |
|---|---|---|
| Channel Condition | 4 | Channel shows evidence of incision with moderate-high banks relative to its small size. Broken concrete has been placed along banks as crude stabilization. Channel appears moderately altered but retains some natural characteristics. Downcutting evidence visible from bank heights relative to apparent bankfull indicators. |

| Side | Stability | Veg. Protection | Erosion | Notes |
|---|---|---|---|---|
| Right | 3 | 3 | 26_50_percent | Right bank is the more impaired bank with limited buffer, agricultural encroachment, and informal concrete dumping used as stabilization. Bank is moderately unstable with active erosion. Agricultural barn is within approximately 25 feet of the stream channel. |

| Metric | Score/Value | Notes |
|---|---|---|
| TDEC 30ft Buffer Met? | L: Yes / R: No | Right bank buffer is severely deficient. Agricultural barn and field encroach within the 30-foot buffer zone. Buffer restoration on the right bank would require setback of agricultural activities. Left bank buffer exists but requires invasive species management to restore native riparian function. Per TDEC MS4 permit section 4.2.5.4, buffer compliance is not met on the right bank. |

| Action | Priority | Timeline |
|---|---|---|
| Document concrete debris dumping along right bank as potential unpermitted fill in stream buffer. Investigate whether ARAP permit was obtained for bank stabilization activities. | high | 90_days |
| Document right bank buffer deficiency. Agricultural barn and field encroach within TDEC 30-foot minimum buffer zone. | medium | 90_days |
