# Scene 24 · MS4 Assessment

Black Branch 2

City of Lebanon TN

## Detailed Observations · Scene 24

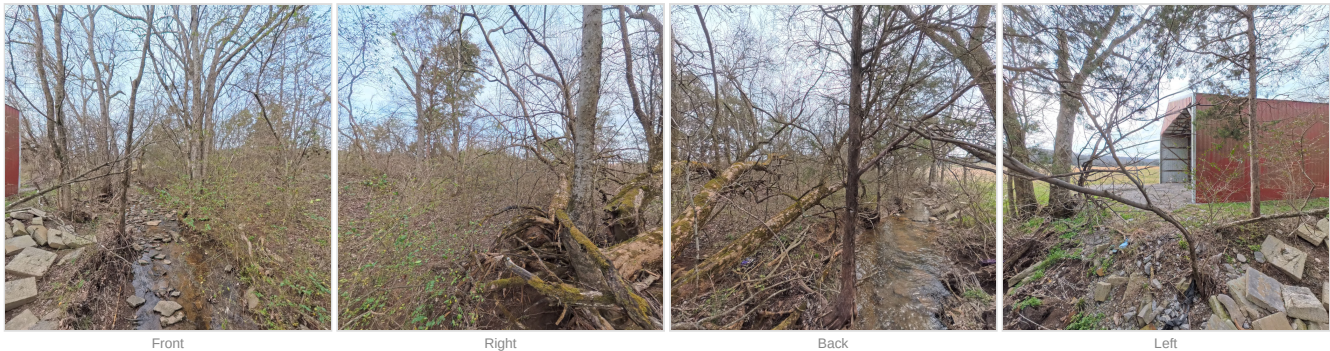
**Front:** Looking downstream, a very narrow, shallow stream channel flows through a deciduous forest corridor. The channel bed is dominated by flat, angular stones that appear to be concrete rubble rather than natural bedrock. A red metal barn or agricultural structure is visible on the left bank. Bare deciduous trees line both sides with some early spring green growth in the understory.

**Right:** The right bank (left bank when facing downstream) rises steeply into a wooded hillside. A large fallen tree with moss-covered trunk and exposed root wad is prominent. The hillside is covered with bare deciduous trees and dense understory brush. Early spring green growth (possibly invasive honeysuckle) is visible at ground level. The bank shows moderate slope with leaf litter covering the ground.

**Back:** Looking upstream, the narrow channel extends through the wooded corridor with shallow flowing water visible over a rocky/rubble bed. A large moss-covered fallen log spans across the left bank area. The channel appears slightly wider upstream with more visible water flow. Both banks are lined with bare deciduous trees. Some litter (possibly blue/purple fabric or plastic) is visible on the left bank among the debris. An open field or pasture area is faintly visible through the trees on the far right.

**Left:** The left bank direction reveals a large red metal barn/agricultural building very close to the stream. An open gravel or dirt area surrounds the barn entrance with mowed grass/pasture beyond. Angular stone and concrete rubble is piled along the bank edge between the stream and the barn. Some trash (blue plastic, black plastic sheeting) is visible among the rubble. Several trees including eastern red cedars stand between the barn and the stream channel.

Black Branch at this location (Scene #24) is severely impaired, primarily due to illegal dumping of construction and demolition concrete debris in the channel and along the left bank. The natural substrate has been completely replaced by broken concrete slabs, eliminating pool-riffle morphology and degrading macroinvertebrate and fish habitat. A red metal agricultural barn is located within 20-30 feet of the channel on the left bank, well within the TDEC minimum 30-foot riparian buffer, and the left bank buffer is functionally absent. The right bank maintains a reasonable wooded hillside buffer. Invasive shrubs (likely bush honeysuckle) are colonizing the understory. This reach requires enforcement action regarding the concrete dumping and a comprehensive restoration plan to remove debris and restore natural channel function.

| Metric | Score | Notes |
|---|---|---|
| Channel Condition | 2 | Channel bed is dominated by dumped concrete rubble. The left bank has been armored with stacked concrete debris. The channel shows evidence of incision and the natural substrate has been completely replaced by artificial material. While not formal channelization, the concrete dumping has fundamentally altered channel character. |

| Side | Stability | Veg. Protection | Erosion | Notes |
|---|---|---|---|---|
| Left | 3 | 3 | 26_50_percent | Left bank heavily impacted by adjacent agricultural building. Concrete rubble dumping along bank is both informal stabilization and an environmental concern. The barn is approximately 20-30 feet from the channel, well within the riparian buffer zone. Trash and debris (plastic) mixed with rubble. |

| Metric | Score/Value | Notes |
|---|---|---|
| TDEC 30ft Buffer Met? | L: No / R: Yes | Left bank buffer is non-compliant with TDEC MS4 permit section 4.2.5.4 requirements. The red metal barn/agricultural structure is within the 30-foot minimum buffer. Concrete rubble dumping within the buffer zone constitutes an additional violation. Right bank buffer appears adequate. |

| Action | Priority | Timeline |
|---|---|---|
| Document and report illegal dumping of construction and demolition concrete debris in stream channel | critical | immediate |
| Investigate agricultural structure encroachment within riparian buffer zone for compliance with local stormwater and buffer ordinances | high | 30_days |
