# Scene 25 · MS4 Assessment

Black Branch 2

City of Lebanon TN

36.17013, -86.27005 · Generated October 22, 2026

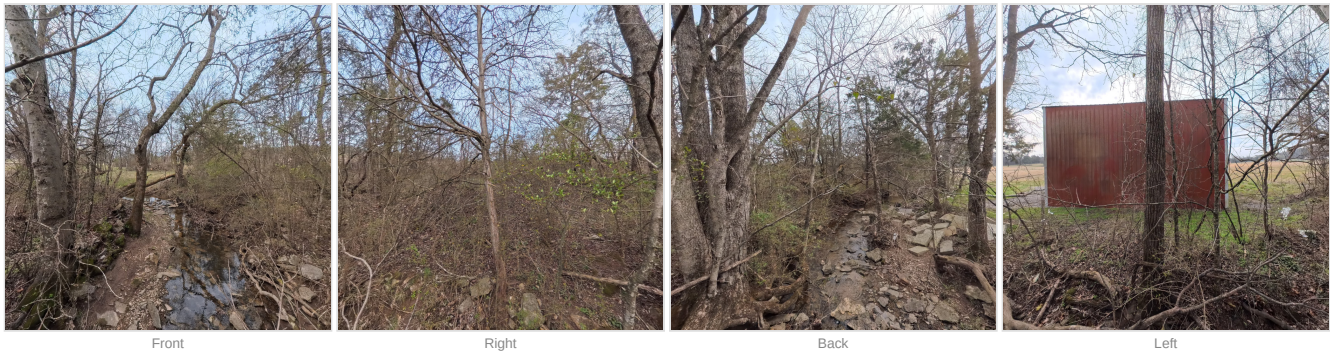
**Front:** Looking downstream, a very narrow, low-flow stream channel winds through a wooded corridor. The channel bed is exposed limestone/bedrock with thin water flow. A large sycamore tree stands on the left bank, and a fallen tree spans across the channel in the mid-distance. Beyond the riparian zone, an open green pasture/field is visible.

**Right:** Looking toward the right bank (left bank when facing downstream), a steep wooded hillside rises from the channel. Dense deciduous trees are bare with some early green leaves visible on what appears to be an evergreen shrub (possibly privet). The understory is thick with dormant vegetation and leaf litter covers the slope. Some rock visible at base of slope near channel margin.

**Back:** Looking upstream, the narrow channel continues with exposed flat limestone bedrock substrate dominating the bed. The channel appears very shallow with water barely covering the rock. Large mature sycamore trees line the left bank with significant exposed root systems. Flat rock slabs in the channel show natural geological layering and weathering patterns. Some structures may be partially visible in the far right background through the vegetation.

**Left:** Looking toward the left bank (right bank when facing downstream), a large red metal agricultural building/barn is visible approximately 50-75 feet from the stream channel. Beyond the structure, an open pasture/agricultural field extends into the distance. The riparian buffer between the stream and the structure is narrow, consisting of a thin strip of dormant deciduous trees and shrubs. Some litter is visible near the structure. The ground is trampled and shows root exposure near the channel margin.

Black Branch at scene #25 is a small headwater stream with a natural bedrock-controlled channel flowing through an asymmetric corridor with forested hillside on the right bank and narrow agricultural buffer on the left bank. Water quality appears good with clear water and no evidence of contamination, but instream habitat is limited by bedrock substrate dominance and very low flow conditions. The primary management concerns are the narrow riparian buffer on the left bank where an agricultural building sits approximately 50-75 feet from the channel, limited aquatic habitat diversity, and potential invasive species in the understory. No stormwater infrastructure or outfalls were observed at this location.

| Side | Stability | Veg. Protection | Erosion | Notes |
|---|---|---|---|---|
| Left | 6 | 5 | 1_25_percent | Left bank is lower than right bank with a narrow riparian buffer. Agricultural building approximately 50-75 feet from channel edge. Pasture extends beyond the structure. Buffer is thin but trees are present. |

| Metric | Score/Value | Notes |
|---|---|---|
| TDEC 30ft Buffer Met? | L: No / R: Yes | The agricultural building on the left bank is approximately 50-75 feet from the channel, but the effective woody vegetative buffer is only 10-25 feet. The building appears to be an existing agricultural structure. Buffer restoration potential is moderate - the area between the building and the stream could support additional woody plantings if landowner cooperation is obtained. |

| Action | Priority | Timeline |
|---|---|---|
| Document narrow riparian buffer on left bank for buffer compliance tracking | medium | 90_days |
| Assess agricultural building for potential runoff impacts to stream during wet weather | low | annual |
