# Scene 26 · MS4 Assessment

Black Branch 2

City of Lebanon TN

36.17011, -86.27011 · Generated October 22, 2026

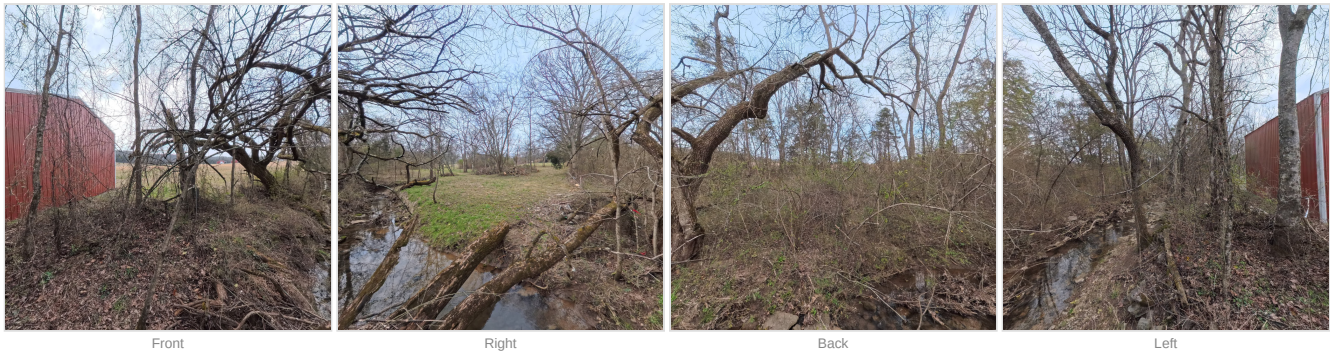
**Front:** Looking downstream (direction of travel), a large red metal agricultural building/barn is visible on the left bank very close to the stream corridor. Bare deciduous trees line the bank with leaf litter on the ground. Beyond the barn, open agricultural fields are visible in the background with another small red structure in the distance. The bank slopes up from the stream toward the barn.

**Right:** Looking to the right bank (when facing downstream), the stream is visible in the lower portion of the frame as a narrow channel with shallow water. The right bank has a grassy area transitioning to scattered deciduous trees (all bare). There are brush piles and woody debris on the floodplain. The landscape opens to a mowed/maintained grassy area with scattered trees suggesting rural residential or agricultural use. Fallen logs span across the channel.

**Back:** Looking upstream, the view shows a densely vegetated hillside rising steeply from the stream corridor. The bank and slope are covered with dormant deciduous shrubs, vines, and trees (all bare). Some green early spring growth is emerging in the understory. A small wet area or tributary seep is visible at the base of the slope. The vegetation is thick but mostly dormant woody material with tangled vines.

**Left:** Looking at the left bank, the stream channel is visible flowing alongside the bank with shallow water and exposed substrate. The red metal barn/building is visible again on the upper right portion of the frame, positioned very close to the stream corridor. Bare deciduous trees grow between the stream and the barn. Rock material is visible along the bank toe and in the channel - this appears to be natural limestone/bedrock outcrop consistent with the geology of the Nashville Basin area, though some angular fragments may include placed material near the barn foundation.

Black Branch at position 26 is a small headwater perennial stream flowing through an agricultural landscape in the Nashville Basin near coordinates 36.17, -86.27. The stream is marginally impaired, primarily limited by a severely compromised riparian buffer on the left bank where a red metal agricultural building sits within 20-30 feet of the channel, moderate bank erosion on both banks, and poor habitat diversity with the channel dominated by slow shallow pools lacking riffle features. Water quality appears acceptable with no evidence of illicit discharge, nutrient enrichment, or contamination. No stormwater outfalls or engineered infrastructure are present at this location. The most impactful management actions would be riparian buffer enhancement on the right bank and addressing sediment sources.

| Side | Stability | Veg. Protection | Erosion | Notes |
|---|---|---|---|---|
| Left | 5 | 4 | 26_50_percent | Left bank is adjacent to a red metal agricultural building. Narrow riparian buffer between barn and stream. Moderate erosion with some undercutting. Angular limestone fragments at bank toe may provide some natural armoring. |
| Right | 5 | 5 | 26_50_percent | Right bank has grassy floodplain area with scattered trees. Bank toe erosion is evident with exposed roots and soil. Fallen logs cross the channel from this bank, providing some habitat but indicating bank retreat. |

| Metric | Score/Value | Notes |
|---|---|---|
| TDEC 30ft Buffer Met? | L: No / R: Yes | The red metal agricultural building on the left bank represents a significant encroachment into the riparian buffer zone, likely within 20-30 feet of the stream. This pre-existing structure limits buffer restoration potential on the left side. The right bank has moderate restoration potential through reduced mowing and native planting. Per TDEC MS4 permit section 4.2.5.4, a minimum 30-foot riparian buffer is required. |

| Action | Priority | Timeline |
|---|---|---|
| Document the agricultural building encroachment within the 30-foot riparian buffer zone on the left bank for compliance records | medium | 90_days |
| Continue visual stream survey documentation along the reach to identify any outfalls or illicit discharges upstream and downstream of this position | medium | annual |
