# Scene 27 · MS4 Assessment

Black Branch 2

City of Lebanon TN

36.17005, -86.27018 · Generated October 23, 2026

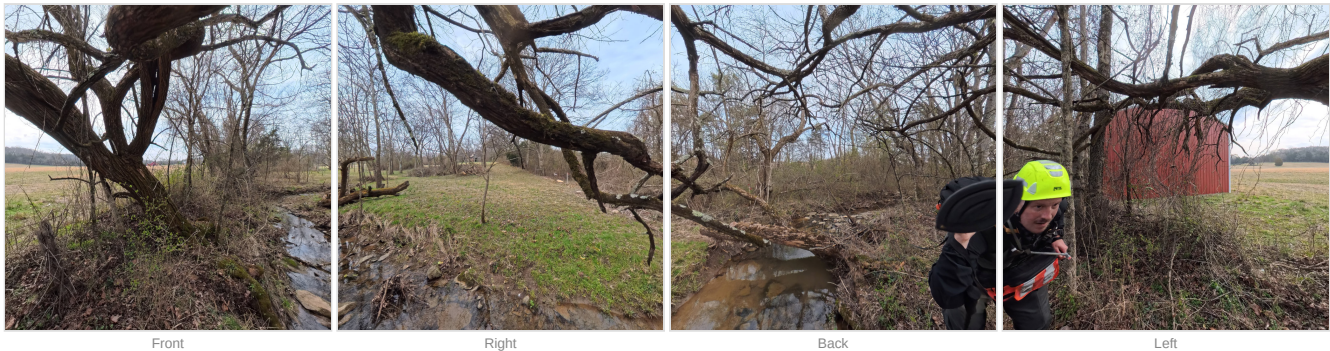
**Front:** Looking downstream, the view shows a very small stream channel winding through a rural landscape. A large mature tree with deeply furrowed bark dominates the left foreground. The stream is narrow with shallow, slow-moving water. Beyond the riparian fringe, open agricultural pasture or hayfield extends to the distance. Some red agricultural equipment or a structure is faintly visible in the far background.

**Right:** Looking right (left bank when facing downstream), the view shows a mowed or grazed grassy area sloping gently up from the stream bank. The stream channel is visible at the left edge with exposed bedrock/limestone substrate. Several mature deciduous trees are scattered in the background, all bare of leaves. A structure (possibly a gazebo or small building) is faintly visible in the distance. Woody debris from fallen branches is scattered on the ground. The grass is green, suggesting mild winter or early spring conditions.

**Back:** Looking upstream, a small pool is visible with a large fallen log spanning the channel. The water is shallow and slightly turbid with a brownish tint. Exposed limestone bedrock forms the bed. The right bank (looking upstream) has bare deciduous forest with moderate understory. A person wearing a black helmet (Petzl brand) and high-visibility vest is visible at the right edge - this is the field survey crew member. The channel is very small, perhaps 4-6 feet wide. Scattered rocks and cobble are visible in and around the channel.

**Left:** Looking left (right bank when facing downstream), a red agricultural barn or shed is prominently visible approximately 30-50 feet from the stream. A survey crew member wearing a yellow Petzl helmet and high-visibility safety vest is visible in the foreground. The area between the stream and barn is vegetated with dormant shrubs and vines, with some grass. Agricultural pasture/hayfield extends beyond the barn into the distance. A large mature tree with spreading limbs dominates the near view. The riparian buffer on this side is very narrow, with the barn and agricultural use encroaching close to the stream.

Black Branch at this location (#27 of 53) is a small headwater stream with a natural bedrock-controlled channel in a rural agricultural setting. The stream receives a marginal overall rating (6.2/10), primarily limited by severely inadequate riparian buffers on both banks due to agricultural land use encroachment. The channel itself is relatively natural with no engineered modifications, and floodplain connectivity is maintained. Water quality appears fair to good with no evidence of illicit discharge or contamination. The most significant management need is riparian buffer restoration, particularly on the left bank where grass is mowed to the stream edge, and on the right bank where an agricultural barn encroaches within 30-50 feet.

| Side | Stability | Veg. Protection | Erosion | Notes |
|---|---|---|---|---|
| Left | 6 | 5 | 1_25_percent | Left bank is low with grass cover transitioning to mowed/grazed area. Minimal woody riparian vegetation. Some natural bedrock exposure at bank toe provides some stability. |
| Right | 5 | 5 | 1_25_percent | Right bank has narrow riparian buffer with agricultural barn approximately 30-50 feet from stream. Some undercutting visible upstream. Dormant vegetation in winter makes coverage assessment partially limited. |

| Metric | Score/Value | Notes |
|---|---|---|
| TDEC 30ft Buffer Met? | L: No / R: No | Both banks have inadequate riparian buffers. The left bank has virtually no woody riparian buffer with grass mowed to the bank edge. The right bank has a narrow buffer encroached by an agricultural barn within approximately 30-50 feet. High potential for buffer restoration through planting programs, especially on the left bank where the flat terrain would support establishment of native riparian species. |

| Action | Priority | Timeline |
|---|---|---|
| Document this reach as part of visual stream assessment inventory. No outfalls present at this location. | medium | annual |
| Verify whether this agricultural area falls within the MS4 permitted boundary. If so, coordinate with agricultural operators regarding riparian buffer preservation. | low | 90_days |
