# Scene 28 · MS4 Assessment

Black Branch 2

City of Lebanon TN

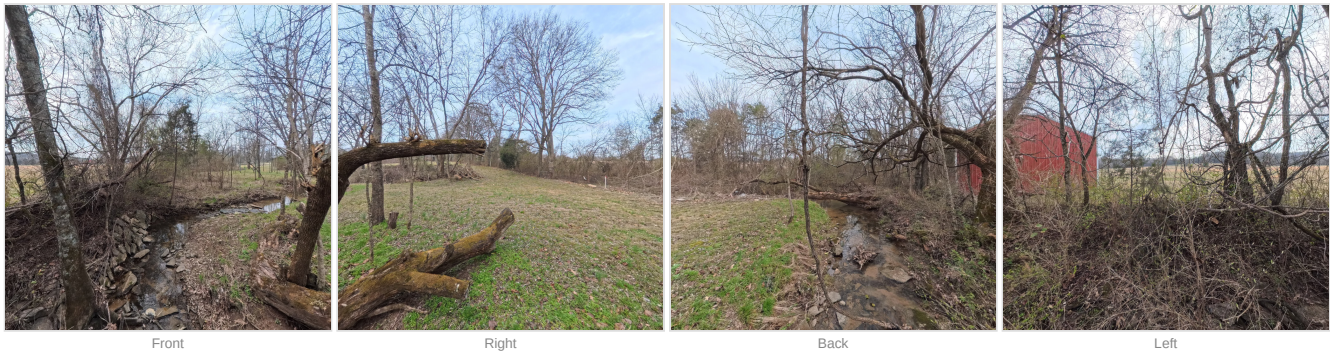
**Front:** Looking downstream, a narrow stream channel meanders through a rural landscape with scattered deciduous trees in bare winter/early spring condition. The left bank shows a notable accumulation of flat, stacked rock material along the bank edge. The channel is very narrow (approximately 3-5 feet wide) with shallow water flowing over a rocky bed. Open pastoral land is visible beyond the riparian corridor on both sides.

**Right:** Looking toward the right bank (when facing downstream), the view shows a mowed grass area with scattered mature deciduous trees in bare condition. A moss-covered fallen log and a broken overhanging limb are prominent. A wood pile or brush pile is visible in the mid-ground, and fencing or fence posts may be present at the right edge of the image. The land slopes gently upward away from the stream, indicating a pastoral/residential setting.

**Back:** Looking upstream, the narrow stream channel is visible with very shallow flow over a rocky/flat substrate. A large fallen tree spans the channel creating a natural debris jam. A red agricultural barn or outbuilding is visible on the left bank (right side when facing upstream), very close to the stream. The banks are low with grass and bare deciduous trees. Flat rock substrate is visible in the channel bed.

**Left:** Looking toward the left bank (when facing downstream), a red agricultural barn or outbuilding is prominently visible very close to the stream. Dense dormant shrub and vine thickets dominate the bank between the stream and the barn. Agricultural fields are visible in the distance beyond the barn. The vegetation is dense but appears to include invasive species (likely bush honeysuckle or multiflora rose based on growth form).

| Side | Stability | Veg. Protection | Erosion | Notes |
|---|---|---|---|---|
| Left | 6 | 6 | 1_25_percent | Left bank has dense shrub cover with possible invasive species. Red barn/agricultural building very close to stream (~25-50 ft). Agricultural fields visible beyond. The stacked rock along the bank requires field verification to determine if it is placed stabilization or natural outcrop. |
| Right | 6 | 5 | 1_25_percent | Right bank is maintained as mowed grass/pastoral area with scattered mature trees. Low bank angle provides good floodplain access but limited woody riparian vegetation. The mowed condition up to the stream edge suggests the riparian buffer is compromised by land management practices. |

| Metric | Score/Value | Notes |
|---|---|---|
| TDEC 30ft Buffer Met? | L: No / R: No | Both banks show significant buffer deficiencies. The left bank has a barn within the buffer zone and invasive vegetation. The right bank is mowed to the stream edge. Riparian buffer restoration through cessation of mowing, invasive species removal, and native tree/shrub planting would be highly beneficial and feasible at this location. |

| Action | Priority | Timeline |
|---|---|---|
| Document this reach as having inadequate riparian buffers on both banks for watershed planning purposes | medium | 90_days |
| Verify material composition of stacked rock on left bank during next field visit to determine if it is placed bank stabilization requiring inventory | low | annual |
