# Scene 29 · MS4 Assessment

Black Branch 2

City of Lebanon TN

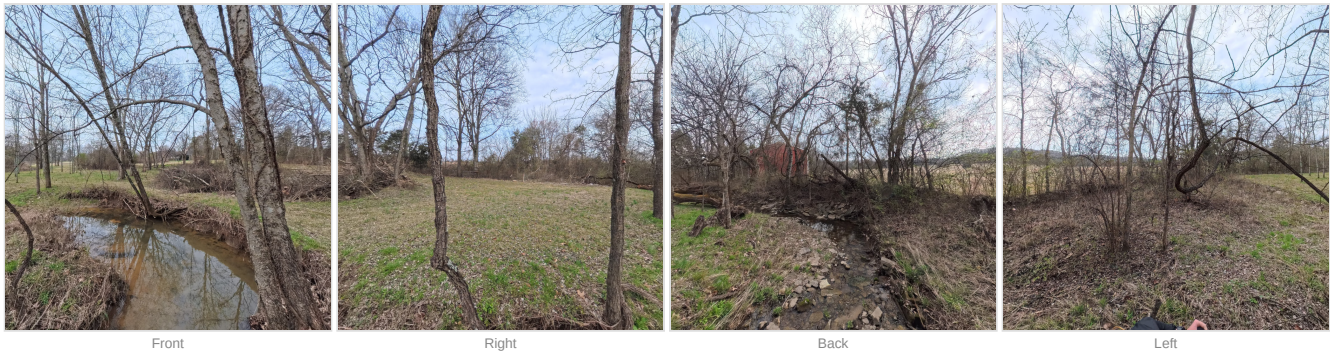
**Front:** Looking downstream, a small stream channel winds through a pastoral landscape with scattered deciduous trees in bare winter/early spring condition. The water surface is calm and reflective in a pool area. A structure or outbuilding is visible in the background through the trees. The banks are low with grass and dormant vegetation.

**Right:** Looking toward the right bank, an open mowed or grazed grassy field extends away from the stream. Scattered deciduous trees in bare condition line the area. Some fallen trees and brush piles are visible at the edge of the field. The land is relatively flat with short grass suggesting regular mowing or grazing.

**Back:** Looking upstream, the stream channel narrows significantly with exposed rock/substrate visible in the bed. A red barn or agricultural building is visible through the bare trees on the left bank side. The channel has flat angular rock pieces exposed along the banks and bed. Fallen trees span parts of the channel area. The substrate appears to be flat limestone or possibly broken concrete fragments requiring closer inspection.

**Left:** Looking toward the left bank, a brushy area with dormant shrubs and small trees extends along the bank and into the floodplain. The terrain is gently sloping with dry grass and leaf litter. A person's hand and equipment are visible at the bottom of frame confirming this is a backpack-mounted camera on a walking survey. Beyond the brush, open fields and distant hills/ridgelines are visible.

| Metric | Score | Notes |
|---|---|---|
| Sediment Deposition | 6 | Silt deposition is visible in pool areas as seen in the front and down views. The pool downstream appears to have some fine sediment accumulation on the bottom. Estimated 15-25% of the visible bed is affected by fine sediment deposition, which is moderate for this stream type. |

| Side | Stability | Veg. Protection | Erosion | Notes |
|---|---|---|---|---|
| Right | 5 | 4 | 1_25_percent | Right bank is dominated by grass/turf with sparse tree cover. Open field begins within approximately 20-30 feet of the channel. Bank stability is compromised by lack of deep-rooted woody vegetation along the bank face. The mowing/grazing pattern extends relatively close to the stream edge. |

| Metric | Score/Value | Notes |
|---|---|---|
| TDEC 30ft Buffer Met? | L: No / R: No | Both banks show inadequate riparian buffers relative to TDEC MS4 30-foot minimum standard. The right bank is more severely compromised with mowed grass extending nearly to the channel edge. Buffer restoration potential is high given the flat terrain and existing scattered trees that could serve as seed sources. This is a priority area for riparian planting and buffer expansion. |

| Action | Priority | Timeline |
|---|---|---|
| Document inadequate riparian buffers for MS4 watershed management planning | medium | 90_days |
