# Scene 3 · MS4 Assessment

Black Branch 2

City of Lebanon TN

36.17004, -86.26836 · Generated October 23, 2026

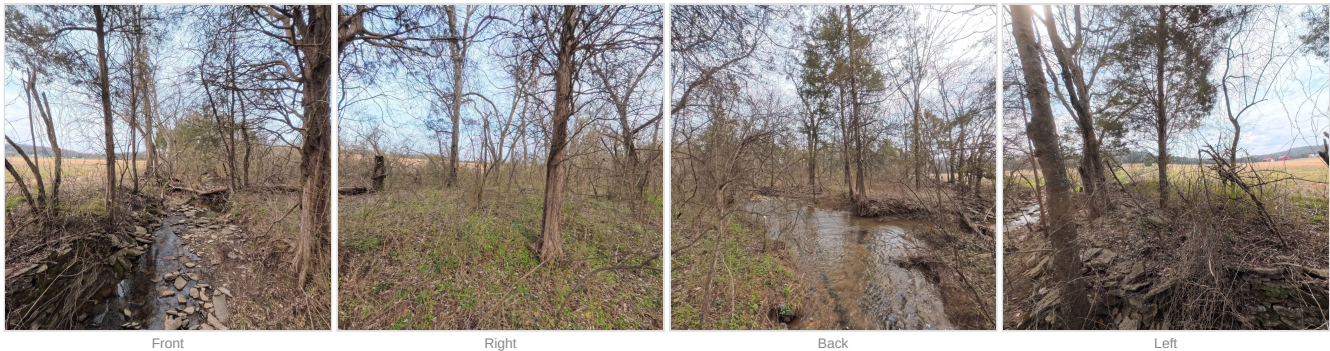
**Front:** Looking downstream, the channel is a very narrow, shallow stream with exposed flat rock substrate and scattered loose cobble/gravel. Water flows in a thin film over bedrock. Deciduous trees are bare on both banks, with open agricultural fields visible through the tree line to the left. A fallen log/debris jam partially spans the channel ahead.

**Right:** The right bank (left bank when facing downstream) shows a wooded riparian area with bare deciduous trees and a mix of green herbaceous ground cover emerging in early spring. Beyond the tree line, open agricultural/pasture fields are visible. The riparian buffer extends approximately 25-50 feet before transitioning to open land. A possible old structure or large debris is visible in the mid-ground.

**Back:** Looking upstream, the channel widens slightly and the water is somewhat deeper with a visible flowing surface over a sand/gravel/bedrock substrate. Trees with exposed root systems line the banks, especially on the right (left bank facing downstream) where significant root exposure and minor bank erosion is evident. Bare deciduous trees dominate with a few evergreens (cedars) visible. A fence line or wire is visible crossing the upper portion of the scene.

**Left:** The left bank (right bank when facing downstream) shows a steep, rocky bank with exposed flat limestone rock and scattered trees growing from the bank face. Beyond the narrow riparian strip, open agricultural/pasture land is visible with a red barn structure in the distance. The rock on the bank appears to be natural limestone layers consistent with local geology, though some flat pieces have somewhat angular edges. Hills/ridgeline visible in the far background.

| Metric | Score | Notes |
|---|---|---|
| Channel Condition | 8 | The channel appears largely natural with no evidence of straightening, armoring, or significant alteration. The limestone bedrock substrate provides natural grade control. Minor lateral erosion is present upstream but not excessive for a natural stream. The channel appears to be in a naturally evolved state within its agricultural landscape. |
| Hydrologic Alteration | 6 | The stream shows slight incision through the limestone bedrock with banks approximately 3-4 feet high in places. The floodplain appears connected based on the low bank heights in some areas and evidence of flood deposits, but the agricultural land use and potential drainage alterations may have increased peak flows and altered hydrology somewhat. The bedrock channel limits further downcutting. |
| Sediment Deposition | 7 | The bedrock-controlled channel shows minimal sediment deposition. The exposed limestone bed has scattered loose rock fragments and minor gravel/sediment accumulation in low spots, but less than 30% of the visible bed is affected. The bedrock substrate prevents significant sediment storage. |

| Side | Stability | Veg. Protection | Erosion | Notes |
|---|---|---|---|---|
| Left | 6 | 6 | 1_25_percent | Left bank shows natural limestone bedrock exposure in places with tree root stabilization. Minor undercutting visible upstream where trees have exposed root masses. Riparian corridor is narrow with agricultural fields beyond. |
| Right | 6 | 5 | 1_25_percent | Right bank characterized by steep limestone rock faces with scattered trees. The narrow riparian buffer transitions quickly to open agricultural/pasture land with a barn visible. The exposed rock bank is naturally stable but the sparse vegetation and narrow buffer are limiting factors. |

| Metric | Score/Value | Notes |
|---|---|---|
| TDEC 30ft Buffer Met? | L: Yes / R: No | The right bank riparian buffer appears inadequate relative to TDEC MS4 permit requirements. Agricultural land use encroaches close to the stream on the right bank. Buffer restoration through native tree and shrub planting would significantly improve filtering capacity, bank stability, and stream health. The left bank buffer is marginally adequate but would also benefit from widening. |
