# Scene 30 · MS4 Assessment

Black Branch 2

City of Lebanon TN

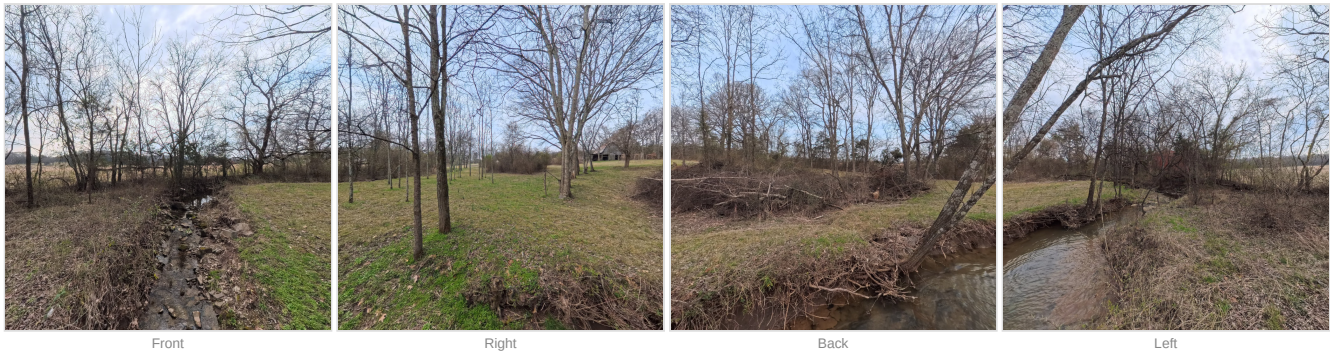
**Front:** Looking downstream, a narrow shallow stream channel flows through a rocky bed with exposed flat limestone/bedrock substrate. The channel is flanked by bare deciduous trees on both sides with dormant herbaceous vegetation. Open pasture/agricultural fields are visible beyond the thin riparian corridor. A small pool of water is visible mid-channel among the exposed rock.

**Right:** Looking toward the right bank (when facing downstream), an open grassy area extends outward with scattered bare deciduous trees. A wooden barn or agricultural outbuilding is visible in the mid-distance to the right. The grass is winter-green with some bare patches. The area appears to be mowed pasture or maintained agricultural land extending beyond the thin riparian strip. The stream bank edge is visible at the near foreground.

**Back:** Looking upstream, the stream channel is visible with flowing water and significant woody debris and brush piles along the left bank. There is a large accumulation of cut/fallen branches and tree debris piled along the bank, suggesting recent clearing or storm damage. The right bank shows exposed soil and root masses at the water's edge with some bank erosion. Bare deciduous trees line both sides with open pasture beyond. A leaning tree is present on the right bank.

**Left:** Looking toward the left bank (when facing downstream), the stream flows past with slightly turbid brown water. The bank shows some erosion and exposed soil. Beyond the bank is a mix of bare deciduous trees and dormant shrubs/herbaceous vegetation. A red structure (possibly barn or outbuilding) is partially visible through the trees in the distance. Open pasture fields are visible beyond the thin riparian corridor. The stream meanders in this direction showing the channel curving.

| Metric | Score | Notes |
|---|---|---|
| Channel Condition | 7 | Channel appears natural with no visible engineered modifications. Bedrock controls prevent significant downcutting. Some lateral erosion is present on banks, particularly upstream where root exposure and bank cutting are visible. The channel is functioning relatively naturally but the thin riparian buffer and adjacent pasture may be contributing to some bank instability. |

| Side | Stability | Veg. Protection | Erosion | Notes |
|---|---|---|---|---|
| Left | 5 | 4 | 26_50_percent | Left bank shows evidence of recent tree clearing with large brush/debris piles visible upstream. This clearing may have reduced bank stability and vegetative protection. Grass and herbaceous cover extends to bank edge in some areas. Moderate erosion present where clearing has occurred. |
| Right | 6 | 5 | 1_25_percent | Right bank is generally stable with grass extending to the bank edge. Thin riparian buffer transitions quickly to maintained pasture/lawn. Minor scour erosion in some areas. The bank is low, allowing good floodplain connectivity. |

| Metric | Score/Value | Notes |
|---|---|---|
| TDEC 30ft Buffer Met? | L: No / R: No | Both banks fail to meet TDEC 30ft minimum buffer requirements. The adjacent pasture land presents excellent opportunities for buffer restoration through riparian planting programs. Recent clearing on the left bank has exacerbated the buffer deficiency. The barn/outbuilding on the right side is within the buffer zone. |

| Action | Priority | Timeline |
|---|---|---|
| Investigate the recent riparian vegetation clearing visible on the left bank to determine if appropriate permits were obtained | high | 30_days |
| Document buffer deficiencies on both banks for MS4 buffer compliance tracking | medium | 90_days |
