# Scene 31 · MS4 Assessment

Black Branch 2

City of Lebanon TN

36.16982, -86.27041 · Generated October 22, 2026

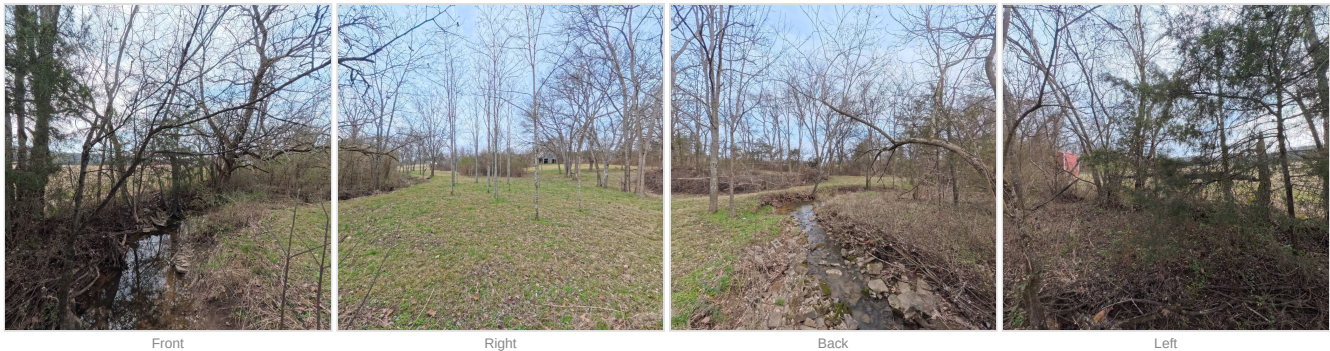
**Front:** Looking downstream, a very narrow channel with still/slow water is visible winding through bare deciduous trees. A rock/rubble accumulation is visible on the far bank forming what appears to be a natural or placed stone pile. Agricultural/pastoral fields are visible through the leafless trees in the background with rolling hills beyond.

**Right:** Looking to the right bank (when facing downstream), a mowed grass area extends away from the channel with scattered bare deciduous trees. An old wooden barn or outbuilding is visible in the mid-ground. The grass is mostly dormant with some green patches. The riparian buffer on this side is very narrow to non-existent — the mowed area comes nearly to the bank edge.

**Back:** Looking upstream, the narrow stream channel is clearly visible flowing over exposed rocky substrate. The channel is very narrow (approximately 3-5 feet wide) with shallow flow over cobble and flat rock. Both banks are visible with moderate erosion. The left bank has green grass nearly to the edge, while the right bank has more woody vegetation and dead herbaceous material. Flat angular rock fragments are abundant in and along the channel.

**Left:** Looking toward the left bank (when facing downstream), dense shrubby and vine-covered vegetation is visible with some evergreen trees (likely eastern red cedar). A red-roofed building or barn is partially visible through the vegetation in the background. The understory is thick with dormant vines and brush, providing relatively dense bank coverage despite being leafless. This side has more robust riparian vegetation than the right bank.

Black Branch 231 at this location is a small headwater stream (1st-2nd order) flowing through a rural agricultural/pastoral setting near Lebanon, Tennessee. The stream exhibits a marginal overall condition driven primarily by the severely compromised riparian buffer on the right bank, where mowing/grazing extends nearly to the channel edge, and by sparse large woody debris limiting instream habitat. The left bank maintains a better vegetative buffer with dense shrub and vine coverage, though some invasive species are suspected. Water quality appears fair to good during dry weather conditions with clear flow over natural limestone cobble substrate. No stormwater infrastructure or outfalls were identified at this location. The primary management need is right bank riparian buffer restoration to meet TDEC minimum 30ft buffer requirements.

| Side | Stability | Veg. Protection | Erosion | Notes |
|---|---|---|---|---|
| Right | 5 | 4 | 26_50_percent | Right bank lacks adequate riparian buffer. Mowed grass extends nearly to the channel edge. Scattered deciduous trees provide some protection but are not continuous. Bank erosion and bare soil exposure more pronounced on this side. An old barn/outbuilding is visible approximately 100+ feet from the bank. |

| Metric | Score/Value | Notes |
|---|---|---|
| TDEC 30ft Buffer Met? | L: Yes / R: No | The right bank riparian buffer is severely compromised by mowing/grazing extending to the channel edge. TDEC MS4 permit section 4.2.5.4 requires minimum 30ft riparian buffers. Restoration potential is high on the right bank as simply ceasing mowing activities would allow natural regrowth. Active planting could accelerate restoration. The left bank buffer appears adequate. |

| Action | Priority | Timeline |
|---|---|---|
| Document the inadequate riparian buffer on the right bank for MS4 buffer compliance tracking | medium | 90_days |
