# Scene 32 · MS4 Assessment

Black Branch 2

City of Lebanon TN

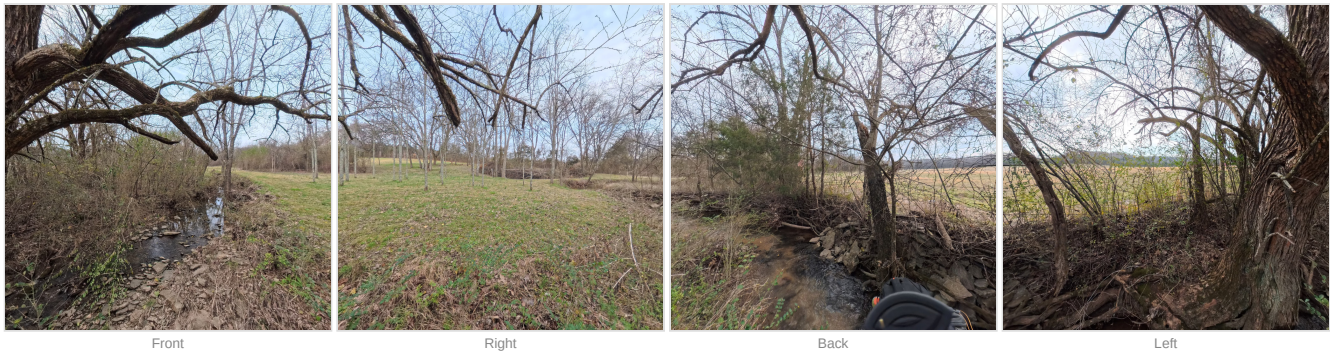
**Front:** Looking downstream, a very narrow channel (approximately 3-5 feet wide) extends with shallow water flowing over a substrate of flat, thin rock fragments. The channel is bordered on the left by dense bare deciduous trees and shrubs, and on the right by a mowed grass area. A large mature tree with sprawling branches overhangs the channel from the left bank.

**Right:** Looking right (right bank facing downstream), a broad mowed grass area extends from the bank edge. Scattered deciduous trees, mostly bare, stand in the grassy area. A large brush pile or downed tree debris is visible in the mid-ground near where the channel curves. A structure (possibly a barn or outbuilding) is visible in the distance through the bare trees. The mowed grass extends right up to the channel edge with minimal riparian buffer.

**Back:** Looking upstream, the narrow channel continues with flowing water over rocky substrate. The left bank has exposed rock/stone along the bank edge with tree roots and some vegetation. The right bank shows open pasture or agricultural land beyond a thin fringe of vegetation. A person with survey/assessment equipment is partially visible in the bottom of the frame. The flat rock fragments along the bank edge require careful assessment for concrete vs natural origin.

**Left:** Looking left (left bank facing downstream), a large mature tree trunk dominates the near view with deeply furrowed bark. Beyond the tree, through bare branches and thin understory, open agricultural or pastoral land is visible extending to distant hills. A wire fence line may be present. The bank drops off behind the tree toward the channel. Exposed roots of the large tree are visible, and the ground surface shows leaf litter and some low green vegetation.

Black Branch at this location is a small headwater stream in marginal condition, primarily limited by severely inadequate riparian buffer on the right bank where mowed grass extends to the channel edge, and limited instream habitat diversity. The left bank retains a narrow strip of mature trees providing some bank stability and shade, but this buffer is insufficient to meet TDEC 30-foot minimums. Water quality indicators are fair with slight turbidity and no evidence of illicit discharge. The agricultural/pastoral land use on both sides of the stream is the primary driver of habitat degradation, and riparian buffer restoration represents the highest-priority management action for this reach.

| Side | Stability | Veg. Protection | Erosion | Notes |
|---|---|---|---|---|
| Left | 5 | 6 | 1_25_percent | The left bank features a narrow riparian corridor with mature hardwood trees (possible walnut or hackberry). The bank is steeper than the right bank and shows signs of active erosion with exposed rock and root exposure. The riparian buffer is very narrow, transitioning quickly to open agricultural/pastoral land visible in the left face view. |
| Right | 4 | 4 | 1_25_percent | The right bank is characterized by mowed grass extending nearly to the stream edge with only scattered trees set back from the bank. This lack of riparian woody vegetation is the most significant deficiency at this location. The bank is low and currently stable but vulnerable to future erosion without improved vegetative protection. |

| Metric | Score/Value | Notes |
|---|---|---|
| TDEC 30ft Buffer Met? | L: No / R: No | This location has significant riparian buffer deficiencies on both banks. The right bank is the most critical need with mowed grass extending to the bank edge. The left bank buffer, while present, is narrow and may not meet TDEC 30-foot minimums. Buffer restoration through native tree and shrub planting would be highly effective given the rural setting and available land area. |

| Action | Priority | Timeline |
|---|---|---|
| Document riparian buffer deficiency on both banks as part of visual stream survey records | medium | 90_days |
