# Scene 33 · MS4 Assessment

Black Branch 2

City of Lebanon TN

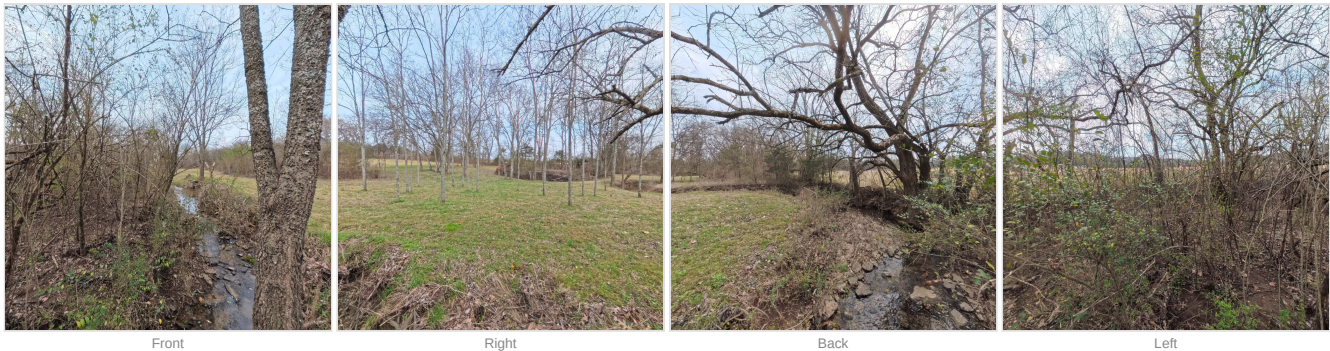
**Front:** Looking downstream, a very narrow channel (approximately 3-5 feet wide) winds through a mixed riparian corridor. The left bank has dense shrubby vegetation and some mature trees, while the right bank transitions quickly to mowed grass/pasture. Water is shallow with visible substrate and a small pool area visible in the mid-distance.

**Right:** The right bank (when facing downstream) opens to a broad, mowed grass area with scattered young deciduous trees in a parkland or pasture setting. Trees are bare, indicating early spring. A debris pile or brush pile is visible at the far right near the stream bank edge. The grass area extends well back from the channel with no significant riparian buffer.

**Back:** Looking upstream, the narrow channel continues with shallow flowing water over a rocky/silty substrate. The left bank (right side of image looking upstream) shows grassy pasture with minimal buffer, while the right bank (left side looking upstream) has some woody vegetation and a large mature tree with extensive root exposure at the bank edge. Flat angular rock fragments are visible in the streambed.

**Left:** The left bank when facing downstream shows dense shrubby understory and bare deciduous trees. Beyond the immediate riparian zone, open pasture or agricultural land is visible through the vegetation. The shrub layer includes some green-leaved vines that appear to be evergreen invasives (possibly Japanese honeysuckle). The ground is covered with leaf litter and bare soil.

Black Branch at scene #33 is a small headwater stream (1st-2nd order, ~3-4 ft wide) in marginal condition flowing through a mixed rural/pastoral landscape near Nashville, TN. The most significant impairment is the severely deficient riparian buffer on the right bank where mowing extends to the bank edge, resulting in bank instability, reduced shade, and limited habitat. The left bank retains a moderate woody buffer but is colonized by invasive Japanese honeysuckle. Instream habitat is poor with fine sediment dominating the substrate and very limited large woody debris. No stormwater infrastructure or outfalls are present at this rural location, but the adjacent land use contributes sediment and limits stream corridor function.

| Side | Stability | Veg. Protection | Erosion | Notes |
|---|---|---|---|---|
| Right | 3 | 3 | 26_50_percent | Right bank is the weaker of the two banks with inadequate riparian buffer. Mowed grass/pasture extends to near the bank edge with only scattered young deciduous trees providing minimal root protection. Active erosion is evident with bare soil exposure on the bank face. This bank would benefit significantly from riparian buffer establishment. |

| Metric | Score/Value | Notes |
|---|---|---|
| TDEC 30ft Buffer Met? | L: Yes / R: No | Right bank riparian buffer is severely deficient relative to TDEC 30ft minimum standard. Mowing extends to the bank edge. This is a high priority area for riparian buffer restoration. Left bank buffer is marginal but meets minimum standards. Invasive species management on the left bank would improve buffer quality. |

| Action | Priority | Timeline |
|---|---|---|
| Document riparian buffer deficiency on right bank in MS4 stream survey database | medium | 90_days |
| Coordinate with landowner regarding riparian buffer establishment on right bank | medium | 90_days |
