# Scene 34 · MS4 Assessment

Black Branch 2

City of Lebanon TN

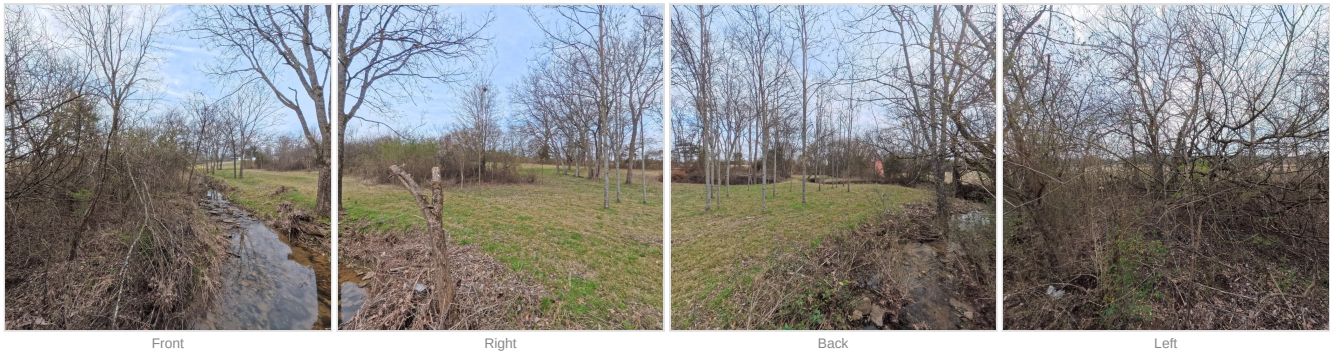
**Front:** Looking downstream, a narrow, shallow channel flows through a rural/suburban setting. The channel is narrow (approximately 3-6 feet wide) with exposed flat rock/limestone substrate visible in the bed. Water is very shallow and flows gently downstream. The right bank transitions quickly to a mowed grass field with scattered bare deciduous trees. The left bank has dense shrubby vegetation and small trees. A structure or building is faintly visible in the distance on the right side.

**Right:** The right bank (left bank when facing downstream) shows a mowed grass field extending back from the stream channel with scattered bare deciduous trees. The bank edge has leaf litter and woody debris. A broken tree stump is prominent near the bank edge. The grass is green and appears maintained. Beyond the field, a tree line is visible along what appears to be a property boundary or road.

**Back:** Looking upstream, the view shows a mowed grass area to the left with scattered bare deciduous trees. The channel edge is visible on the right side with exposed rock/limestone substrate at the bank. A red building or barn is visible in the background through the bare trees. The riparian zone transitions quickly from channel edge to mowed grass, with some shrubby vegetation and small trees along the bank. Some flat rock fragments are visible at the bank edge.

**Left:** The left bank (right bank when facing downstream) shows dense shrubby vegetation and small trees, most of which are bare/dormant. The vegetation is tangled with vines and brush creating a thick but low-quality riparian buffer. Beyond the immediate riparian vegetation, structures or buildings appear to be present in the background. Some litter is visible on the ground. The vegetation is primarily composed of what appears to be invasive shrubs (possibly bush honeysuckle or multiflora rose) given the dense tangled growth pattern.

Black Branch at this location is a small, low-gradient limestone-bedrock headwater stream that is marginally impaired due to severely deficient riparian buffers and limited instream habitat diversity. The right bank (facing downstream) has essentially no functional riparian buffer with mowed grass extending to the channel edge, while the left bank is dominated by invasive shrubs (likely bush honeysuckle). Channel condition is fair with moderate incision, and water quality appears acceptable during this dry weather observation. The primary management needs are riparian buffer establishment on the right bank, invasive species management on the left bank, and potential LWD augmentation to improve instream habitat.

| Metric | Score | Notes |
|---|---|---|
| Sediment Deposition | 5 | Fine sediment (silt and mud) visible overlying bedrock substrate, particularly in the down view where turbid muddy water covers portions of the bed. Approximately 20-40% of the visible bed appears affected by fine sediment deposition. The bedrock substrate is partially obscured. Not severe enough to cause braiding but pool habitat is likely compromised by sedimentation. |

| Side | Stability | Veg. Protection | Erosion | Notes |
|---|---|---|---|---|
| Left | 5 | 6 | 1_25_percent | Left bank has dense invasive shrub coverage that provides some bank protection. Structures and possible fencing visible behind the riparian zone. Some litter present. Bank is steep with moderate height. |
| Right | 4 | 4 | 1_25_percent | Right bank is significantly compromised by mowing/grass management extending to the channel edge. Very minimal woody riparian buffer. Scattered mature trees provide limited bank protection but most of the bank face lacks deep root systems. |

| Metric | Score/Value | Notes |
|---|---|---|
| Canopy Cover | 3 | Currently in winter with bare deciduous trees, canopy shade is under 25%. Even in full leaf, the right bank's scattered trees and the left bank's short shrubby vegetation would provide perhaps 25-40% shade. The open mowed area on the right bank ensures significant solar exposure. For a warmwater stream, this level of shade is below optimal. |
| TDEC 30ft Buffer Met? | L: No / R: No | The right bank represents the most critical buffer deficiency. The mowed grass field provides essentially zero riparian buffering function. Establishing a native riparian buffer of at least 30 feet on the right bank should be a high priority. The left bank would benefit from invasive species management and replanting with native trees and shrubs to improve buffer quality even if width is constrained. |

| Metric | Score | Notes |
|---|---|---|
| Water Appearance | 5 | Water appears slightly turbid to turbid with a brownish color. In the front view, the substrate is partially visible through shallow water suggesting moderate clarity. In the down view, the water is more turbid with reduced visibility. No oil sheen, foam, or unusual odor indicators visible. The brown color may be partly from tannins and partly from suspended sediment. Visibility estimated at 0.5-1 foot. |

| Action | Priority | Timeline |
|---|---|---|
| Continue outfall mapping along this reach — no outfalls observed at this location but upstream and downstream sections should be surveyed | medium | annual |
| Document this reach in visual stream survey database with riparian buffer deficiency flagged | medium | 90_days |
| Conduct dry weather screening of any outfalls identified in adjacent reaches of this stream | medium | 90_days |
