# Scene 35 · MS4 Assessment

Black Branch 2

City of Lebanon TN

36.16969, -86.27081 · Generated October 23, 2026

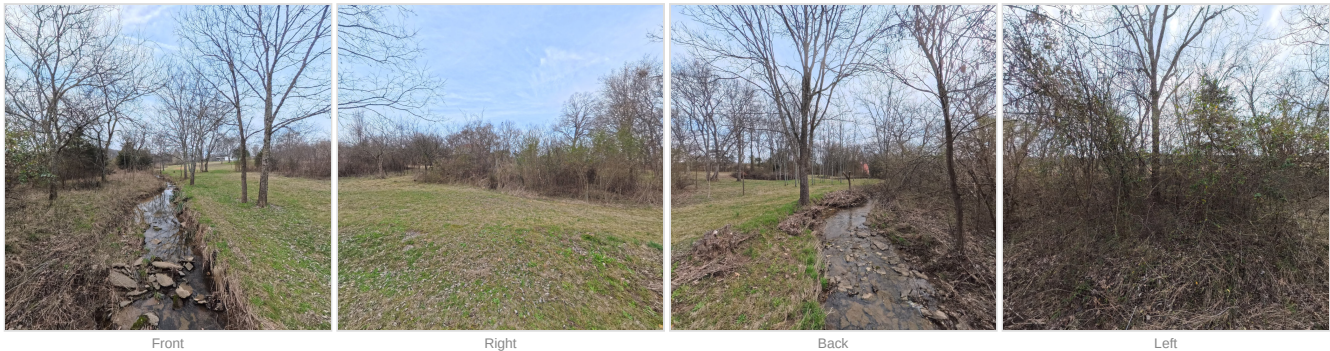
**Front:** Looking downstream, a narrow stream channel extends into the distance with very shallow flow over exposed rock/flat substrate. The channel is approximately 3-5 feet wide. The left bank has sparse dormant grass and scattered mature deciduous trees in bare winter condition. The right bank is lined with mowed green grass extending to scattered trees with a structure (barn/shed) visible in the far background. A yucca plant is growing on the right bank edge.

**Right:** The right bank view shows a mowed grass area extending away from the stream, transitioning to a thicket of dense dormant shrubs and small trees. A few scattered mature deciduous trees stand in the mowed area. The vegetation in the thicket is heavily tangled and dormant, with some potential invasive species (bush honeysuckle or privet) evident from the dense growth habit. The area appears to be rural residential or agricultural land.

**Back:** Looking upstream, the narrow stream channel is visible with very shallow flow over exposed flat limestone bedrock substrate. The channel curves slightly. The left bank (right side of image looking upstream) shows mowed green grass with scattered mature trees and a large tree stump/rootwad on the bank. A structure with a reddish/pink color is visible in the background through the bare trees. The right bank (left in image) has dense dormant shrubs and vine thicket. Woody debris accumulation is visible on the left bank near the channel.

**Left:** The left bank view shows dense dormant vegetation including a thick tangle of shrubs, vines, and small trees. Several mature deciduous trees extend above the understory. The vegetation is heavily dormant and some green leaves visible appear to be evergreen species or possibly invasive species with extended growing season (privet or Japanese honeysuckle retaining some foliage). The ground is covered in leaf litter and dead vine material. This side has a much denser riparian buffer compared to the mowed right bank.

Black Branch at this location is a small headwater stream (1st-2nd order) flowing over natural limestone bedrock in a rural/agricultural setting near Lebanon, TN. The stream exhibits marginal overall condition, primarily limited by a severely deficient riparian buffer on the right bank where mowed lawn extends to the channel edge, poor instream habitat diversity with uniform shallow flow over bedrock and minimal pool development, and active bank erosion on both sides. The left bank has a denser riparian zone but is compromised by invasive species (likely bush honeysuckle, privet, and Japanese honeysuckle). No stormwater infrastructure, outfalls, or illicit discharge indicators were observed. The primary management opportunity is restoration of the right bank riparian buffer, which would improve bank stability, shade, habitat, and water quality filtering.

| Metric | Score | Notes |
|---|---|---|
| Channel Condition | 6 | Channel appears natural with no direct structural modifications, however there is evidence of moderate incision with steep, eroding banks on both sides. The channel is narrow and deeply cut relative to the surrounding floodplain. The mowed grass extending to the bank edge on the right side has likely contributed to bank instability. Some lateral erosion is evident. Score of 6 reflects a natural but moderately degraded channel with active erosion processes. |
| Hydrologic Alteration | 5 | The stream shows moderate incision with steep banks approximately 2 feet above the water surface. While the channel is not deeply entrenched, the banks are steep enough to suggest reduced floodplain access during smaller events. The surrounding land use (agriculture/rural residential) may contribute to altered hydrology through increased runoff from cleared/mowed areas. |
| Sediment Deposition | 6 | The bedrock-dominated substrate shows limited sediment deposition. Some silt/mud is visible covering portions of the bedrock, suggesting minor fine sediment transport and deposition. No significant bar development or pool filling observed. The bedrock substrate provides natural resistance to aggradation. Score of 6 reflects minor silt deposition over bedrock. |

| Side | Stability | Veg. Protection | Erosion | Notes |
|---|---|---|---|---|
| Left | 5 | 6 | 1_25_percent | Left bank has dense dormant shrub/vine thicket providing reasonable riparian buffer. Bank face shows some bare soil and minor erosion at the channel edge. Potential invasive species present in understory. During growing season, this side would provide significantly more cover and root stabilization. |
| Right | 4 | 4 | 26_50_percent | Right bank is maintained/mowed grass extending to channel edge. This significantly reduces natural bank stability compared to the left bank. Scattered mature deciduous trees provide some root mass but are insufficient to protect the full bank. Active erosion and bare soil visible on bank face. Yucca plant observed growing at bank edge. Residential/agricultural structure visible in background. |

| Metric | Score/Value | Notes |
|---|---|---|
| TDEC 30ft Buffer Met? | L: Yes / R: No | The right bank riparian buffer is severely deficient. Mowing extends to the channel edge, eliminating natural woody vegetation within the minimum 30ft buffer zone. The left bank has adequate width but invasive species management would improve buffer function. High restoration potential exists on the right bank - simply ceasing mowing within 30-60ft of the channel would allow natural succession to begin restoring buffer function. Active planting would accelerate recovery. |

| Metric | Score | Notes |
|---|---|---|
| Water Appearance | 6 | Water appears slightly turbid with a brownish coloration, likely from silt/mud on the bedrock substrate being stirred up. The water is shallow enough to see the bottom throughout, and visibility appears to be at least 1-2 feet in deeper areas. No oil sheen, foam, or algal mats observed. No surface film visible. The brown color may be partly from dissolved tannins in winter conditions. Score of 6 reflects slightly turbid but generally acceptable appearance. |

| Action | Priority | Timeline |
|---|---|---|
| Document this reach as part of visual stream survey for MS4 permit compliance. Note absence of outfalls and no evidence of illicit discharge. | medium | annual |
| Continue monitoring for any new outfall installations or discharges as surrounding land use may change. | low | annual |
