# Scene 36 · MS4 Assessment

Black Branch 2

City of Lebanon TN

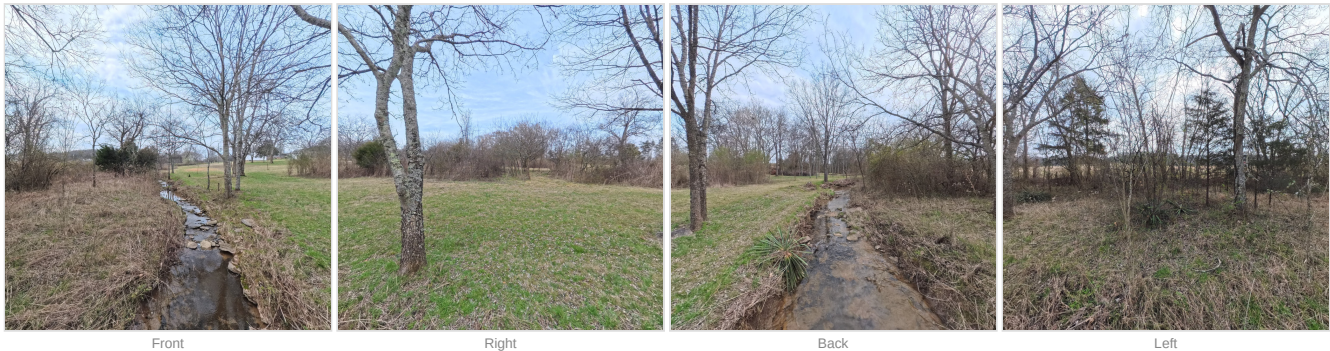
**Front:** Looking downstream, a very narrow channel (approximately 3-5 feet wide) flows through a pastoral landscape. The channel has exposed flat rock substrate with thin sheet flow over it. Scattered deciduous trees line the corridor, all bare of leaves. The right side shows mowed green pasture extending to the horizon, while the left side has dormant herbaceous cover and some shrubby growth.

**Right:** Looking toward the right bank, a mowed green pasture extends across a gently rolling landscape. A single mature deciduous tree with lichen-covered bark stands prominently. Beyond the pasture, a dense thicket of bare shrubs and small trees forms a hedgerow. The grass is short and well-maintained, indicating active grazing or mowing. No stream infrastructure visible.

**Back:** Looking upstream, the narrow channel continues with exposed bedrock and thin flowing water over limestone. Both banks are low with some minor erosion visible on the left bank where turf has been undercut. A yucca plant grows on the left bank edge. The right bank has dormant herbaceous vegetation and scattered shrubs. Mature deciduous trees line both sides at varying distances. The landscape is open pastoral on the left with denser shrub/tree cover on the right.

**Left:** Looking toward the left bank, a moderately dense thicket of dormant deciduous trees and shrubs extends from the stream corridor. The understory has dormant herbaceous growth with some green patches. A few yucca plants are visible in the understory, which are non-native ornamental plants that may indicate past homestead activity. Some evergreen trees (possibly cedar) visible in the mid-ground. The vegetation is denser on this side compared to the right bank pasture.

Black Branch at scene #36 is a small, bedrock-controlled headwater stream flowing through a rural agricultural/pastoral landscape east of Nashville. The channel exhibits natural morphology with limestone bedrock controlling grade and preventing incision, and good floodplain connectivity. However, the stream is significantly limited by severely deficient riparian buffer on the right bank where mowed pasture extends to the channel edge, complete absence of large woody debris, and extremely shallow flow over featureless bedrock providing minimal aquatic habitat diversity. Water quality indicators are fair with no evidence of contamination, but the lack of riparian buffer on one side creates vulnerability to nutrient runoff, thermal stress, and continued bank erosion. No stormwater infrastructure or outfalls were observed at this rural location.

| Side | Stability | Veg. Protection | Erosion | Notes |
|---|---|---|---|---|
| Left | 6 | 6 | 1_25_percent | Left bank has better riparian buffer than right bank with denser shrub/tree cover extending away from the channel. Some yucca plants present which may indicate old homestead site. Minor erosion at bank-channel interface. |
| Right | 5 | 5 | 1_25_percent | Right bank has minimal riparian buffer - mowed pasture extends to channel edge. Scattered mature trees provide some shade but insufficient woody root structure for bank protection. This is the more compromised bank in terms of riparian function. |

| Metric | Score/Value | Notes |
|---|---|---|
| TDEC 30ft Buffer Met? | L: Yes / R: No | The right bank has severe buffer deficiency with mowed pasture/lawn extending to the channel edge. This is a significant deviation from TDEC MS4 permit section 4.2.5.4 requirements. Buffer restoration on the right bank would be highly beneficial and feasible given the flat terrain and available area. Left bank buffer is marginally adequate. |

| Action | Priority | Timeline |
|---|---|---|
| Document lack of riparian buffer on right bank as part of visual stream survey inventory | medium | annual |
