# Scene 37 · MS4 Assessment

Black Branch 2

City of Lebanon TN

36.16955, -86.27103 · Generated October 22, 2026

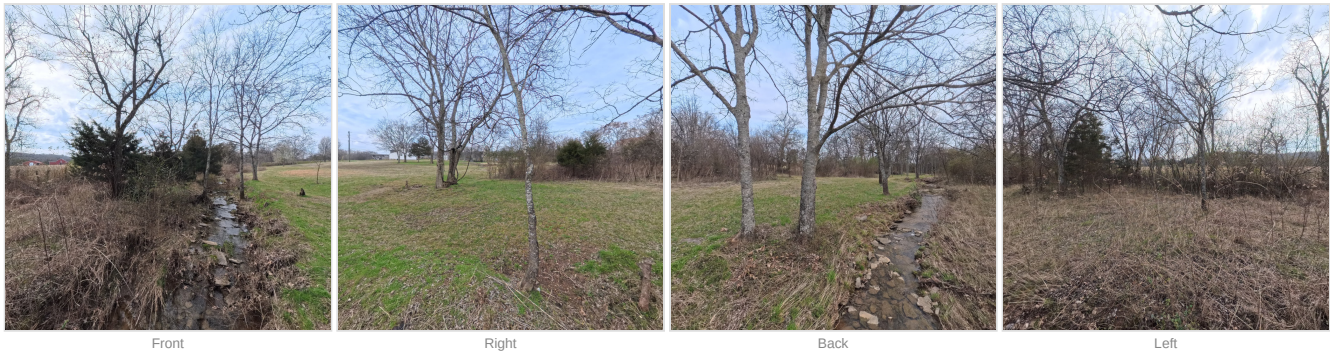
Black Branch at this location is a very small headwater stream flowing over exposed limestone bedrock in a rural agricultural setting near Nashville, TN. The stream is severely impacted by the near-complete absence of riparian buffer, particularly on the right bank where mowed pasture extends directly to the channel edge. Instream habitat is extremely limited with bedrock-dominated substrate, no large woody debris, minimal pool habitat, and only 2 fish cover types available. While water quality appears visually adequate and the channel maintains natural geomorphology with full floodplain connectivity, the lack of riparian functions (shading, bank stabilization, organic matter input, filtering) severely limits overall stream health. No stormwater infrastructure, outfalls, or illicit discharges were observed in this rural reach.

| Metric | Score | Notes |
|---|---|---|
| Channel Condition | 7 | The channel appears natural with no evidence of straightening, riprap, or concrete modification. The bedrock substrate provides natural grade control. However, the very narrow and shallow nature of the channel, combined with adjacent pasture use, suggests some historical impact from agricultural land clearing. The channel maintains floodplain connectivity with low banks. |

| Side | Stability | Veg. Protection | Erosion | Notes |
|---|---|---|---|---|
| Left | 7 | 7 | 0_percent | Left bank has better vegetative cover than right bank. Low, stable banks with moderate herbaceous and shrub buffer. Some eastern red cedars provide additional structure. Winter dormancy limits visual assessment of vegetation density. |
| Right | 6 | 5 | 1_25_percent | Right bank severely lacks riparian buffer. Mowed pasture extends directly to channel edge with no transition zone. While banks are naturally stable due to low height and bedrock, the lack of woody vegetation reduces long-term bank stability and ecosystem function. |

| Metric | Score/Value | Notes |
|---|---|---|
| Canopy Cover | 3 | During winter dormancy, canopy cover is very low with bare deciduous trees providing minimal shade. Even during growing season, the scattered nature of trees and lack of continuous canopy would likely result in less than 25% shade over this reach. The right bank contributes almost no shading. |
| TDEC 30ft Buffer Met? | L: No / R: No | This reach has significant riparian buffer deficiency on both banks. The right bank is most critically impacted with mowed pasture extending to the channel edge. Agricultural land use patterns make buffer restoration feasible if landowner cooperation can be obtained. This area would benefit greatly from TDEC MS4 permit section 4.2.5.4 buffer restoration efforts. |

| Action | Priority | Timeline |
|---|---|---|
| Document this reach as having severe riparian buffer deficiency for watershed planning purposes | medium | 90_days |
| Verify no livestock have direct access to stream channel; if present, recommend exclusion fencing | medium | 90_days |
