# Scene 38 · MS4 Assessment

Black Branch 2

City of Lebanon TN

36.16947, -86.27111 · Generated October 22, 2026

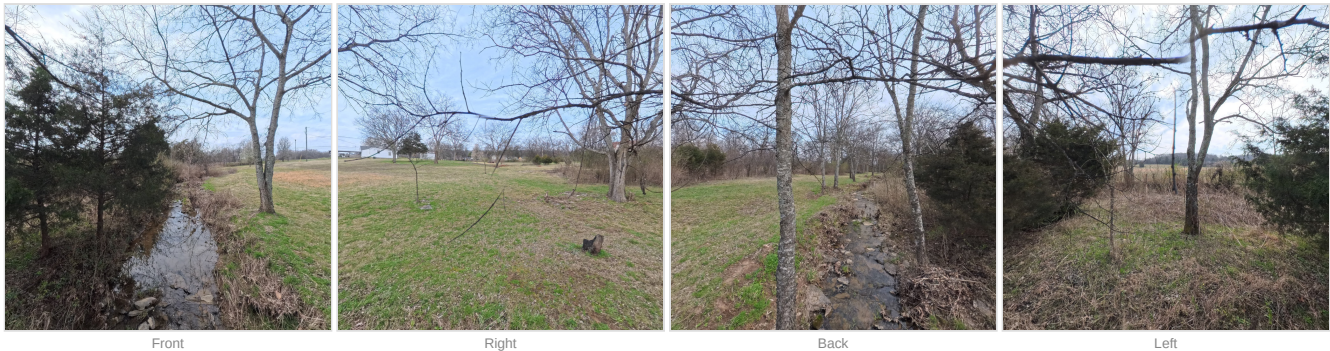
**Front:** Looking downstream, a narrow, shallow stream channel extends into the distance flanked by cedar trees on the left bank and open mowed grass on the right bank. The channel is narrow (approximately 3-5 feet wide) with shallow water flowing over a substrate of rock and mud. A utility pole with power lines is visible in the far right background.

**Right:** Looking toward the right bank (when facing downstream), an open mowed grass lawn extends to residential structures in the background. Several deciduous trees (bare, winter dormant) are scattered across the lawn. A tree stump is visible near the bank edge. The riparian buffer is virtually nonexistent — mowed grass extends to within a few feet of the channel.

**Back:** Looking upstream, the narrow stream channel continues with exposed rock/limestone substrate visible in the bed. The channel is very shallow with water flowing over flat rock slabs and loose rock. Trees line both sides but the left bank (from upstream perspective) has mowed grass extending close to the channel. Several deciduous trees flank the channel. The substrate appears to be natural limestone bedrock with some loose cobble and gravel.

**Left:** Looking toward the left bank (when facing downstream), the view shows eastern red cedar trees and mixed deciduous shrubs with dormant brown grass and herbaceous vegetation. Beyond the immediate riparian strip, an open agricultural field or pasture extends to the distance. A utility pole or fence post is visible in the mid-ground. The vegetation is denser on this side than the right bank but is predominantly cedar and dormant herbaceous cover rather than a mature hardwood buffer.

Black Branch at scene #38 is a small headwater stream in poor condition, primarily impaired by the near-complete absence of riparian buffer on the right bank where mowed residential lawn extends to the channel edge. The stream is very narrow (3-4 feet), extremely shallow (under 1 inch), and flows over exposed limestone bedrock with minimal habitat diversity. No large woody debris, no pools, and very limited fish or macroinvertebrate habitat are present. While water quality appears acceptable with no evidence of pollution, the severely degraded riparian zone and instream habitat represent the primary limiting factors. Riparian buffer restoration on the right bank is the highest priority management action.

| Side | Stability | Veg. Protection | Erosion | Notes |
|---|---|---|---|---|
| Right | 5 | 4 | 1_25_percent | Right bank critically lacks riparian buffer. Mowed grass lawn extends from residential properties directly to channel edge. This is the primary concern for this location — no woody vegetation, no natural buffer, direct runoff pathway from lawn to stream. |

| Metric | Score/Value | Notes |
|---|---|---|
| TDEC 30ft Buffer Met? | L: No / R: No | Right bank buffer is critically deficient. Mowing extends to channel edge, eliminating all natural buffer function. Left bank buffer is marginal — cedar trees provide some function but lack hardwood diversity. Both banks would benefit from riparian buffer restoration. High restoration potential exists given the low banks and available space. |

| Action | Priority | Timeline |
|---|---|---|
| Document absence of riparian buffer on right bank for MS4 permit compliance records | high | 30_days |
| Investigate tree stump on right bank — recent tree removal from riparian zone may constitute buffer violation | medium | 30_days |
