# Scene 39 · MS4 Assessment

Black Branch 2

City of Lebanon TN

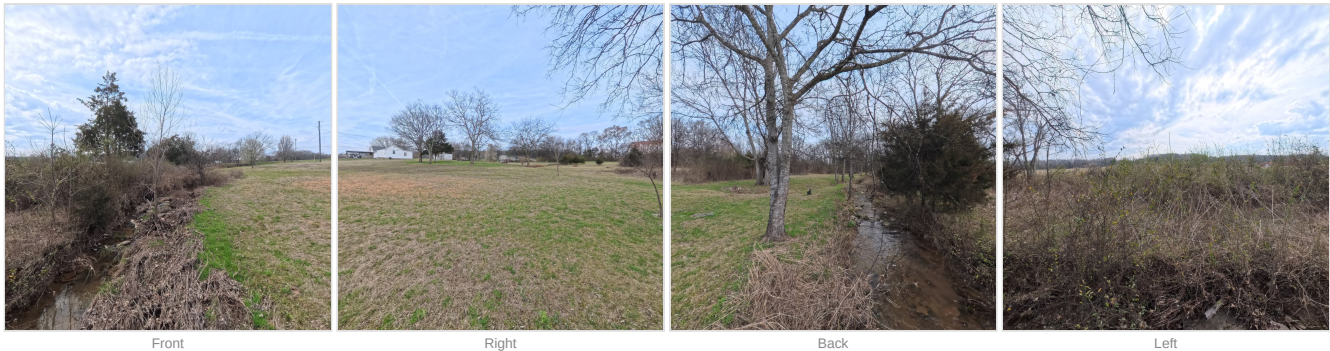
Black Branch scene #39 shows a small headwater stream flowing through a rural agricultural/pasture landscape near coordinates 36.169433, -86.271209. The stream is significantly impaired by the near-complete absence of riparian buffer on the right bank (mowed pasture to bank edge) and an inadequate narrow buffer on the left bank. The channel is moderately incised (Rosgen F-type), disconnected from its floodplain, and lacks instream habitat diversity including woody debris and deep pools. Water quality appears fair during dry weather conditions with no evidence of illicit discharge, but the degraded riparian and habitat conditions indicate the stream is not fully supporting its designated aquatic life uses. Priority management actions include riparian buffer establishment on both banks and long-term monitoring of channel stability.

| Metric | Score | Notes |
|---|---|---|
| Channel Condition | 5 | Channel appears natural with no direct structural modifications, but shows moderate incision (3-6 ft bank heights for a stream this small indicate downcutting). The channel is somewhat entrenched relative to the adjacent floodplain pasture. No riprap or channelization observed, but natural geomorphic adjustment is occurring likely in response to land use changes. |
| Hydrologic Alteration | 4 | The channel shows moderate incision with banks 3-6 feet high for a stream that is only 3-5 feet wide. The adjacent pasture/floodplain appears well above normal flow levels, suggesting the stream has downcut and is partially disconnected from its floodplain. Mowed pasture extending to the bank edge on the right side likely increases flashiness through increased runoff. |

| Side | Stability | Veg. Protection | Erosion | Notes |
|---|---|---|---|---|
| Left | 5 | 6 | 1_25_percent | Left bank has better vegetative cover with dense shrub thicket. Bank is moderately incised but root systems provide some stability. Natural limestone outcrops may provide localized bank toe protection. |
| Right | 3 | 3 | 26_50_percent | Right bank is the most impacted. Mowed pasture extends directly to the bank edge with zero woody riparian buffer. This is a significant compliance concern regarding TDEC buffer requirements. Active erosion and bare soil visible on the steep bank face. This bank is a priority for riparian restoration. |

| Metric | Score/Value | Notes |
|---|---|---|
| Canopy Cover | 3 | Currently in dormant season with bare deciduous canopy, so shade is very limited. Even in full leaf, the right bank has no canopy trees and the left bank has only scattered trees. Estimated summer canopy cover would be approximately 20-30% at best, concentrated on the left bank. The stream is largely exposed to direct sunlight. |
| TDEC 30ft Buffer Met? | L: No / R: No | This is a significant buffer compliance concern. The right bank has no functional riparian buffer, with mowed pasture extending directly to the bank edge. The left bank has some natural vegetation but it is narrow and does not meet the 30 ft minimum. Riparian restoration on both banks, particularly the right bank, should be a high priority. The flat, accessible terrain of the right bank floodplain makes restoration feasible with high potential for success. |

| Action | Priority | Timeline |
|---|---|---|
| Document riparian buffer deficiency on both banks, particularly the right bank with zero woody buffer | high | 30_days |
| Map this reach as a priority area for riparian buffer restoration in the MS4 watershed plan | high | 90_days |
| Verify no upstream stormwater outfalls are contributing to channel incision | medium | 90_days |
