# Scene 4 · MS4 Assessment

Black Branch 2

City of Lebanon TN

36.17006, -86.26841 · Generated October 23, 2026

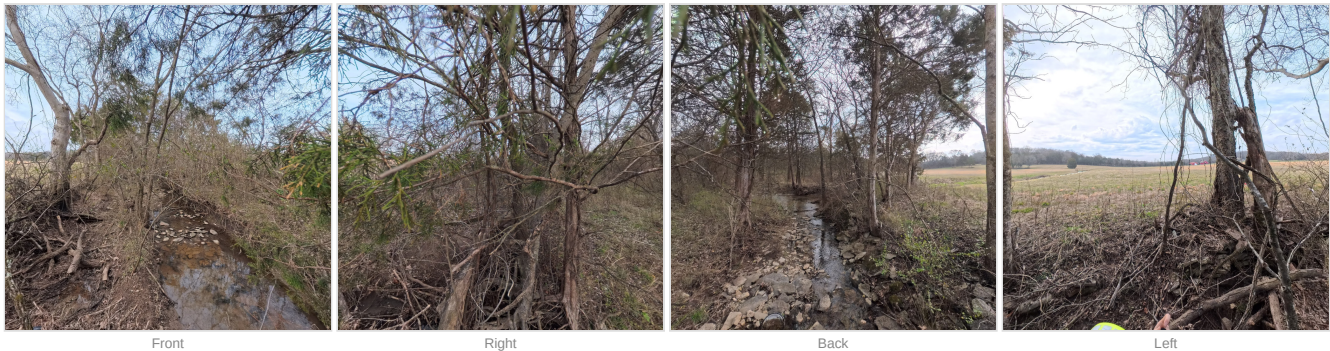
**Front:** Looking downstream, a very small stream channel is visible with shallow water flowing over a limestone/flat rock substrate. The channel is narrow (approximately 3-5 feet wide) and flanked by dense dormant vegetation including cedars (eastern red cedar) and deciduous trees. Flat tabular rocks are exposed as mid-channel bars and bed substrate.

**Right:** Looking toward the right bank (when facing downstream), dense dormant vegetation is visible including eastern red cedar trees and tangled deciduous shrubs and vines. The bank rises moderately from the channel with a mix of grass and dormant herbaceous cover. The vegetation is thick but largely bare of leaves, suggesting winter dormancy. Some cedars retain green foliage.

**Back:** Looking upstream, the narrow stream channel stretches away with a rocky limestone bed clearly exposed. Water is very shallow, flowing in a thin ribbon over flat rock substrate. The channel is flanked by cedars and deciduous trees on both sides, with an open agricultural field visible through the trees on the right (which corresponds to the left bank when facing downstream). The rocky bed shows natural layered limestone with some larger cobble/flat rock pieces.

**Left:** Looking toward the left bank (when facing downstream), an expansive open agricultural field (pasture/hay) is visible beyond a narrow strip of riparian trees. A red barn and farm structures are visible in the distance approximately 500+ feet from the stream. The bank itself is moderately high with exposed roots and rock. The riparian buffer on this side appears thin, with the agricultural field encroaching relatively close to the channel. A fluorescent green hard hat or safety equipment is visible at the bottom of frame, confirming backpack-pole survey method.

| Metric | Score | Notes |
|---|---|---|
| Channel Condition | 7 | The channel appears largely natural with no direct structural modifications. However, the moderate incision (banks are 3-6 ft on the left side) and disconnection from the floodplain suggest some degree of downcutting, likely related to land use changes in the watershed. The channel geometry appears relatively stable at present with natural bed substrate intact. |
| Hydrologic Alteration | 5 | The channel shows moderate incision, particularly evident on the left bank where banks are 3-6 ft high and steep. Adjacent agricultural land use suggests altered hydrology from drainage modifications. The low flow condition with significant exposed substrate suggests the channel may be oversized relative to current baseflow, indicating flashy hydrology typical of agricultural watersheds. |
| Sediment Deposition | 6 | Some sediment deposition is evident as gravel and flat rock accumulation in the mid-channel area visible in the front view. The substrate appears to be a mix of bedrock-influenced limestone pieces and transported gravel. Approximately 10-25% of the visible bed shows signs of active deposition. Pools appear limited, suggesting some infilling. |

| Side | Stability | Veg. Protection | Erosion | Notes |
|---|---|---|---|---|
| Left | 5 | 4 | 26_50_percent | Left bank is steeper and more eroded than right bank. The narrow riparian buffer transitions rapidly to open agricultural pasture/hay field. Root exposure is moderate indicating active bank erosion. Red barn and farm structures visible approximately 500+ ft from stream. |
| Right | 7 | 7 | 1_25_percent | Right bank is more stable than left, with denser vegetation and lower bank heights in places. Cedar trees provide good root stabilization. The riparian buffer appears wider on this side, contributing to better bank stability. |

| Metric | Score/Value | Notes |
|---|---|---|
| TDEC 30ft Buffer Met? | L: No / R: Yes | The left bank riparian buffer is inadequate, with agricultural pasture/hay field encroaching close to the channel. Buffer restoration on the left side through tree planting and exclusion fencing would significantly improve filtering capacity and bank stability. The right side buffer is marginal but more adequate. |

| Action | Priority | Timeline |
|---|---|---|
| Document this reach as part of the visual stream survey inventory for Black Branch 24 | medium | annual |
| Continue dry weather screening along the reach to check for any agricultural discharge inputs | medium | annual |
