# Scene 40 · MS4 Assessment

Black Branch 2

City of Lebanon TN

36.16937, -86.27135 · Generated October 22, 2026

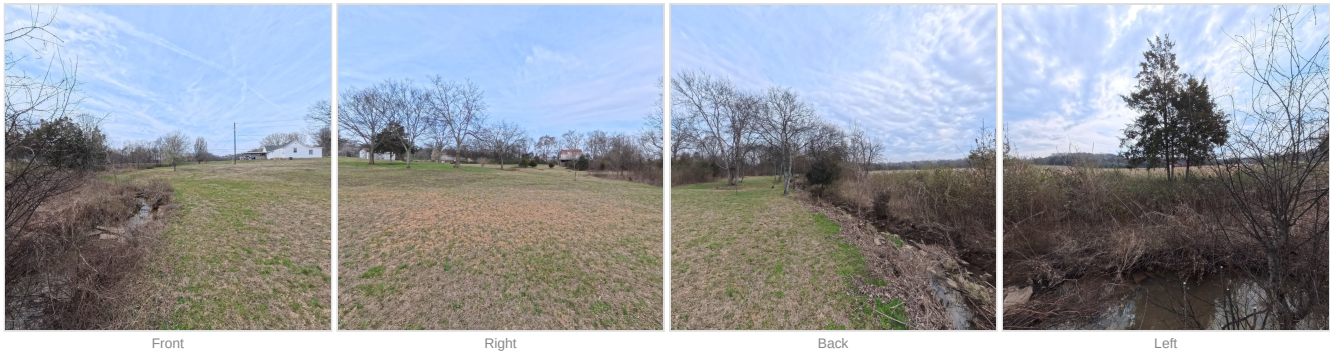
**Front:** Looking downstream, a very small stream channel is visible cutting through a rural residential landscape. The channel is narrow with low flow, bordered by dormant brown vegetation on the left and mowed grass lawn extending to the right. A white residential house with utility pole and power lines is visible in the mid-ground on the right side.

**Right:** View to the right bank (facing downstream) shows a wide expanse of mowed dormant lawn/pasture extending uphill toward scattered bare deciduous trees, a white outbuilding or shed in the far left, and an older barn with a red/rusted metal roof on the right. The landscape is open rural residential with very limited riparian buffer.

**Back:** Looking upstream, the small stream channel is visible running along the edge of mowed lawn on the left and dense dormant shrub/brush vegetation on the right. The channel appears narrow and incised with dark muddy water. Mowed grass extends directly to the channel edge on the left bank with no riparian buffer. Trees line the stream corridor in the distance.

**Left:** View to the left bank (facing downstream) shows the stream channel with dense dormant shrub and brush vegetation along the bank edge and beyond. An evergreen tree (likely eastern red cedar) stands prominently on the far bank. Open agricultural or pasture field is visible beyond the brush. Water pools are visible in the channel below, appearing brown and turbid. The stream appears incised below the surrounding landscape.

Black Branch at this location (scene 40 of 53) is a small headwater stream in poor condition, flowing through a rural residential landscape. The most significant impairment is the complete absence of riparian buffer on the right bank where mowed lawn extends to the channel edge, combined with moderate channel incision that has disconnected the stream from its floodplain. Instream habitat is severely degraded with mud substrate, no large woody debris, and very limited cover for aquatic life. The left bank retains a narrow strip of shrub vegetation but neither bank meets TDEC 30ft buffer minimums. Water quality appears moderately impaired by sedimentation. This reach is a strong candidate for riparian buffer restoration, particularly on the right bank, and would benefit from landowner engagement programs.

| Metric | Score | Notes |
|---|---|---|
| Channel Condition | 5 | Channel is natural with no direct structural alteration, but shows moderate incision (estimated 3-6ft below surrounding grade) and evidence of downcutting. The channel is disconnected from its floodplain due to incision, likely exacerbated by adjacent land use changes (mowing to bank edge, loss of riparian buffer). No riprap or channelization, but the incision represents significant departure from reference condition. |
| Sediment Deposition | 4 | The channel bed appears to be dominated by fine sediment (mud/silt), suggesting significant sediment deposition. Pools appear partially filled with fine sediment. The mud substrate throughout indicates ongoing sedimentation issues, likely from erosion of exposed banks and overland runoff from adjacent mowed areas. Estimated 30-50% of bottom affected by fine sediment deposition. |

| Side | Stability | Veg. Protection | Erosion | Notes |
|---|---|---|---|---|
| Left | 4 | 5 | 26_50_percent | Left bank has moderate brush/shrub cover providing some stability but is actively eroding in places. Dense dormant shrub thicket provides some protection but gaps allow ongoing erosion. Agricultural/pasture field visible beyond the brush strip on this bank. |
| Right | 3 | 3 | 26_50_percent | Right bank is the more degraded of the two banks. Mowed lawn to bank edge provides essentially no riparian buffer. Grass provides minimal deep root structure for bank stabilization. This bank is a priority for riparian restoration. Adjacent residential structures and outbuildings are within 200ft of the stream. |

| Metric | Score/Value | Notes |
|---|---|---|
| TDEC 30ft Buffer Met? | L: No / R: No | Significant non-compliance with TDEC MS4 permit section 4.2.5.4 buffer requirements. The right bank is the highest priority for buffer restoration as it has essentially no natural buffer. The left bank buffer could be expanded to meet the 30ft minimum. Both banks have high restoration potential as the adjacent land appears to be low-intensity use (pasture/lawn) with willing landowner engagement potentially achievable. |

| Action | Priority | Timeline |
|---|---|---|
| Document absence of riparian buffer on right bank and non-compliance with TDEC buffer requirements | high | 30_days |
| Map this reach segment as a priority for buffer restoration in the MS4 stormwater management plan | high | 90_days |
| Conduct follow-up dry weather screening during growing season to assess for illicit discharges and seasonal water quality changes | medium | 90_days |
