# Scene 41 · MS4 Assessment

Black Branch 2

City of Lebanon TN

36.16929, -86.27147 · Generated October 23, 2026

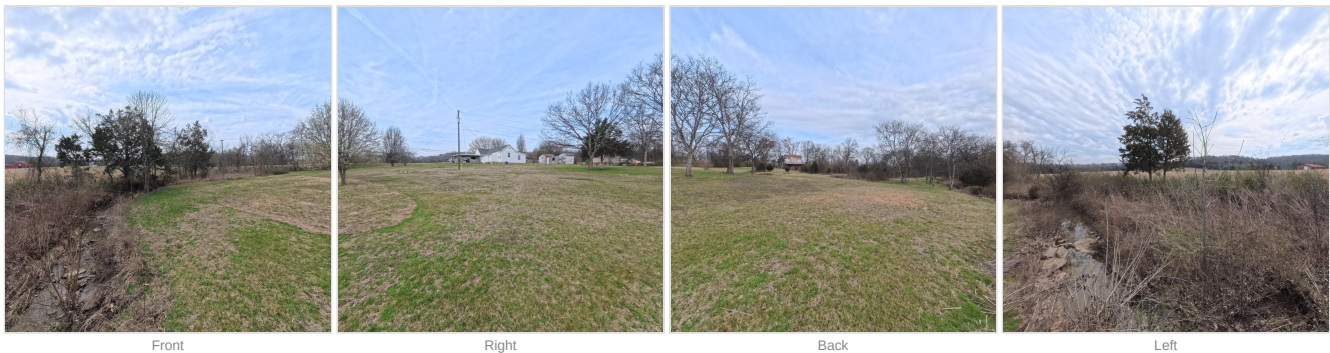
**Front:** Looking downstream, a very small stream channel is visible on the left side of the view, running along the edge of a mowed grass yard. The channel is narrow, incised, and bordered by dormant brown vegetation and brush. Scattered deciduous trees in bare condition and a few evergreens line the stream corridor. A red barn/outbuilding is visible in the far left background beyond agricultural fields.

**Right:** Looking toward the right bank, the view is dominated by a large mowed grass yard extending uphill to a rural residential property with a white house, outbuildings, and sheds. A utility pole with overhead electric lines is prominently visible. The yard is closely mowed with no riparian buffer between the lawn and the stream bank. Trees along the property are deciduous and bare.

**Back:** Looking upstream, the view shows a mowed grass area extending to the left with bare deciduous trees scattered about. An old structure with a rusted tin roof (possibly a barn or cabin) is visible in the middle distance. The stream corridor is barely visible to the right side with dormant shrubs and brush lining it. The landscape is gently rolling rural terrain with mixed pasture and scattered trees.

**Left:** Looking toward the left bank, the small stream channel is clearly visible with very low flow over exposed bedrock or flat rock substrate. The channel is narrow and incised with steep eroded banks showing bare soil and exposed rock. Beyond the channel, dormant brush and weedy vegetation extend to open agricultural fields with a red barn visible in the far distance. A single evergreen tree (likely eastern red cedar) stands prominently near the channel. The rock in the streambed appears to be flat, layered limestone - examining carefully for concrete indicators: the rock shows natural geological layering consistent with Middle Tennessee limestone bedrock, not concrete.

Black Branch at this location (scene #41 of 53) is a small, incised headwater stream in poor condition, flowing through rural residential and agricultural land near Lebanon, Tennessee. The stream suffers from severe riparian buffer deficiency on both banks, with the right bank mowed to the channel edge and the left bank having only a narrow, degraded strip of dormant brush. The channel has incised to bedrock, disconnecting from its floodplain, and instream habitat is extremely limited with no large woody debris and minimal substrate diversity. Water quality indicators are moderate but the physical habitat degradation is the primary limiting factor for aquatic life support.

| Metric | Score | Notes |
|---|---|---|
| Channel Condition | 5 | Channel appears natural with no direct structural alterations, but shows evidence of incision and downcutting to bedrock. The channel has cut down significantly, disconnecting from its floodplain. This is likely a response to changes in watershed hydrology from agricultural land use and impervious surfaces. Score of 5 reflects natural channel form but with significant geomorphic adjustment. |
| Hydrologic Alteration | 4 | Channel is moderately incised with banks 3-6ft high relative to a narrow stream. The channel appears disconnected from its floodplain with flooding likely only during significant storm events. Agricultural land use changes and mowing to bank edge have likely accelerated runoff delivery. |
| Sediment Deposition | 6 | Bedrock-dominated substrate with limited sediment deposition visible. The bedrock exposure actually suggests more erosion than deposition. Some fine sediment (mud/silt) visible in low spots but not excessive. The channel appears to be sediment-starved in areas with exposed bedrock. |

| Side | Stability | Veg. Protection | Erosion | Notes |
|---|---|---|---|---|
| Left | 4 | 4 | 26_50_percent | Left bank (looking downstream) is the outer bank adjacent to agricultural fields. Dormant brush provides partial buffer but bank is actively eroding in sections. Some exposed bedrock at base of bank may provide natural resistance to further downcutting. |
| Right | 3 | 3 | 26_50_percent | Right bank is adjacent to maintained residential lawn that extends to the bank edge with no riparian buffer. Mowing to the edge removes any potential for woody vegetation establishment and limits bank stabilization capacity. This is a significant concern for long-term bank stability and riparian function. |

| Metric | Score/Value | Notes |
|---|---|---|
| Canopy Cover | 2 | The UP face confirms virtually no canopy cover over the stream at this location. The bare deciduous trees and absence of mature riparian trees mean even in full leaf, shade would be minimal. Currently in early spring with bare branches, shade is essentially zero. Even in summer, the few scattered trees would provide well under 25% shade cover. |
| TDEC 30ft Buffer Met? | L: No / R: No | Both banks fail to meet TDEC MS4 permit section 4.2.5.4 buffer requirements. The right bank is severely impacted by residential lawn maintenance extending to the bank edge. The left bank has a narrow, degraded buffer dominated by shrubs with no mature tree component. Both sides have high restoration potential - the right bank could benefit from cease-mowing zones and native tree/shrub planting, while the left bank could be enhanced with native tree planting and invasive removal. |

| Action | Priority | Timeline |
|---|---|---|
| Document riparian buffer deficiency for MS4 visual stream survey records | medium | 90_days |
| Confirm dry weather flow is natural baseflow and not from illicit connections upstream | low | annual |
