# Scene 42 · MS4 Assessment

Black Branch 2

City of Lebanon TN

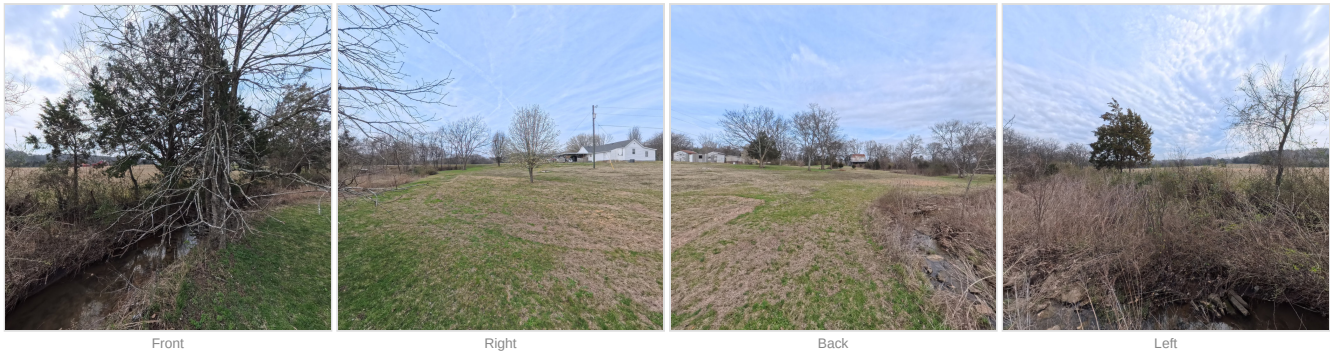
**Front:** Looking downstream, a small narrow stream channel is visible flowing through a rural area. The left bank has dense dormant shrubs and a few scattered trees including an eastern red cedar, with agricultural fields visible in the background including a red barn structure. The right bank has mowed grass extending to the stream edge with minimal riparian buffer.

**Right:** The right bank (left when facing downstream) shows a wide expanse of mowed grass lawn extending to a white residential house with an outbuilding/carport. A utility pole with power lines is visible. The lawn is mowed right up to the stream edge with essentially no riparian buffer. A few scattered deciduous trees are present in the yard, mostly bare.

**Back:** Looking upstream, the narrow stream channel is visible on the right side of the frame with shallow water flowing through it. The left side shows a wide mowed lawn extending to several outbuildings and an older farmhouse with a metal roof. The stream bank on the right has dormant shrubby vegetation. Some flat rock material is visible in and along the stream bed which could be natural limestone outcrops consistent with the region's geology.

**Left:** The left bank (right bank when facing downstream) shows the stream channel with moderately steep eroding banks. Dense dormant shrubby vegetation lines the bank top with some scattered cedars and deciduous trees. Beyond the narrow riparian strip, agricultural pasture or hay fields extend into the distance. Exposed soil and some rock fragments are visible along the bank face. The bank shows active erosion with undercut areas.

Black Branch at this location (Scene #42) is a small, incised headwater stream in poor condition, flowing through rural agricultural and residential land. The stream exhibits severe riparian buffer deficiency on both banks, with mowed lawn extending to the stream edge on the right bank and only a narrow shrub strip on the left bank. Channel incision has disconnected the stream from its floodplain, leading to active bank erosion and a degraded geomorphic condition. Instream habitat is extremely limited with silt-dominated substrate, no significant large woody debris, and uniform shallow flow lacking pool-riffle development. No stormwater outfalls or MS4 infrastructure were observed, consistent with the rural setting. Priority management actions should focus on riparian buffer establishment on both banks and addressing the root causes of channel incision.

| Metric | Score | Notes |
|---|---|---|
| Channel Condition | 5 | The channel appears naturally formed without direct structural alterations, but there is evidence of channel incision and active bank erosion. The stream is downcutting into its floodplain, likely driven by increased runoff from the surrounding agricultural land use and lack of riparian buffer. No riprap or channelization is present, but the active downcutting and lateral cutting warrants a mid-range score. |
| Hydrologic Alteration | 4 | The channel appears moderately incised with banks approximately 3-6ft high relative to the narrow channel. The stream is likely disconnected from its floodplain for most flow events. The surrounding agricultural land use and mowed yards may contribute to flashier hydrology. Incision level suggests flooding of the adjacent floodplain occurs only during significant events. |
| Sediment Deposition | 5 | The stream bed appears to be silt-dominated with fine sediment throughout. While no distinct point bars or mid-channel bars are visible, the uniform silt substrate suggests chronic sediment loading from the surrounding agricultural land. The lack of defined pools and riffles indicates sediment deposition has homogenized the channel. |

| Side | Stability | Veg. Protection | Erosion | Notes |
|---|---|---|---|---|
| Left | 5 | 5 | 26_50_percent | Left bank has a narrow strip of dormant shrubby vegetation but transitions quickly to agricultural pasture/hay fields beyond. The narrow buffer provides limited protection. Active undercutting and scour evident at bank toe. Moderate 3-6ft bank heights with steep angles. |
| Right | 3 | 2 | 26_50_percent | Right bank is severely compromised by mowing practices extending grass to the stream edge. No woody riparian vegetation buffer exists. Bank faces show active erosion with steep angles. Residential property with house visible approximately 100-150ft from stream. |

| Metric | Score/Value | Notes |
|---|---|---|
| Canopy Cover | 2 | Canopy cover is very limited, estimated at less than 25%. The UP face confirms mostly open sky with only scattered bare branches. A few cedars and deciduous trees provide minimal shade. During leaf-out, canopy may increase slightly but will remain well below 25% given the sparse tree distribution. |
| TDEC 30ft Buffer Met? | L: No / R: No | Both banks fail to meet TDEC MS4 permit section 4.2.5.4 buffer requirements. The right bank is more severely impacted with active mowing to the bank edge and a residential structure within 150ft. The left bank has some natural regeneration that could be enhanced. Both banks present good restoration potential if mowing practices change and riparian planting is implemented. |

| Metric | Score | Notes |
|---|---|---|
| Water Appearance | 5 | Water appears slightly turbid with a brown coloration, likely from suspended fine sediments. Clarity appears to be approximately 0.5-1ft based on the ability to partially see the bed in shallow areas. No oil sheen, algal mats, or scum are visible. The brown color is consistent with silt-laden water from the surrounding agricultural land use. |

| Action | Priority | Timeline |
|---|---|---|
| Document this reach as lacking adequate riparian buffer per TDEC buffer requirements on both banks | medium | 90_days |
| Verify reach inclusion in MS4 outfall mapping; no outfalls detected but confirm no unmapped inputs exist | low | annual |
