# Scene 43 · MS4 Assessment

Black Branch 2

City of Lebanon TN

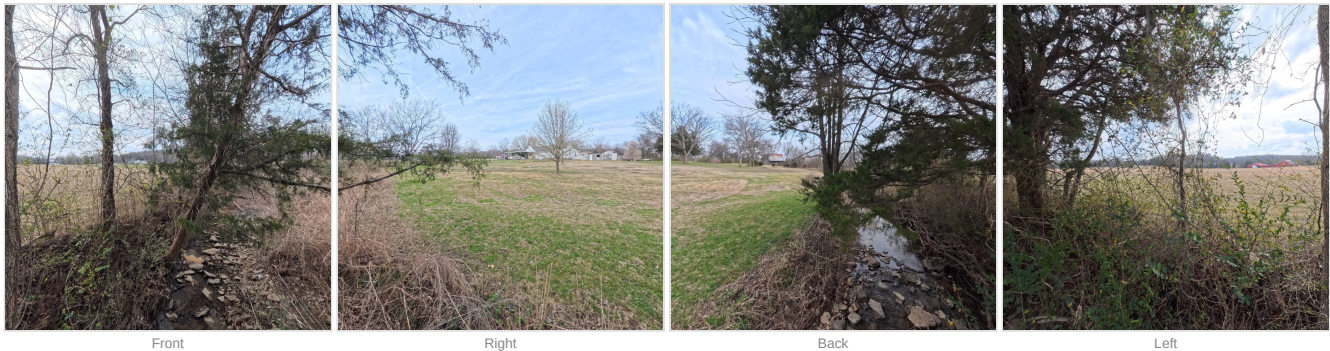
Black Branch at this location (Scene 43 of 53) is a small, intermittent headwater stream in poor overall condition, flowing through a rural agricultural landscape. The most significant impairment is the near-complete absence of riparian buffer on the right bank where mowed residential lawn extends to the channel edge, and a very narrow cedar-dominated buffer on the left bank with agricultural pasture beyond. The channel is moderately incised with 3-6 foot steep banks, disconnected from its floodplain. Instream habitat is severely limited by the narrow channel, very low flow, and absence of large woody debris. No stormwater infrastructure or outfalls were detected, consistent with the rural setting. Riparian buffer restoration represents the highest-priority management action for this reach.

| Metric | Score | Notes |
|---|---|---|
| Channel Condition | 6 | Channel appears to be in a natural form but shows moderate incision. No direct channelization or structural modifications are visible. However, the steep banks and incised condition suggest the channel has adjusted to altered hydrology from surrounding agricultural land use. Some downcutting evidence is present with exposed rock substrate and steep bank angles. |
| Hydrologic Alteration | 4 | Channel is moderately incised with banks 3-6 feet high relative to a very narrow channel. The stream appears disconnected from its floodplain. Agricultural land use likely contributes to flashy hydrology with altered runoff patterns. The mowed lawn on the right bank extends to the channel edge, removing natural buffer and increasing runoff velocity. |

| Side | Stability | Veg. Protection | Erosion | Notes |
|---|---|---|---|---|
| Left | 5 | 5 | 1_25_percent | Left bank has a narrow riparian corridor dominated by eastern red cedar with invasive vine growth. Agricultural pasture begins immediately beyond the tree line. The narrow buffer provides partial bank stabilization but is insufficient for full protection. Bank height is moderate with steep angles. |
| Right | 3 | 2 | 1_25_percent | Right bank is severely lacking in riparian vegetation. Mowed lawn extends to the channel edge with minimal woody buffer. This represents a significant riparian buffer deficiency. The bank is vulnerable to erosion during high flow events. Residential/agricultural structures are within close proximity. |

| Metric | Score/Value | Notes |
|---|---|---|
| TDEC 30ft Buffer Met? | L: No / R: No | Both banks fail to meet TDEC minimum 30-foot riparian buffer requirements. The right bank is most critically deficient with mowed lawn to the channel edge. The left bank has a narrow but present tree line that could be expanded. Buffer restoration on both sides would significantly improve stream health and MS4 compliance. High restoration potential exists given the agricultural/rural land use context. |

| Action | Priority | Timeline |
|---|---|---|
| Document riparian buffer deficiency in MS4 visual stream survey database. Both banks fail to meet TDEC 30-foot minimum buffer standard. | medium | 90_days |
| Conduct dry weather screening at this reach to verify observed low flow is baseflow and not from illicit sources. The trickle of brown water should be confirmed as natural. | low | annual |
