# Scene 44 · MS4 Assessment

Black Branch 2

City of Lebanon TN

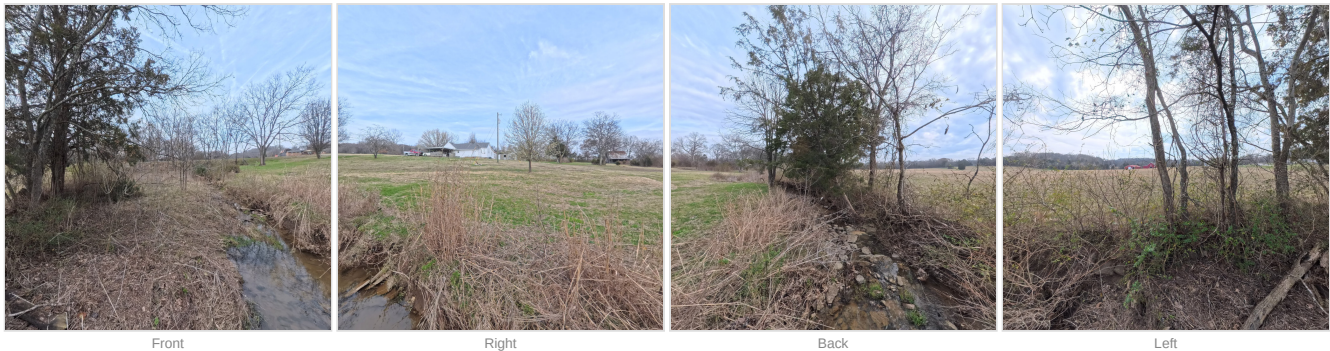
**Front:** Looking downstream, a narrow stream channel curves slightly to the right through a rural landscape. The left bank has scattered deciduous trees (bare) and one evergreen (likely eastern red cedar). The right bank is bordered by dormant grass and herbaceous vegetation with a residential structure visible in the far right background. The channel is very narrow with shallow water.

**Right:** Right bank (left bank when facing downstream) shows a gently sloping mowed/grazed pasture rising to a white farmhouse with carport, a red truck, and utility poles. The riparian buffer is essentially absent on this side - grass extends nearly to the stream bank edge with only dormant herbaceous weeds providing minimal bank protection. A barn or outbuilding is visible to the far right.

**Back:** Looking upstream, the narrow stream channel is visible winding through a narrow corridor of scattered trees including an evergreen (eastern red cedar) and bare deciduous trees. Rocky/stony substrate is visible in the channel bed. The banks are low with dormant herbaceous vegetation. Open agricultural fields extend on both sides beyond the thin tree line. The bed substrate includes flat, angular stone pieces that could be natural limestone or potentially placed material.

**Left:** Left bank (right bank when facing downstream) shows a narrow strip of deciduous trees and shrubs along the stream, mostly bare in winter. Beyond the thin riparian corridor, expansive agricultural fields extend to the distance with a red barn or farm building visible in the background. The bank appears moderately steep with some root exposure and bare soil. Vines and dormant herbaceous understory are present along the bank top.

Black Branch at this location (scene 44 of 53) is a small, low-gradient headwater stream flowing through an agricultural/rural residential landscape near coordinates 36.169079, - 86.271672. The stream is severely impacted by inadequate riparian buffers, particularly on the left bank where mowed pasture extends to the channel edge. Heavy fine sediment loading has created a silt-dominated substrate with very limited aquatic habitat diversity. Key management priorities include riparian buffer establishment through fencing and native planting on both banks, with the left bank as the highest priority. No stormwater infrastructure or outfalls were observed at this location, and no illicit discharge indicators were noted.

| Metric | Score | Notes |
|---|---|---|
| Channel Condition | 6 | Channel appears natural without structural alteration; however, the channel is narrow with some bank erosion and the adjacent land use (agriculture, pasture) has likely influenced channel form. No channelization or armoring present. Some lateral erosion visible but not excessive. Channel maintains floodplain connection. Score between 5-7 range due to minor impacts from surrounding land use. |
| Hydrologic Alteration | 6 | The stream shows slight incision with banks 2-3 feet in height near the surveyor but maintains some floodplain connectivity. The low banks in some areas suggest the stream can access its floodplain during higher flow events. No dams or major structures visible. Agricultural land use may have slightly altered hydrology through increased runoff. |
| Sediment Deposition | 4 | The turbid brown water and silt-dominated substrate indicate significant fine sediment loading from surrounding agricultural land. The bed appears to be heavily silted with little visible coarser substrate except in the upstream view. Sediment deposition is likely affecting 30-50% of the channel bottom. Pool habitat appears to be filled or reduced by sediment. |

| Side | Stability | Veg. Protection | Erosion | Notes |
|---|---|---|---|---|
| Left | 5 | 3 | 1_25_percent | Left bank lacks adequate riparian buffer. Mowed/grazed pasture extends to within a few feet of channel edge. Grass provides minimal root depth for bank stabilization. Agricultural runoff enters stream directly from this side. |
| Right | 5 | 5 | 1_25_percent | Right bank has a thin corridor of trees providing marginally better protection than the left bank. Undercutting visible at base in some areas. Agricultural field extends beyond the narrow tree line. |

| Metric | Score/Value | Notes |
|---|---|---|
| Canopy Cover | 3 | With winter leaf-off and the sparse tree cover, canopy shade is well below 25%. Even during full leaf-on conditions, shade would be limited to perhaps 25-40% due to the very thin riparian corridor on only one side. Currently <15% shade. |
| TDEC 30ft Buffer Met? | L: No / R: No | Both banks fail to meet TDEC MS4 minimum 30ft buffer requirements. Left bank is the most critical with pasture/mowing extending to the stream edge. Right bank has partial tree cover but is insufficient. Buffer restoration through fencing and planting would significantly improve water quality and habitat. This is a priority for MS4 compliance under section 4.2.5.4. |

| Metric | Score | Notes |
|---|---|---|
| Water Appearance | 4 | Water is turbid with brown coloration consistent with suspended sediment. Visibility appears to be approximately 0.5-1 foot based on the down face view where the bed is barely visible in shallow areas. No oil sheen, foam, or algal mats observed. The turbidity may be partly due to the surveyor's wading disturbance but the overall brown color suggests elevated sediment from recent precipitation and agricultural runoff. Score of 4 between marginal and fair. |

| Action | Priority | Timeline |
|---|---|---|
| Document inadequate riparian buffer conditions for watershed management plan updates | medium | 90_days |
| Coordinate with agricultural programs (NRCS, USDA) for voluntary buffer establishment | medium | annual |
