# Scene 45 · MS4 Assessment

Black Branch 2

City of Lebanon TN

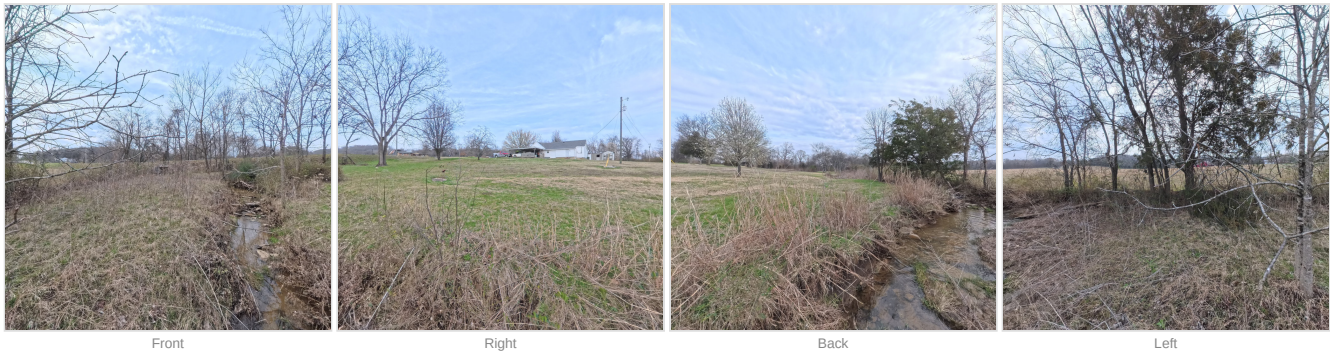
**Front:** Looking downstream, a very small stream channel winds through a rural pastoral landscape. The channel is narrow (roughly 2-4 feet wide) with shallow brown water flowing over rocky/silty substrate. Scattered bare deciduous trees line the corridor with dormant grass on both sides. A small structure or equipment item (possibly a deer stand or old equipment) is visible in the mid-ground left of center.

**Right:** Looking to the right bank (when facing downstream), the view shows a gently sloping open pasture/lawn area rising uphill toward a rural residential property with a white building, carport with a red truck, utility pole, and scattered mature bare deciduous trees. The grass is a mix of green and dormant brown. The riparian buffer on this side is essentially absent — mowed grass extends close to the stream bank.

**Back:** Looking upstream, the narrow stream channel is visible with shallow brown water flowing over rocky substrate. The left bank shows moderate erosion with bare soil and exposed rock/rubble along the bank edge. Dormant grass and scattered trees are visible on both sides. Some flat rock pieces are visible at the bank edge — these appear to be natural limestone fragments consistent with the local Middle Tennessee geology, showing natural layering and irregular edges rather than engineered placement.

**Left:** Looking to the left bank (when facing downstream), the view shows an open agricultural/pasture landscape with scattered bare deciduous trees and one large evergreen tree (likely eastern red cedar). A fenceline is partially visible. In the far background, a red structure (possibly a barn) is visible through the trees. The riparian buffer is very narrow to absent, with open pasture extending close to the channel. Dormant grass and dead herbaceous material dominate the ground cover.

Black Branch at scene #45 is a small headwater stream (1st-2nd order, approximately 2-3 feet wide) in a rural area of Wilson County, Tennessee, flowing through pasture and residential land. The stream is rated as 'poor' condition overall, primarily due to severely deficient riparian buffers on both banks (mowed grass/pasture extends directly to the channel edge), extremely limited instream habitat (no LWD, no pool-riffle complexity, silt-dominated bed), and fine sediment impairment from adjacent land use. The channel retains a natural planform and floodplain connectivity, and no stormwater outfalls or illicit discharges were observed. This reach has high restoration potential through riparian buffer establishment, which would address multiple limiting factors simultaneously.

| Metric | Score | Notes |
|---|---|---|
| Channel Condition | 6 | Channel appears natural without direct structural alteration. However, adjacent land use (pasture extending to bank edge, lack of riparian buffer) has likely altered hydrology and sediment delivery, resulting in a channel that is slightly incised and laterally eroding in places. No straightening or armoring observed. Score of 6 reflects natural form with some degradation from land use impacts. |
| Hydrologic Alteration | 6 | The channel shows slight incision with banks approximately 1.5-2 feet above the water surface. Floodplain appears accessible during moderate events. No major impoundments or withdrawals visible. Adjacent pastoral land use has likely increased flashiness of runoff. Score of 6 reflects slight alteration from land use changes. |
| Sediment Deposition | 5 | The bed substrate is dominated by fine silt/mud, indicating significant fine sediment loading from adjacent pasture and agricultural land. While no large point bars are forming (channel is too small), the pervasive fine sediment coverage of the bed (~20-30% affected beyond natural conditions) suggests moderate sediment deposition issues. Score of 5 reflects noticeable sediment enrichment. |

| Side | Stability | Veg. Protection | Erosion | Notes |
|---|---|---|---|---|
| Left | 4 | 4 | 26_50_percent | Left bank shows active erosion from pasture runoff and lack of woody riparian vegetation. Fencing partially visible suggesting livestock may be present or recently removed. Bank composed primarily of soil with some embedded limestone fragments. |
| Right | 5 | 4 | 1_25_percent | Right bank transitions to mowed residential lawn with gentle slope. Riparian buffer essentially absent — mowed grass extends to bank edge. Less erosion than left bank but vulnerable due to lack of woody root reinforcement. |

| Metric | Score/Value | Notes |
|---|---|---|
| Canopy Cover | 2 | Canopy cover is very low, estimated at less than 15-20%. The UP face confirms mostly open sky with only scattered bare tree branches. Even in full leaf season, the sparse trees would provide only partial shade. Score of 2 reflects inadequate canopy cover for a warmwater stream. |
| TDEC 30ft Buffer Met? | L: No / R: No | Both banks are severely deficient in riparian buffer relative to TDEC MS4 permit section 4.2.5.4 requirements. The 30-foot minimum buffer standard is not met on either side. High restoration potential exists if willing landowners can be engaged — the flat terrain and existing soil conditions would readily support tree/shrub plantings. This is a priority location for buffer restoration. |

| Metric | Score | Notes |
|---|---|---|
| Water Appearance | 5 | Water has a brown/tan coloration typical of streams with fine sediment substrates. Clarity appears moderate — objects on the bed are visible but water has noticeable turbidity. No oil sheen, foam, or algal growth observed. The brown color may be partly natural (dissolved organics from leaf litter) but likely also reflects fine sediment suspension. Score of 5 reflects fair water appearance with moderate turbidity. |
| Manure/Waste | 7 | Fencing is partially visible on the left bank side suggesting potential livestock access or recent fencing for exclusion. Adjacent pasture land could support livestock. No manure is directly visible in or near the stream, and no waste pipes or discharge observed. However, the pastoral land use and fencing suggest potential livestock access. Score of 7 reflects possible but not confirmed livestock impact. |

| Action | Priority | Timeline |
|---|---|---|
| Document this reach as having severely deficient riparian buffers for watershed planning purposes | medium | 90_days |
| Confirm no stormwater outfalls exist upstream or downstream that may not have been visible from this scene position | low | annual |
