# Scene 46 · MS4 Assessment

Black Branch 2

City of Lebanon TN

36.16903, -86.27187 · Generated October 23, 2026

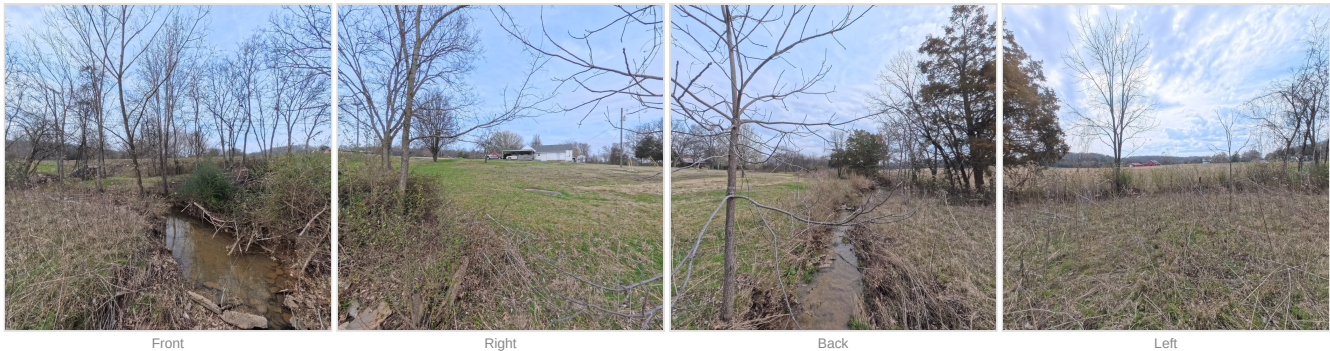
**Front:** Looking downstream, a very narrow stream channel (approximately 2-4 feet wide) winds through a rural landscape with dormant deciduous trees. The channel has shallow, brownish water with exposed limestone/rock substrate visible. Banks are low and vegetated with dormant grass and herbaceous material. Some woody debris (fallen branches) crosses the channel. A green shrub (possibly evergreen or early-leaving invasive) is visible on the right bank.

**Right:** Looking toward the right bank (left bank when facing downstream), a mowed lawn slopes upward toward a residential property with a garage/outbuilding, parked vehicles including a boat, and a utility pole. The riparian buffer is minimal — just a few scattered trees at the bank edge with the lawn extending nearly to the stream. The bank drops off steeply from the mowed yard to the channel.

**Back:** Looking upstream, the narrow stream channel continues through a rural/pastoral landscape. The channel is very narrow (2-3 feet wide) with shallow brown water flowing over what appears to be natural limestone bedrock and gravel. Banks are low with dormant grass and sparse deciduous trees. The left side shows mowed grass extending toward a residential area, while the right side has more natural herbaceous vegetation. The stream has low sinuosity in this section.

**Left:** Looking toward the left bank (right bank when facing downstream), a wide open pastoral/agricultural field extends to the distance with a red barn visible in the background. The field is dominated by dormant tall grass and herbaceous vegetation (likely old-field or hay field). A few scattered deciduous trees are present along the stream corridor but the riparian buffer is extremely thin, transitioning quickly to open pasture. The landscape is gently rolling.

Black Branch at position 46 is a small headwater stream (1st-2nd order) in marginal condition, flowing through a rural residential and agricultural landscape near Nashville, TN. The most significant issue is the severely inadequate riparian buffer on both banks — residential lawn mowing extends to within 5-10 feet of the left bank and pasture/agricultural use encroaches on the right bank, both failing to meet TDEC 30ft minimum buffer standards. Instream habitat is limited by the small channel size and lack of diverse features including pools, woody debris, and substrate complexity. Water quality appears acceptable during this dry weather assessment with no evidence of illicit discharge or acute contamination, though the adjacent land uses pose chronic risks for sediment and nutrient inputs. No stormwater infrastructure or outfalls were observed at this location.

| Side | Stability | Veg. Protection | Erosion | Notes |
|---|---|---|---|---|
| Left | 5 | 4 | 1_25_percent | Left bank (residential side) has minimal riparian buffer with mowed lawn extending nearly to stream edge. Bank is steeper here due to slight incision. Scattered trees provide some root stabilization but coverage is inadequate. |
| Right | 6 | 5 | 1_25_percent | Right bank (pasture side) has more natural herbaceous cover but still lacks adequate woody riparian vegetation. Bank is lower and more gradually sloped than left bank. Dormant grass and tall herbaceous vegetation provide seasonal protection. |

| Metric | Score/Value | Notes |
|---|---|---|
| TDEC 30ft Buffer Met? | L: No / R: No | Both banks fail to meet TDEC MS4 permit section 4.2.5.4 minimum buffer requirements. The left bank has severe encroachment from residential lawn maintenance extending to within feet of the channel. The right bank has moderate encroachment from pasture/agricultural use. Both sides have high restoration potential if willing landowners can be engaged for buffer planting programs. |

| Action | Priority | Timeline |
|---|---|---|
| Document inadequate riparian buffer conditions for MS4 watershed planning purposes | medium | 90_days |
| Complete dry weather screening documentation for this reach segment — no outfalls observed but adjacent residential property should be noted for potential non-point source contributions | low | annual |
