# Scene 47 · MS4 Assessment

Black Branch 2

City of Lebanon TN

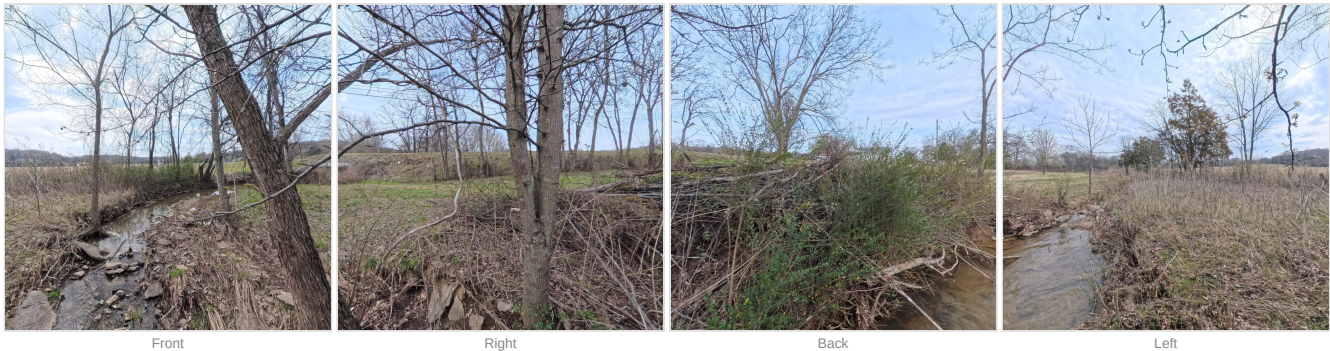
**Front:** Looking downstream, a very narrow shallow stream channel flows through a semi-rural landscape. The channel is 3-5 feet wide with exposed rocky/rubble substrate. Bare deciduous trees line the channel corridor. Beyond the riparian zone, open pasture/agricultural fields extend on both sides. Some scattered litter is visible along the channel margins.

**Right:** Looking toward the right bank (left bank when facing downstream from upstream), the view shows a mowed grass area transitioning to open pasture/agricultural fields. Bare deciduous trees stand along the bank with some brush piles and debris. Power/utility lines are visible in the background. A structure (possibly a barn or shed) is partially visible in the far left background. The bank shows moderate height with some bare soil and erosion evident.

**Back:** Looking upstream, the stream bank is heavily vegetated with dense shrubs and invasive-looking evergreen vegetation (likely privet or bush honeysuckle retaining green leaves in early spring). A large bare deciduous tree stands prominently. The bank appears steep with exposed roots and soil. Open pasture is visible beyond the vegetation. The stream channel is partially visible at lower right with flowing water over rocky substrate.

**Left:** Looking toward the left bank (right bank facing downstream), open pasture/agricultural land extends into the distance with scattered deciduous trees. The stream channel is visible at the left edge of the frame with flowing turbid water. The bank is low with grass and herbaceous vegetation. The landscape is flat to gently rolling with dormant winter/early spring grass. A fence post is visible suggesting agricultural use. The riparian buffer is very narrow here, transitioning quickly to open grassland.

Black Branch at position 47 of 53 is a small headwater stream in poor condition, flowing through an agricultural landscape with severely deficient riparian buffers on both banks. The channel is very shallow and uniform with limited habitat diversity — no pools, minimal woody debris, and only 2-3 fish cover types present. Bank erosion is active on the right bank with invasive privet colonizing the disturbed areas. The primary stressors are riparian loss from agricultural encroachment, sedimentation from pasture runoff, and active bank erosion. No stormwater infrastructure or outfalls were observed at this rural location. Riparian buffer restoration is the highest priority management action for this reach.

| Side | Stability | Veg. Protection | Erosion | Notes |
|---|---|---|---|---|
| Left | 5 | 4 | 1_25_percent | Left bank is lower than right bank with grass-dominated cover. Minimal riparian buffer; pasture extends close to bank edge. Fence post visible indicating agricultural property boundary. Low bank height reduces erosion risk but lack of deep-rooted vegetation limits long-term stability. |
| Right | 4 | 5 | 26_50_percent | Right bank is higher and steeper than left bank with active erosion processes including undercutting and slumping. Dense invasive shrub growth (likely privet) on upper bank. Mowed grass area visible beyond the immediate bank, suggesting property maintenance extends close to the stream. Overhead utility lines cross near the right bank. |

| Metric | Score/Value | Notes |
|---|---|---|
| TDEC 30ft Buffer Met? | L: No / R: No | Both banks fall well short of TDEC MS4 permit section 4.2.5.4 minimum buffer requirements. Agricultural use (pasture) extends nearly to the stream bank on the left side. The right side has some woody vegetation but is dominated by invasive species. High potential for buffer restoration through native tree and shrub planting and invasive removal. Fencing to exclude livestock may also be needed. |

| Action | Priority | Timeline |
|---|---|---|
| Document riparian buffer deficiency for watershed planning and buffer restoration prioritization | medium | 90_days |
| Verify no illicit discharges upstream contributing to turbidity — confirm base flow turbidity is from diffuse agricultural sources | low | annual |
