# Scene 48 · MS4 Assessment

Black Branch 2

City of Lebanon TN

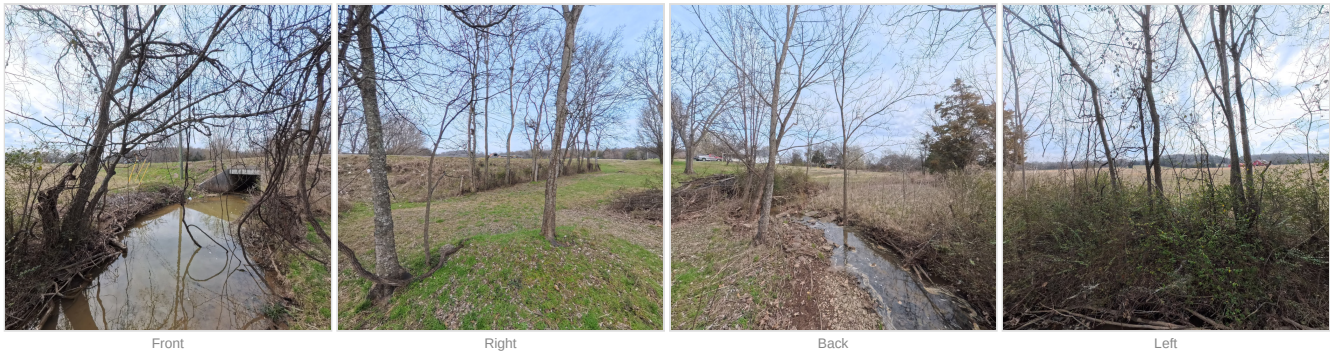
**Front:** Looking downstream toward a concrete box culvert that passes under a road embankment. The stream is pooled with brown, turbid water reflecting bare tree branches. A debris jam of woody material sits on the left bank just upstream of the culvert entrance. Yellow utility markers are visible on the road embankment above the culvert.

**Right:** Looking to the right bank (when facing downstream), the view shows a gently sloping grassy area with scattered deciduous trees, all leafless. The ground is a mix of green grass and leaf litter. A structure or building is visible in the background through the bare trees. The bank rises gradually from the stream channel. There appears to be some litter scattered in the area.

**Back:** Looking upstream, the channel narrows significantly and appears to have exposed bedrock or possibly concrete substrate. The stream is very shallow with water barely covering the bed surface. The left bank shows bare soil and erosion with exposed rocky/gravelly material. A vehicle is visible in the background on the left, suggesting proximity to a road or parking area. The right bank has dormant herbaceous vegetation and small trees.

**Left:** Looking to the left bank (when facing downstream), dense herbaceous vegetation and vine growth are visible, with scattered small deciduous trees in bare winter condition. Beyond the vegetation, an agricultural field or pasture is visible with a red barn structure in the distance. The riparian buffer here is narrow with a mix of dormant grass, vines, and weedy growth. Some green vine growth suggests possible invasive species (Japanese honeysuckle or similar evergreen vine).

Black Branch at this location (scene 48 of 53, near end of reach) is a small, incised perennial stream in marginal condition approaching a concrete box culvert road crossing. The channel is entrenched with moderate bank erosion, inadequate riparian buffers on both banks, and heavy fine sediment deposition. Agricultural land use on the left bank and maintained grass on the right bank encroach within the riparian zone, failing to meet TDEC 30ft minimum buffer requirements. The primary stressors are sedimentation from agricultural runoff, riparian buffer loss, and channel incision that disconnects the stream from its floodplain. The culvert creates a pooled backwater with limited habitat diversity. Restoration priorities should focus on riparian buffer establishment, particularly native tree and shrub planting, and addressing upstream sediment sources.

| Metric | Score | Notes |
|---|---|---|
| Channel Condition | 5 | Channel shows evidence of incision and is approaching a concrete box culvert road crossing. The culvert represents a significant channel alteration point. Upstream the channel appears relatively natural but incised. Some bank erosion and downcutting evident. The channel is not extensively armored but the culvert influence is notable. |
| Hydrologic Alteration | 4 | Channel appears moderately incised with banks 3-6ft high. The culvert road crossing and incision limit floodplain connectivity. The stream is unlikely to access its floodplain during typical annual flood events. Agricultural land use in the watershed likely contributes to flashy hydrology and increased peak flows. |
| Sediment Deposition | 4 | The pool upstream of the culvert appears to have significant fine sediment deposition. The brown turbid water prevents assessment of bottom conditions, but the uniform flat pool bottom and turbidity suggest substantial silt/mud accumulation. Estimated 30-50% of visible channel bottom affected by sediment deposition. |

| Side | Stability | Veg. Protection | Erosion | Notes |
|---|---|---|---|---|
| Left | 5 | 5 | 26_50_percent | Left bank has narrow riparian buffer with agricultural field beyond. Vine growth (possibly invasive Japanese honeysuckle) provides some bank cover. Moderate erosion upstream. The culvert wingwall provides localized bank stability at the road crossing. |
| Right | 5 | 5 | 26_50_percent | Right bank is more accessible and open with grass and scattered trees. Moderate erosion near waterline. Concrete culvert wingwall provides stability at the road crossing. Some debris accumulation near the culvert entrance. |

| Metric | Score/Value | Notes |
|---|---|---|
| Canopy Cover | 4 | Currently in winter with bare deciduous trees, shade is minimal (<25%). Even in full leaf conditions, the scattered tree coverage and thin buffer would likely provide only 25-50% shade. The right bank is very open with few trees. The left bank has somewhat denser tree coverage but still inadequate for full canopy closure over the channel. |
| TDEC 30ft Buffer Met? | L: No / R: No | Both banks fail to meet TDEC MS4 permit section 4.2.5.4 buffer requirements. Agricultural use encroaches within the buffer zone on the left bank. Mowed grass/lawn maintenance encroaches on the right bank. High potential for buffer restoration through native tree and shrub planting on both sides, particularly the right bank which has open ground available. |

| Metric | Score | Notes |
|---|---|---|
| Water Appearance | 4 | Water is brown and turbid with visibility estimated at 0.5-1ft based on the inability to see the bottom in the pool. This could be influenced by recent precipitation. No algal mats, sheens, or scum visible. The turbidity appears to be primarily from suspended sediment rather than algal growth. Score of 4 reflects considerable cloudiness that may be partly storm-related but suggests chronic sediment issues. |

| Action | Priority | Timeline |
|---|---|---|
| Document culvert crossing in outfall/infrastructure inventory including condition, dimensions, and debris accumulation | high | 90_days |
| Assess culvert for fish passage adequacy and hydraulic capacity with debris present | medium | 90_days |
| Monitor riparian buffer adequacy along both banks for compliance with TDEC MS4 permit section 4.2.5.4 | medium | annual |
