# Scene 49 · MS4 Assessment

Black Branch 2

City of Lebanon TN

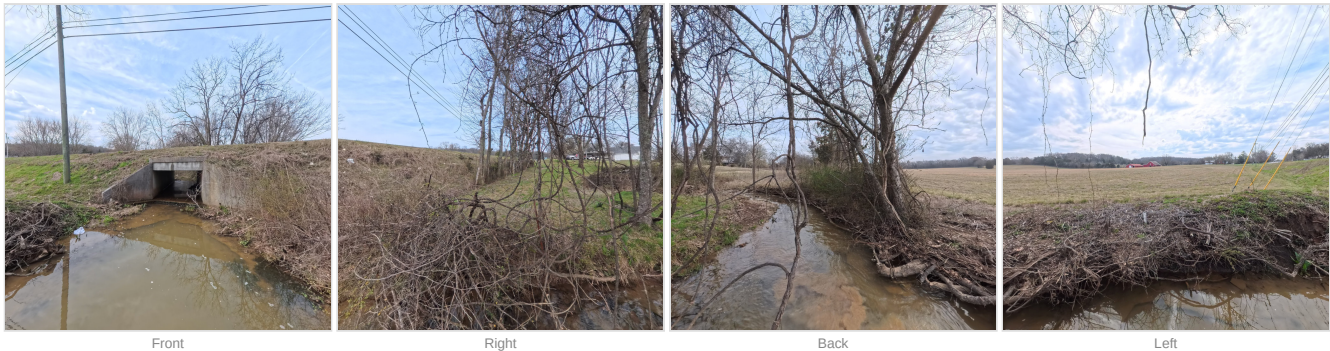
**Front:** Looking downstream toward a concrete box culvert under a road embankment. The culvert has concrete wingwalls on both sides and appears to be a single-cell box approximately 6-8 feet wide and 4-5 feet tall. Water is pooled in front of the culvert entrance with brown, turbid water. A utility pole with overhead power lines is visible on the left bank. The road embankment is grass-covered.

**Right:** Looking toward the right bank (left bank when facing downstream), showing a road embankment rising steeply with dormant grass and dead herbaceous vegetation. Overhead power lines cross the scene. In the background, a white building or structure is visible across a green grassy area. Scattered bare deciduous trees line the bank area. Dense tangles of dormant vines and brush are present at the bank edge.

**Back:** Looking upstream showing the stream channel flowing toward the camera through an agricultural/pastoral landscape. The water is brown and turbid with moderate flow. A large deciduous tree stands on the right bank with extensive vine growth. Both banks are low to moderate height with dormant grass and sparse woody vegetation. Open pasture or hayfields extend on both sides. A structure or house is visible in the far left background.

**Left:** Looking toward the left bank (right bank when facing downstream) showing open agricultural fields extending to the horizon. A red barn is visible in the middle distance. The bank edge is visible in the foreground with exposed soil, dormant roots, and debris. Yellow utility markers (likely gas pipeline) are visible in the field. Overhead power lines cross the scene. The bank shows moderate erosion with exposed roots and bare soil at the waterline.

Black Branch at this location (#49 of 53) is a small perennial agricultural stream in poor overall condition near a concrete box culvert road crossing. The most critical issues are the severely degraded or absent riparian buffer on both banks, chronic sedimentation resulting in silt-dominated substrate and turbid water, and poor instream habitat diversity. Bank erosion is moderate, particularly on the right bank where agricultural fields extend to the stream edge. The concrete box culvert is in good structural condition but represents a potential fish barrier and channel modification point. No stormwater outfalls or illicit discharges were observed, but the road crossing lacks stormwater treatment BMPs. Riparian buffer restoration is the highest priority management action for this reach.

| Metric | Score | Notes |
|---|---|---|
| Channel Condition | 5 | Channel is largely natural upstream but a concrete box culvert at this location represents significant local alteration. The channel appears to maintain a natural planform but is influenced by the road crossing. Some bank erosion and lateral instability evident but not severe downcutting. |
| Sediment Deposition | 3 | Significant sediment deposition evident from extremely turbid water. Pool upstream of culvert appears to be filling with fine sediment. The silt/mud substrate indicates chronic sedimentation. Agricultural land use without adequate riparian buffers contributes to sediment loading. |

| Side | Stability | Veg. Protection | Erosion | Notes |
|---|---|---|---|---|
| Left | 4 | 4 | 26_50_percent | Left bank transitions from natural condition upstream to engineered condition at the culvert. Road embankment is grass-covered. Invasive vine tangles dominate the bank edge vegetation. |
| Right | 3 | 3 | 26_50_percent | Right bank is more vulnerable due to agricultural land use extending close to the bank edge. Very narrow or absent riparian buffer. Utility markers in adjacent field suggest buried pipeline. Bank erosion more pronounced on this side. |

| Metric | Score/Value | Notes |
|---|---|---|
| TDEC 30ft Buffer Met? | L: No / R: No | Both banks fail to meet TDEC's minimum 30ft riparian buffer requirement. The right bank is especially deficient with agriculture extending to the stream edge. Buffer restoration potential is high given the low-intensity agricultural land use and available land area. Riparian planting would significantly benefit water quality and bank stability. |

| Metric | Score | Notes |
|---|---|---|
| Water Appearance | 3 | Water is considerably turbid with a brown/muddy color. Visibility appears to be less than 1 foot, possibly under 0.5 feet given the opaque quality. The bed is not visible even in what appears to be shallow areas. This could be partly from recent precipitation but the chronic fine sediment substrate suggests persistent turbidity issues. |

| Action | Priority | Timeline |
|---|---|---|
| Add concrete box culvert to outfall/crossing inventory with condition assessment | medium | 90_days |
| Document culvert location for fish passage assessment and maintenance schedule | medium | 90_days |
| Map buried utility crossing (gas pipeline markers visible) and assess potential impacts | low | annual |
