# Scene 5 · MS4 Assessment

Black Branch 2

City of Lebanon TN

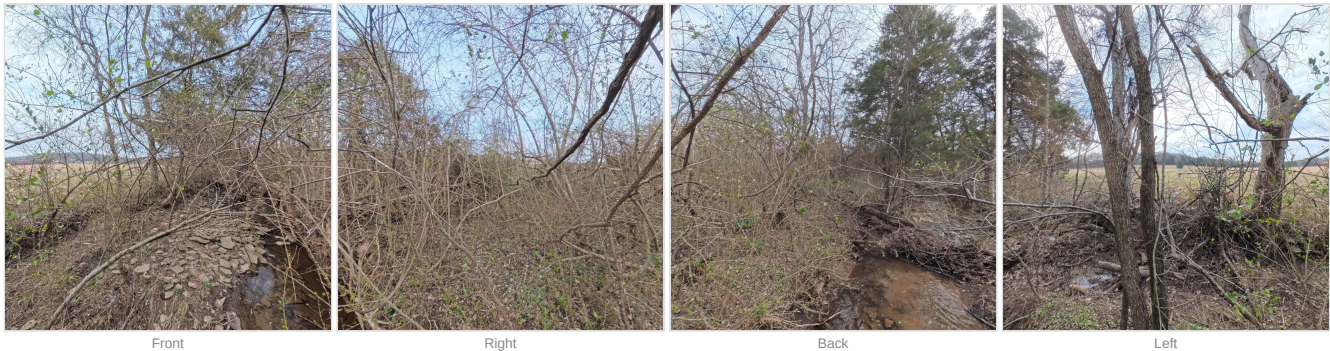
**Front:** Looking downstream through dense shrubby vegetation along a very small stream channel. Flat limestone-like rock fragments visible in the channel bed forming a rocky substrate. Agricultural fields and a red barn/structure visible in the background through the bare branches on the left side. The channel appears narrow and shallow with minimal water flow.

**Right:** Dense thicket of shrubs and small trees covering the right bank, with very little visibility through the vegetation. The bank rises moderately with dense herbaceous ground cover and dormant shrubby growth. Early spring green-up just beginning with scattered small green leaves emerging. The density of the shrub layer suggests possible invasive species such as bush honeysuckle or multiflora rose.

**Back:** Looking upstream, a very small stream channel is visible with shallow brown-tinted water flowing over a rocky and muddy substrate. The left bank shows dense shrubs and small trees. A larger fallen log spans partially across the channel creating a minor debris jam. The right bank is vegetated with trees and shrubs, some showing early spring leaf emergence. An evergreen tree (likely cedar) is visible in the upper right.

**Left:** Looking at the left bank, mature deciduous trees with bare branches frame the view. Beyond the immediate riparian corridor, open agricultural fields are clearly visible extending to the horizon with a red structure (barn) visible in the far distance. The bank area shows some woody debris and sparse ground cover. A small area of standing water or very shallow pool is visible at the base of the bank near the channel.

Black Branch at this location is a small headwater stream in marginal condition, significantly influenced by adjacent agricultural land use. The stream is moderately incised and disconnected from its floodplain, with a narrow and inadequate riparian buffer particularly on the left bank where agricultural fields encroach close to the channel. Instream habitat is limited by uniform shallow flow, embedded substrate, and sparse large woody debris. No stormwater infrastructure or outfalls were observed, and no illicit discharges are suspected. The primary management need is riparian buffer restoration on the left bank to meet TDEC minimum standards and reduce sediment inputs from agricultural runoff.

| Metric | Score | Notes |
|---|---|---|
| Channel Condition | 6 | Channel appears natural with no direct structural modifications. However, the channel shows moderate incision relative to the surrounding floodplain, likely a result of increased runoff from adjacent agricultural land use. The channel is disconnected from its floodplain, indicating past hydrologic alteration from land use change rather than direct channel modification. |
| Hydrologic Alteration | 4 | The channel shows moderate incision with banks approximately 3-6 feet high relative to a narrow channel. This disconnect from the floodplain suggests reduced flood frequency. Agricultural land use in the watershed has likely altered hydrology through increased peak flows and reduced infiltration. The stream appears to be adjusting to altered flow regime. |
| Sediment Deposition | 5 | Moderate fine sediment deposition visible between rock fragments in the bed. The brown water color suggests ongoing sediment transport. Some fine sediment accumulation in low-velocity areas. The substrate mix of gravel and mud indicates moderate sedimentation from agricultural runoff, affecting perhaps 20-30% of the bed. |

| Side | Stability | Veg. Protection | Erosion | Notes |
|---|---|---|---|---|
| Left | 5 | 5 | 1_25_percent | Left bank has narrow riparian buffer with agricultural fields immediately beyond. Bank is moderately high and shows some erosion. Mature deciduous trees provide limited root protection. Buffer width appears to be approximately 10-25 feet in most areas. |
| Right | 6 | 6 | 1_25_percent | Right bank has denser vegetation than left bank, primarily dense shrub thicket. Wider riparian buffer appears present on this side. Some potential invasive shrubs noted. Overall more stable than the left bank. |

| Metric | Score/Value | Notes |
|---|---|---|
| TDEC 30ft Buffer Met? | L: No / R: Yes | Left bank riparian buffer does not meet TDEC minimum 30ft standard. Agricultural field encroaches close to the stream bank. Buffer restoration through planting native trees and shrubs on the left bank would be highly beneficial and relatively straightforward given the flat agricultural terrain. Right bank buffer is marginal but appears to meet minimum standards. |

| Metric | Score | Notes |
|---|---|---|
| Water Appearance | 5 | Water has a brown tint suggesting suspended sediment or tannins. Visibility appears to be approximately 0.5-1 foot based on the ability to see the substrate in the shallow areas. No oil sheen, foam, or algal mats observed. The brown color may be partly natural from leaf litter decomposition in a wooded headwater stream, but agricultural sediment contribution is likely. |

| Action | Priority | Timeline |
|---|---|---|
| Document inadequate riparian buffer on left bank for TDEC buffer compliance tracking | medium | 90_days |
| Verify no agricultural runoff BMPs are needed based on upstream land use review | medium | 90_days |
