# Scene 50 · MS4 Assessment

Black Branch 2

City of Lebanon TN

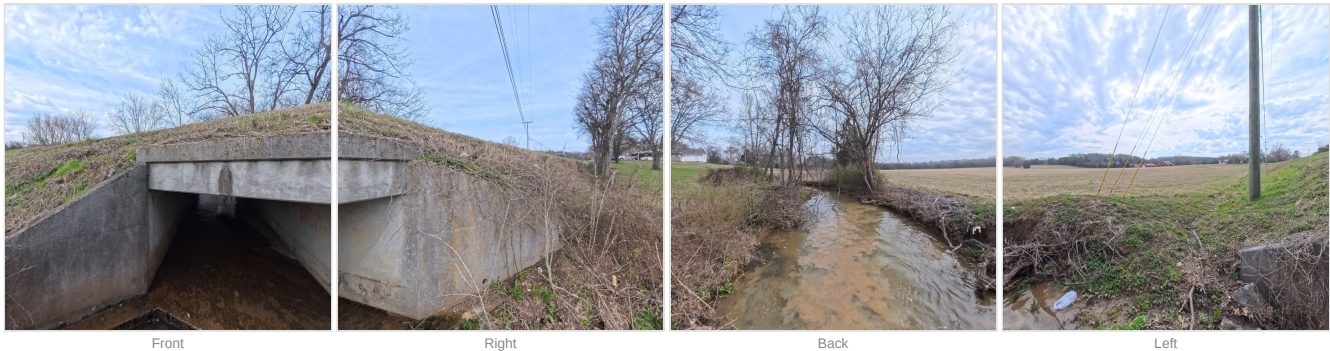
**Front:** Looking downstream into a concrete box culvert that carries the stream under a road embankment. The culvert is a cast-in-place concrete structure with visible header beam and wingwalls. Water is flowing through the culvert with turbid brown color. The road embankment above is covered with dormant grass and some green growth.

**Right:** Looking at the right bank (right when facing downstream) showing the side of the concrete box culvert structure with its wingwall extending along the bank. The concrete wall is weathered with some moss growth. Above the culvert, the road embankment rises with dormant grass and bare deciduous trees. Overhead electric utility lines cross the scene. Beyond the culvert, residential properties and vehicles are visible in the distance.

**Back:** Looking upstream from the culvert entrance showing a small stream channel flowing through a rural agricultural landscape. The stream has turbid brown water with a sand/silt bed visible beneath. Banks are low to moderate with sparse dormant vegetation, bare deciduous trees, and some brush. A white building/barn is visible on the left bank side. Open agricultural fields extend to the right. The riparian buffer is narrow with only scattered trees.

**Left:** Looking to the left bank (left when facing downstream) showing an open agricultural field with dormant grass/pasture extending to the horizon. A utility pole with power lines stands near the bank edge. The bank is eroding with exposed soil and roots. A piece of litter (appears to be a plastic bag or similar) is visible in the water. A concrete block or remnant is visible near the base of the utility pole. A red barn is visible in the far distance across the field.

| Metric | Score | Notes |
|---|---|---|
| Channel Condition | 3 | The stream is channelized through a concrete box culvert at this location. The upstream reach shows some incision and bank erosion. The culvert represents significant channel alteration. Overall the channel shows evidence of straightening and modification associated with the road crossing. The natural channel upstream is somewhat degraded but not fully channelized. |
| Hydrologic Alteration | 4 | Moderate incision is evident upstream of the culvert with banks 3-6ft high relative to water level. The box culvert and road embankment constrict flow. The stream appears somewhat disconnected from its floodplain. Agricultural land use and road infrastructure limit floodplain access. |
| Sediment Deposition | 3 | The stream bed is dominated by silt and mud, indicating heavy sediment loading from the surrounding agricultural landscape. Fine sediment deposition is visible on the culvert floor and throughout the upstream channel. The turbid brown water suggests active sediment transport. Approximately 30-50% of the bed appears affected by fine sediment deposition. |

| Side | Stability | Veg. Protection | Erosion | Notes |
|---|---|---|---|---|
| Left | 3 | 3 | 26_50_percent | Left bank transitions from unprotected eroding agricultural bank upstream to concrete culvert wingwall at the road crossing. Utility pole is situated near bank edge with some concrete foundation material. Minimal riparian buffer - agricultural field extends nearly to bank edge. |
| Right | 4 | 4 | 1_25_percent | Right bank has slightly better riparian conditions than left, with scattered trees upstream providing some root protection. Residential properties visible beyond the right bank with mowed grass areas. Culvert wingwall in good structural condition. |

| Metric | Score/Value | Notes |
|---|---|---|
| TDEC 30ft Buffer Met? | L: No / R: No | Both banks fail to meet TDEC MS4 permit section 4.2.5.4 minimum 30ft buffer requirements. The left bank is the most critical with agricultural use extending to the bank edge, contributing to erosion and sediment loading. Right bank is slightly better but still non-compliant. Buffer restoration, especially on the left bank, would be highly effective given the flat agricultural terrain. |

| Metric | Score | Notes |
|---|---|---|
| Water Appearance | 3 | Water is considerably turbid with brown coloration throughout all views. Visibility appears to be approximately 0.5-1ft based on the partially visible stream bed. The turbidity likely reflects recent rainfall runoff from surrounding agricultural fields. Sediment is the primary water quality concern visually. |

| Action | Priority | Timeline |
|---|---|---|
| Document box culvert in outfall/crossing inventory for MS4 mapping | high | 90_days |
| Assess road runoff entering stream through culvert - no treatment BMPs present | medium | 90_days |
| Conduct growing season follow-up survey to assess invasive species and summer water quality | medium | annual |
