# Scene 51 · MS4 Assessment

Black Branch 2

City of Lebanon TN

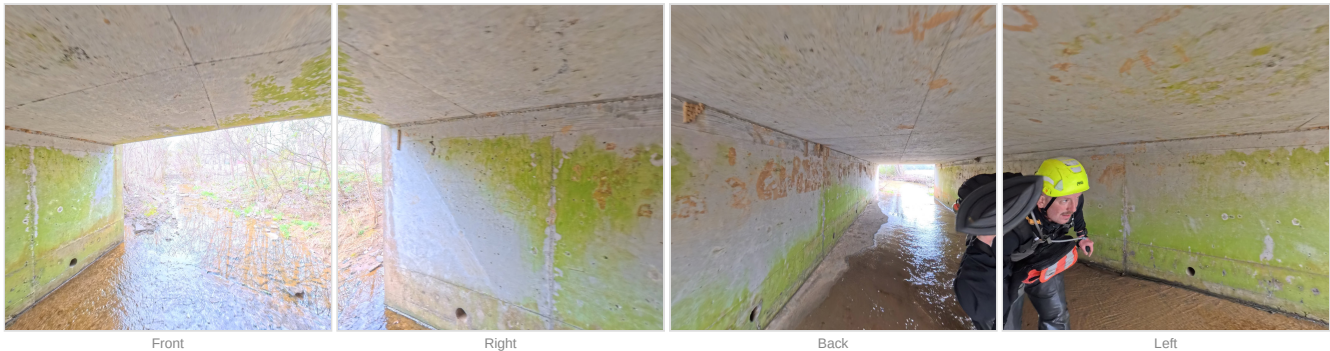
**Front:** Looking downstream (direction of travel) from inside a large concrete box culvert. The downstream opening reveals a narrow stream channel with shallow water continuing through a wooded area with mostly bare deciduous trees and early spring green growth. Small rock fragments and sediment deposits visible at the culvert outlet. The stream narrows significantly beyond the culvert opening.

**Right:** The right side view shows the interior right wall (right bank when facing downstream) of a large concrete box culvert. The wall is cast-in-place concrete with visible panel joints, green algae/moss growth on the lower half, and orange-brown staining on upper portions. A circular weep hole is visible near the base of the wall. Beyond the culvert edge, bare deciduous trees and some herbaceous vegetation are visible on the right bank.

**Back:** Looking upstream (back toward the approach) from inside the concrete box culvert. The view shows the culvert extending upstream with the inlet opening visible in the distance. Shallow brown water flows across the concrete floor. A person wearing a Petzl helmet and safety gear (the survey team member) is visible on the right side. The left culvert wall shows green algae growth and orange-brown staining. Light enters from the upstream opening where debris accumulation and vegetation are partially visible.

**Left:** The left side view shows a survey team member wearing a yellow Petzl helmet, safety harness, and wading gear standing inside the concrete box culvert near the left wall. The left wall is cast-in-place concrete with heavy green algae/moss growth on the lower half and orange-brown mineral staining above. A circular weep hole is visible near the base of the wall. The concrete floor beneath is covered with a thin layer of sandy-brown sediment and shallow water.

Scene 51 captures a concrete box culvert road crossing near the end of Black Branch 251. The stream passes through an approximately 8-10 foot wide by 5-6 foot tall cast-in-place concrete box culvert with moderate sediment deposition on the floor and shallow turbid flow. The culvert completely eliminates all natural channel, habitat, and riparian functions at this location. The structure is in fair condition with minor weathering, algae/moss growth on lower walls, and orange-brown mineral staining. While the water quality appears acceptable (no evidence of illicit discharge, contamination, or severe nutrient enrichment), the habitat value is essentially zero within the culvert. This is a critical point of habitat fragmentation that may impede fish passage during low flow conditions. For MS4 compliance, the culvert weepholes should be monitored during dry weather screening, and sediment accumulation should be periodically assessed for maintenance needs.

| Metric | Score | Notes |
|---|---|---|
| Channel Condition | 2 | The stream at this location is entirely enclosed within a concrete box culvert, representing complete channelization at this point. The natural channel has been replaced with an engineered structure. Score of 2 reflects that while the culvert itself is not actively downcutting, the channel is 100% concrete-modified at this location. Downstream of the culvert, some natural channel characteristics appear present. |
| Hydrologic Alteration | 3 | The box culvert constrains flood flows and disconnects the stream from its floodplain within the crossing. The culvert dimensions appear adequate for low to moderate flows but the structure inherently alters the natural hydrologic regime. Some incision may be present based on the depth of the culvert below grade. |
| Sediment Deposition | 4 | Moderate sediment deposition observed across approximately 60-80% of the culvert floor. Fine sand and silt deposits 1-2 inches thick indicate active sediment transport from upstream. The flat concrete floor promotes deposition during low flow conditions. Score reflects moderate to heavy deposition within the culvert structure. |

| Side | Stability | Veg. Protection | Erosion | Notes |
|---|---|---|---|---|
| Left | 7 | 3 | 0_percent | Left bank is entirely engineered concrete within the culvert. Transitions to natural bank conditions downstream of culvert outlet. Algae growth line on concrete wall indicates normal water level approximately 2 feet above current flow. |
| Right | 7 | 3 | 0_percent | Right bank conditions essentially identical to left bank - full concrete wall within culvert transitioning to natural bank downstream. |

| Metric | Score | Notes |
|---|---|---|
| Water Appearance | 4 | Water is moderately turbid with a brown coloration suggesting suspended sediment. Visibility appears to be approximately 0.5-1 foot based on the ability to partially see the concrete floor through the water. The turbidity may be elevated due to recent precipitation. No sheen, scum, or film observed on the water surface. |

| Action | Priority | Timeline |
|---|---|---|
| Add this box culvert to the outfall/infrastructure inventory for Black Branch 251 | high | 30_days |
| Conduct dry weather screening at culvert weepholes to verify no illicit connections to subsurface drainage | medium | 90_days |
| Document road drainage connections to the culvert from the road surface above | medium | 90_days |
| Assess sediment accumulation for maintenance scheduling | medium | annual |
