# Scene 52 · MS4 Assessment

Black Branch 2

City of Lebanon TN

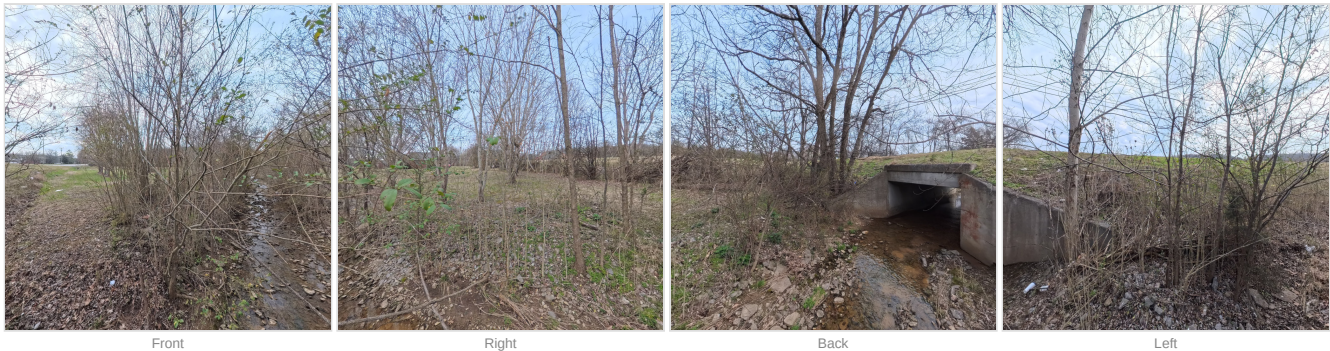
**Front:** Looking downstream, the view shows dense multi-stemmed shrubby vegetation (likely bush honeysuckle) dominating the center of the frame. A narrow shallow stream channel is visible on the right side flowing through a small incised channel. To the left, a mowed grass area and what appears to be a commercial/institutional area with a building and light pole visible in the background. Some litter is visible on the ground.

**Right:** Looking to the right bank (when facing downstream), the view shows sparse deciduous trees and shrubs mostly in bare or early-leaf condition. The ground is covered with gravel, small rocks, and some green herbaceous growth. Residential structures are faintly visible in the background through the bare trees. The terrain appears relatively flat with scattered volunteer woody vegetation.

**Back:** Looking upstream (back), a concrete box culvert is clearly visible carrying the stream under what appears to be a road embankment. The culvert has concrete headwalls and wingwalls. The stream flows from the culvert opening with shallow water over a gravel/cobble bed. The road embankment above is grassed. Bare deciduous trees line the left side of the channel. Overhead utility lines are visible. Some angular rock fragments near the culvert apron may be concrete debris or placed stone.

**Left:** Looking at the left bank (when facing downstream), a concrete wingwall or headwall structure is visible on the left side, part of the culvert system seen in the back view. Dense multi-stemmed shrubs (likely bush honeysuckle) fill the area between the concrete structure and the bank. The road embankment rises steeply behind with mowed grass. A grassy hillslope extends upward. Overhead utility lines are visible. Some litter including what appears to be a white PVC pipe fragment is on the ground. Gravel and rubble are scattered at the base.

Black Branch 252 at this end-of-reach location (Scene 52 of 53) is a severely impaired small headwater stream flowing through a suburban/commercial landscape in middle Tennessee. The stream emerges from a concrete box culvert under a road and flows through a corridor dominated by invasive bush honeysuckle with minimal native riparian vegetation. Instream habitat is poor with uniform shallow flow, limited substrate diversity, no pools, and virtually no large woody debris. The channel is moderately entrenched and disconnected from its floodplain. Water quality appears adequate based on visual indicators but the physical habitat cannot support healthy aquatic communities. Priority management actions include invasive species control, native riparian buffer restoration, and potential instream habitat enhancement.

| Metric | Score | Notes |
|---|---|---|
| Channel Condition | 4 | Channel shows evidence of alteration with the concrete box culvert immediately upstream. Some concrete debris in the bed. Channel appears somewhat incised but not actively downcutting. Less than 50% channelized but significant infrastructure influence at this end-of-reach location. |
| Hydrologic Alteration | 4 | The stream appears moderately incised with banks 2-3ft above the water surface. The culvert and road crossing constrain floodplain access. Commercial development in the surrounding area likely contributes to flashy hydrology. The channel does not appear to regularly access its floodplain. |
| Sediment Deposition | 5 | Gravel deposition is present in the streambed with some accumulation near the culvert outlet. Approximately 10-30% of the bed affected. Some sediment sorting evident but not severe aggradation. |

| Side | Stability | Veg. Protection | Erosion | Notes |
|---|---|---|---|---|
| Left | 5 | 5 | 1_25_percent | Left bank transitions from concrete culvert structure to natural bank with invasive shrubs. Road embankment provides elevated bank above. Grassed slope above. |
| Right | 5 | 4 | 1_25_percent | Right bank is lower than left, with sparse deciduous trees and shrubs. Ground surface is gravelly with scattered rocks. Residential structures visible in background suggesting nearby development. |

| Metric | Score/Value | Notes |
|---|---|---|
| TDEC 30ft Buffer Met? | L: No / R: No | Both banks have inadequate riparian buffers for TDEC MS4 compliance. The left bank is constrained by the road but could benefit from invasive removal and native plantings in the available space. The right bank has more room for buffer restoration but would require invasive species management first. |

| Action | Priority | Timeline |
|---|---|---|
| Complete outfall mapping for upstream storm system feeding the box culvert | medium | 90_days |
| Conduct dry weather screening of the culvert system and any connected storm system inputs upstream | medium | 90_days |
| Document culvert condition and fish passage status for infrastructure inventory | medium | annual |
