# Scene 6 · MS4 Assessment

Black Branch 2

City of Lebanon TN

36.17007, -86.26855 - Generated October 23, 2026

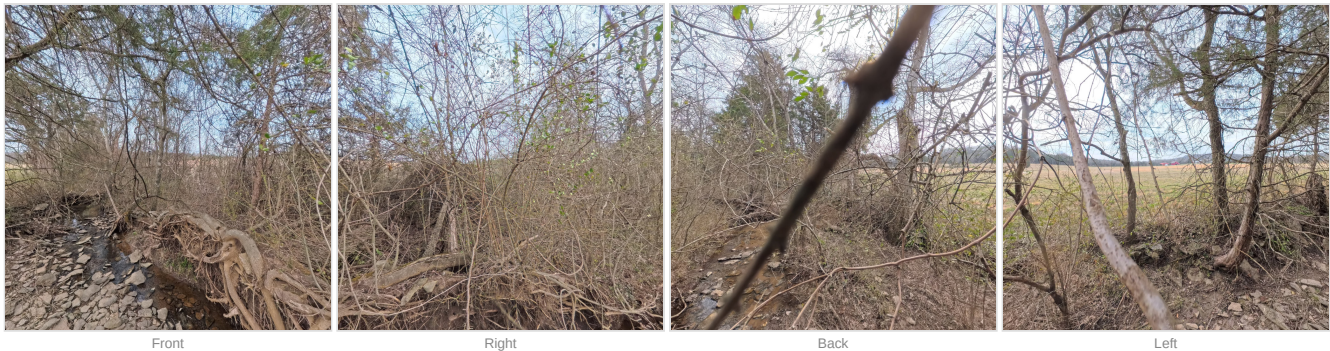
**Front:** Looking downstream, a very narrow thread of low flow water winds through a bed dominated by flat, angular limestone/shale substrate. Exposed tree roots from a large fallen or leaning tree are prominent on the right side of the channel. Dense dormant deciduous shrubs and small trees line both banks with early spring leaf-out beginning. A building or structure is faintly visible in the far left background through the vegetation.

**Right:** Looking toward the right bank (when facing downstream), dense dormant deciduous shrubs and small trees form a thick riparian thicket. Early spring green leaves are emerging on some shrubs, possibly bush honeysuckle or privet based on early leaf-out timing. The bank edge shows exposed roots, woody debris, and some flat rock fragments. Visibility into the landscape beyond is limited by the dense vegetation.

**Back:** Looking upstream, the narrow channel continues with very low flow over flat limestone/shale substrate. The bed is largely exposed with angular rock fragments. Dense dormant shrubs line both sides. A branch partially obstructs the camera view. Through gaps in vegetation on the right side, open pasture/agricultural land and distant structures are visible, indicating the stream corridor is bordered by agricultural land use. The bank on the right shows some bare soil exposure.

**Left:** Looking toward the left bank (when facing downstream), trees and sparse shrubs reveal open agricultural pasture beyond with a distant red barn/farm structure visible. The riparian buffer on this side is narrow — only a thin line of trees separates the stream from the open pasture. The bank shows exposed rock and soil. Some small deciduous trees are present but the buffer appears to be only 10-25 feet wide before transitioning to open grassland.

Black Branch scene #6 reveals a small, entrenched headwater stream with low baseflow flowing through a narrow channel dominated by flat limestone/shale substrate. The stream is moderately impaired primarily due to channel incision disconnecting it from the floodplain, an inadequate riparian buffer on the left bank adjacent to agricultural pasture, and invasive shrub species dominating the right bank buffer. Water quality appears visually acceptable at baseflow, but habitat diversity is poor with limited pools and only 2 of 4 velocity-depth regimes present. No stormwater infrastructure or outfalls were observed at this rural location. Priority management actions include left bank riparian buffer restoration and invasive species management on the right bank.

| Metric | Score | Notes |
|---|---|---|
| Channel Condition | 6 | Channel appears natural with no direct structural modifications, but shows evidence of incision with moderately steep banks (3-6ft) and exposed tree roots indicating downcutting. The channel is entrenched below the surrounding floodplain. No riprap or channelization observed, but hydrologic alteration from adjacent agricultural land use has likely contributed to channel instability. |
| Hydrologic Alteration | 4 | Moderate channel incision with banks approximately 3-6ft high. The channel appears disconnected from its floodplain under normal conditions. Agricultural land use in the watershed has likely increased peak flows and contributed to channel degradation. Low flow conditions suggest possible flashy hydrology. |

| Side | Stability | Veg. Protection | Erosion | Notes |
|---|---|---|---|---|
| Left | 5 | 4 | 26_50_percent | Left bank has a narrow riparian buffer with sparse tree cover. Open agricultural pasture is visible directly beyond the thin tree line. Bank is steep with moderate height. Less vegetative protection than the right bank. |
| Right | 5 | 6 | 1_25_percent | Right bank has dense shrub vegetation providing good coverage, but significant root exposure at bank toe indicates active undercutting. Early leaf-out species may be invasive bush honeysuckle or privet. Dense thicket extends well beyond bank top. |

| Metric | Score/Value | Notes |
|---|---|---|
| TDEC 30ft Buffer Met? | L: No / R: Yes | Left bank buffer is below TDEC 30ft minimum standard. Agricultural pasture extends within the required buffer zone. This is a high priority for buffer restoration. Right bank meets minimum width but would benefit from invasive species management to restore native vegetation composition. |

| Action | Priority | Timeline |
|---|---|---|
| Document inadequate riparian buffer on left bank for watershed management planning | medium | 90_days |
| Continue downstream visual survey to document full reach conditions and identify any outfalls or illicit discharges | medium | annual |
